THIS IS A TECH TIP, NOT A TECHNICAL BULLETIN.

Applicable Vehicles					
Model(s)	Year	Eng. Code	Trans. Code	VIN Range From	VIN Range To
Passat	2012-2014	2.0L TDI (CKRA)	All	All	All

Oil leak from Camshaft Seal.

15-20-02TT Oil Leak at Cylinder Head Area

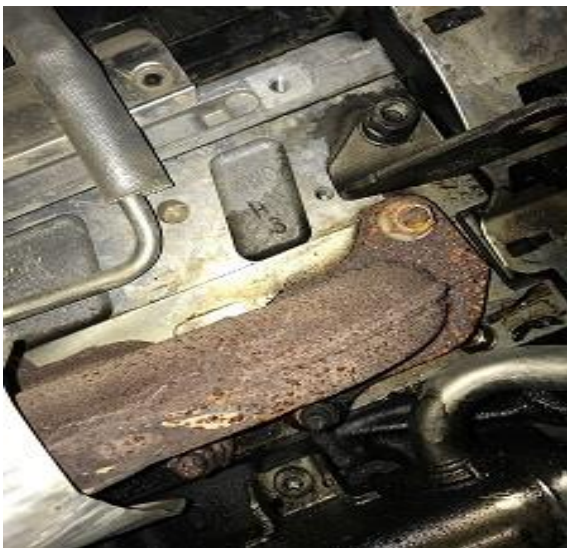
Figure1

If oil is found leaking between the exhaust manifold and timing cover (Figure 1), check for an oil leak at camshaft seal (Figure 2). Replace the seal as needed using the procedure in the repair manual.
