NUMBER: 23-010-20 REV. A

Sunroof Water Leak

This bulletin involves testing the sunroof for leaks and replacing the power sunroof glass, if necessary.

2019	(DS)	RAM 1500 Pickup
2019	(DJ)	RAM 2500 Pickup
2019	(D2)	RAM 3500 Pickup
2019	(DX)	RAM Truck (Mexico)

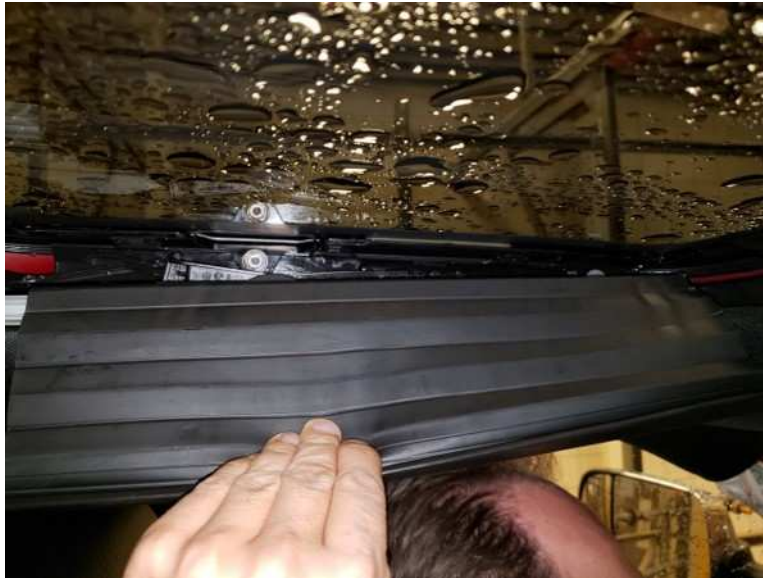
Fig. 1
Sunroof Flex Cover

1. On Driver's side, open sunroof sunshade, locate sunroof mechanism flex cover and remove flex cover from sunroof glass (Fig. 1) .

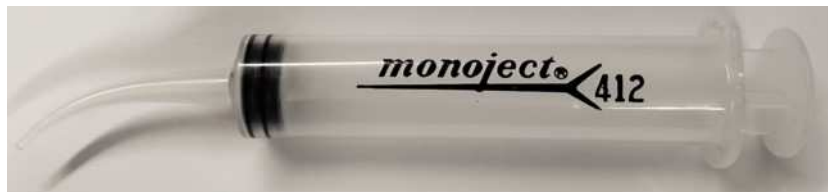
Fig. 2
Plastic Syringe (Monoject® 412)

2. Obtain plastic syringe with curved tip (Monoject® 412) (Fig. 2) and fill with water.

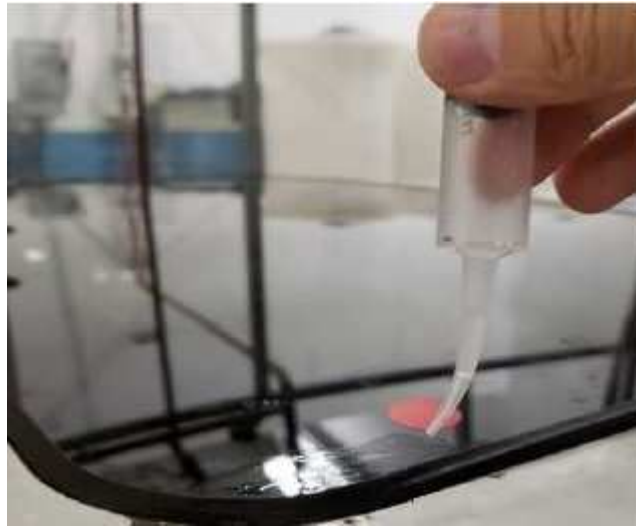
Fig. 3
Testing Area

4. Position syringe filled with water near front corner of glass with curved tip pointing forward as shown in (Fig. 3) .

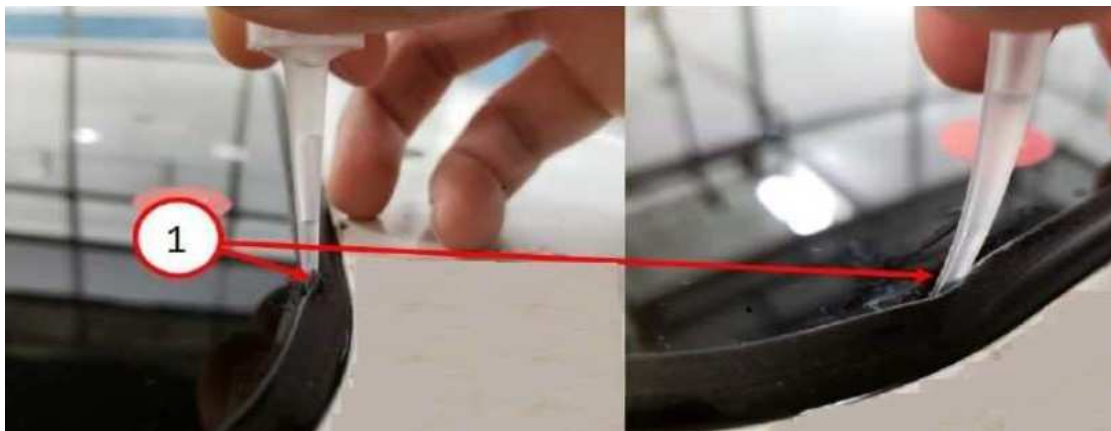
Fig. 4
Seal Testing

5. Insert syringe tip between sunroof glass and seal along side of glass at beginning of front corner tangent. Press on plunger to begin injecting water and empty entire volume over several seconds (Fig. 4) .

NOTE: DO NOT insert syringe tip between seal and body.

1 - Insert Tip of Syringe Into Seal

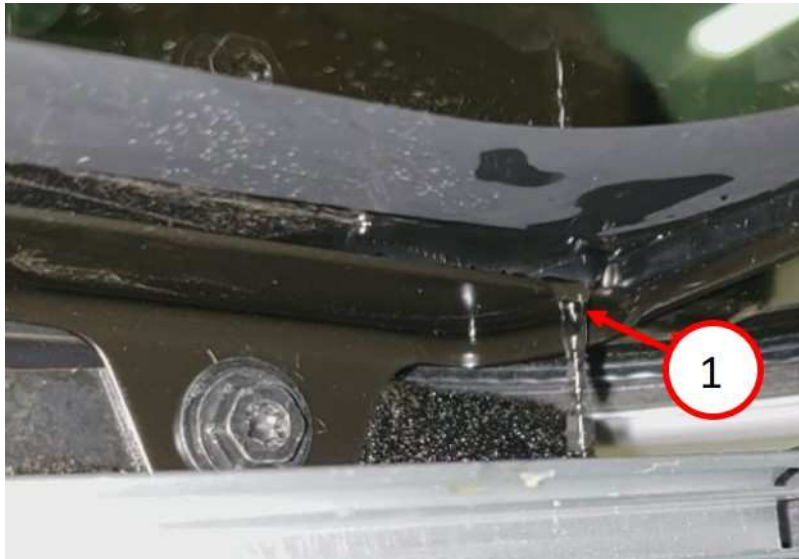
Fig. 5
Example of Water Leak

6. While water is being injected have assistant inspect for water leaking from the sunroof glass frame near front glass attachment (Fig. 5) .

1 - Water Leak

1. Replace the sunroof glass. Refer to the detailed service procedures available in DealerCONNECT/Service Library under: Service Info 23 - Body / Sunroof / Glass, Sunroof / Removal and Installation.
