NUMBER: 09-005-20

3.0L Oil Filter Cartridge Identification Differences And Oil Filter Element Servicing Procedure

****This bulletin outlines the correct procedure for changing an oil filter on a 3.0L diesel to prevent engine damage.**** The bulletin also highlights the design differences in the oil filter cartridges used in the GEN-2 and GEN-3 3.0L diesel. As well as potential issues that can arise should the incorrect filter be used in each application.

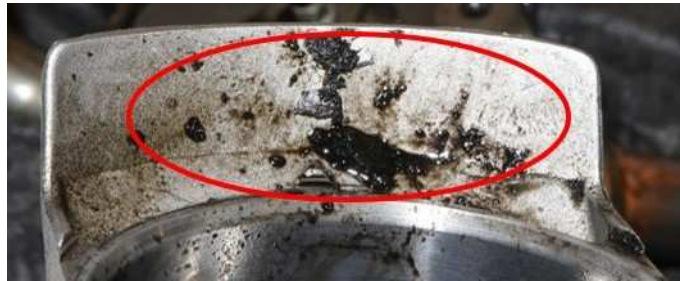
Fig. 1

Dirty Anti Spill Lip (If Equipped)

CAUTION! Clean all dirt off of the anti spill lip before opening the filter cap. Failure to do so may result in debris entering the engine and causing bearing failure.

3. Clean all the dirt off of the anti spill lip of the filter housing (if equipped) (Fig. 1) . If not equipped, proceed to [Step 4](#) of the Repair Procedure.

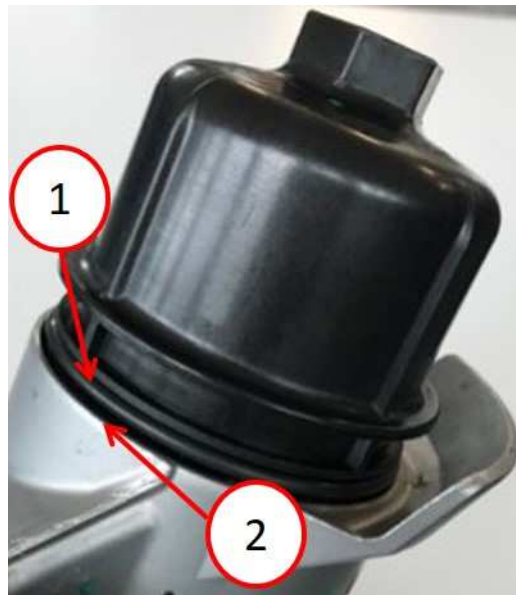
Fig. 2

Filter Cap With Exposed Cap O-Ring

1 - O-Ring

2 - Filter Housing

4. Open the filter cap approximately six turns until the cap O-ring is visible (Fig. 2) and stop. **This will allow air into the filter housing for proper drainage.**

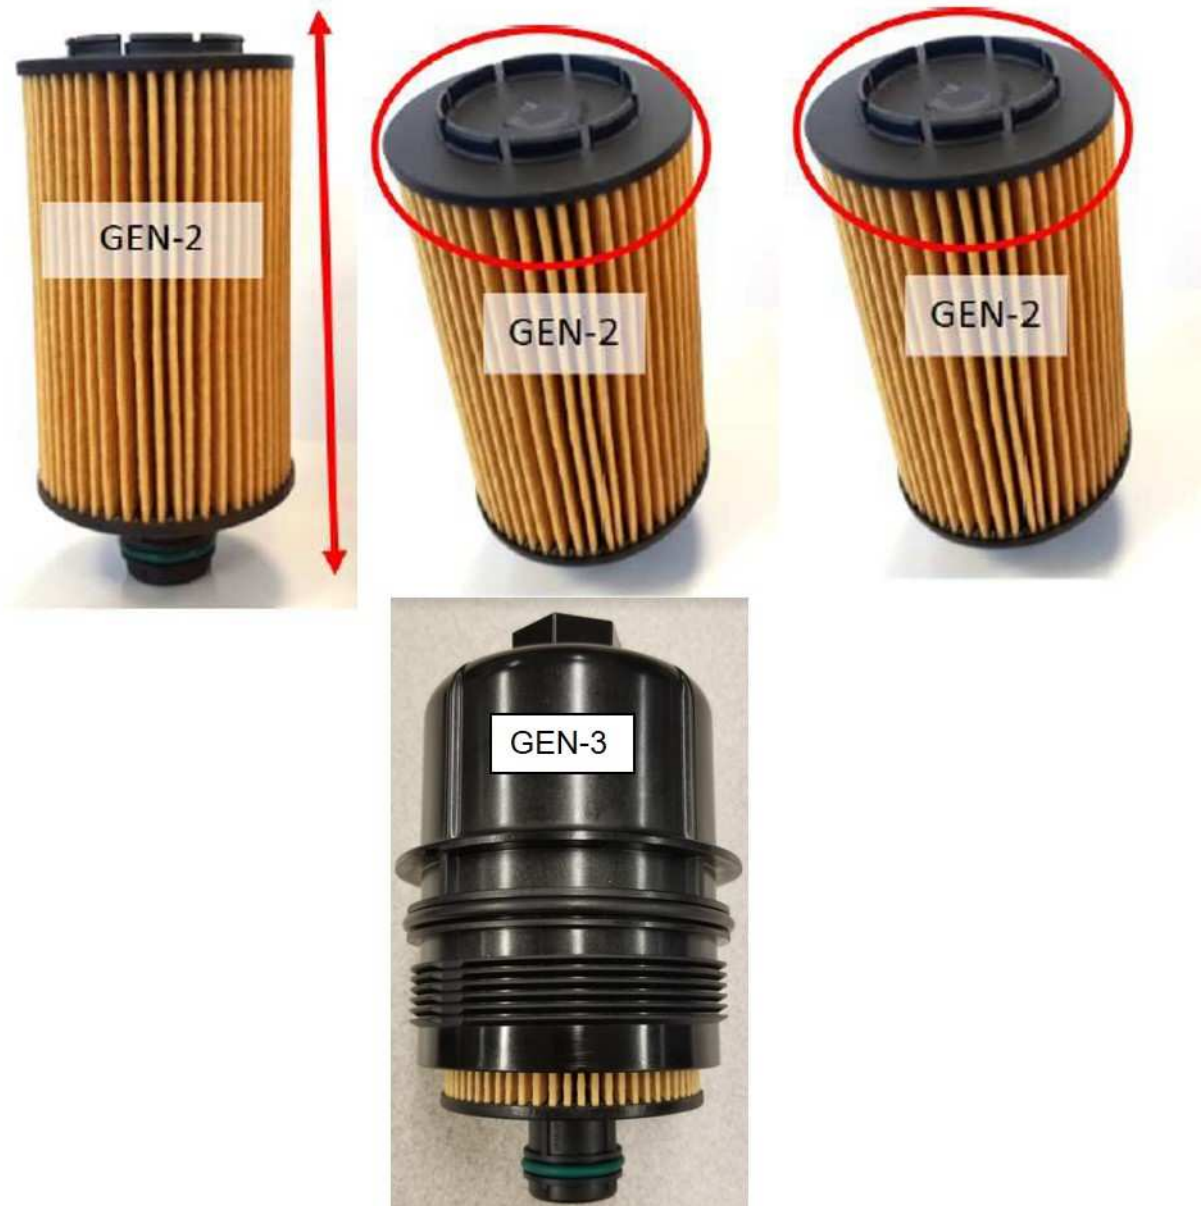
Fig. 3

The key differences between GEN-2 and GEN-3 engine oil filter cartridge assemblies **** (Fig. 3) **** include the GEN-2 oil filter cartridge is replaced separate from the cap. While the GEN-3 is meant to be replaced as a cap and cartridge in one assembly. **Do not attempt to separate the oil filter cartridge from the GEN-3 cap.**

****Physical Differences In GEN-2 And GEN-3 Oil Filter Cartridges****

There are several design changes between the GEN-2 and GEN-3 engines, including the oil filter cartridge. These filters are similar in appearance, however they are different in design and can lead to engine damage should the incorrect filter be used in each engine.

CAUTION! The GEN-3 design filter is designed to be replaced as a set. DO NOT remove the oil filter cartridge from the cap when servicing any oil filter on a GEN-3 engine. Failure to do so may result in damage to the oil filter cartridge or cap.
