GROUP
Product Improvement

NUMBER
PI1802Y/Z (Rev 1, 04/09/2020)

PRODUCT IMPROVEMENT CAMPAIGN

**SUBJECT: ENGINE REPLACEMENT INSTRUCTIONS
FOR DTC P1326 (PI1802Y/Z)**

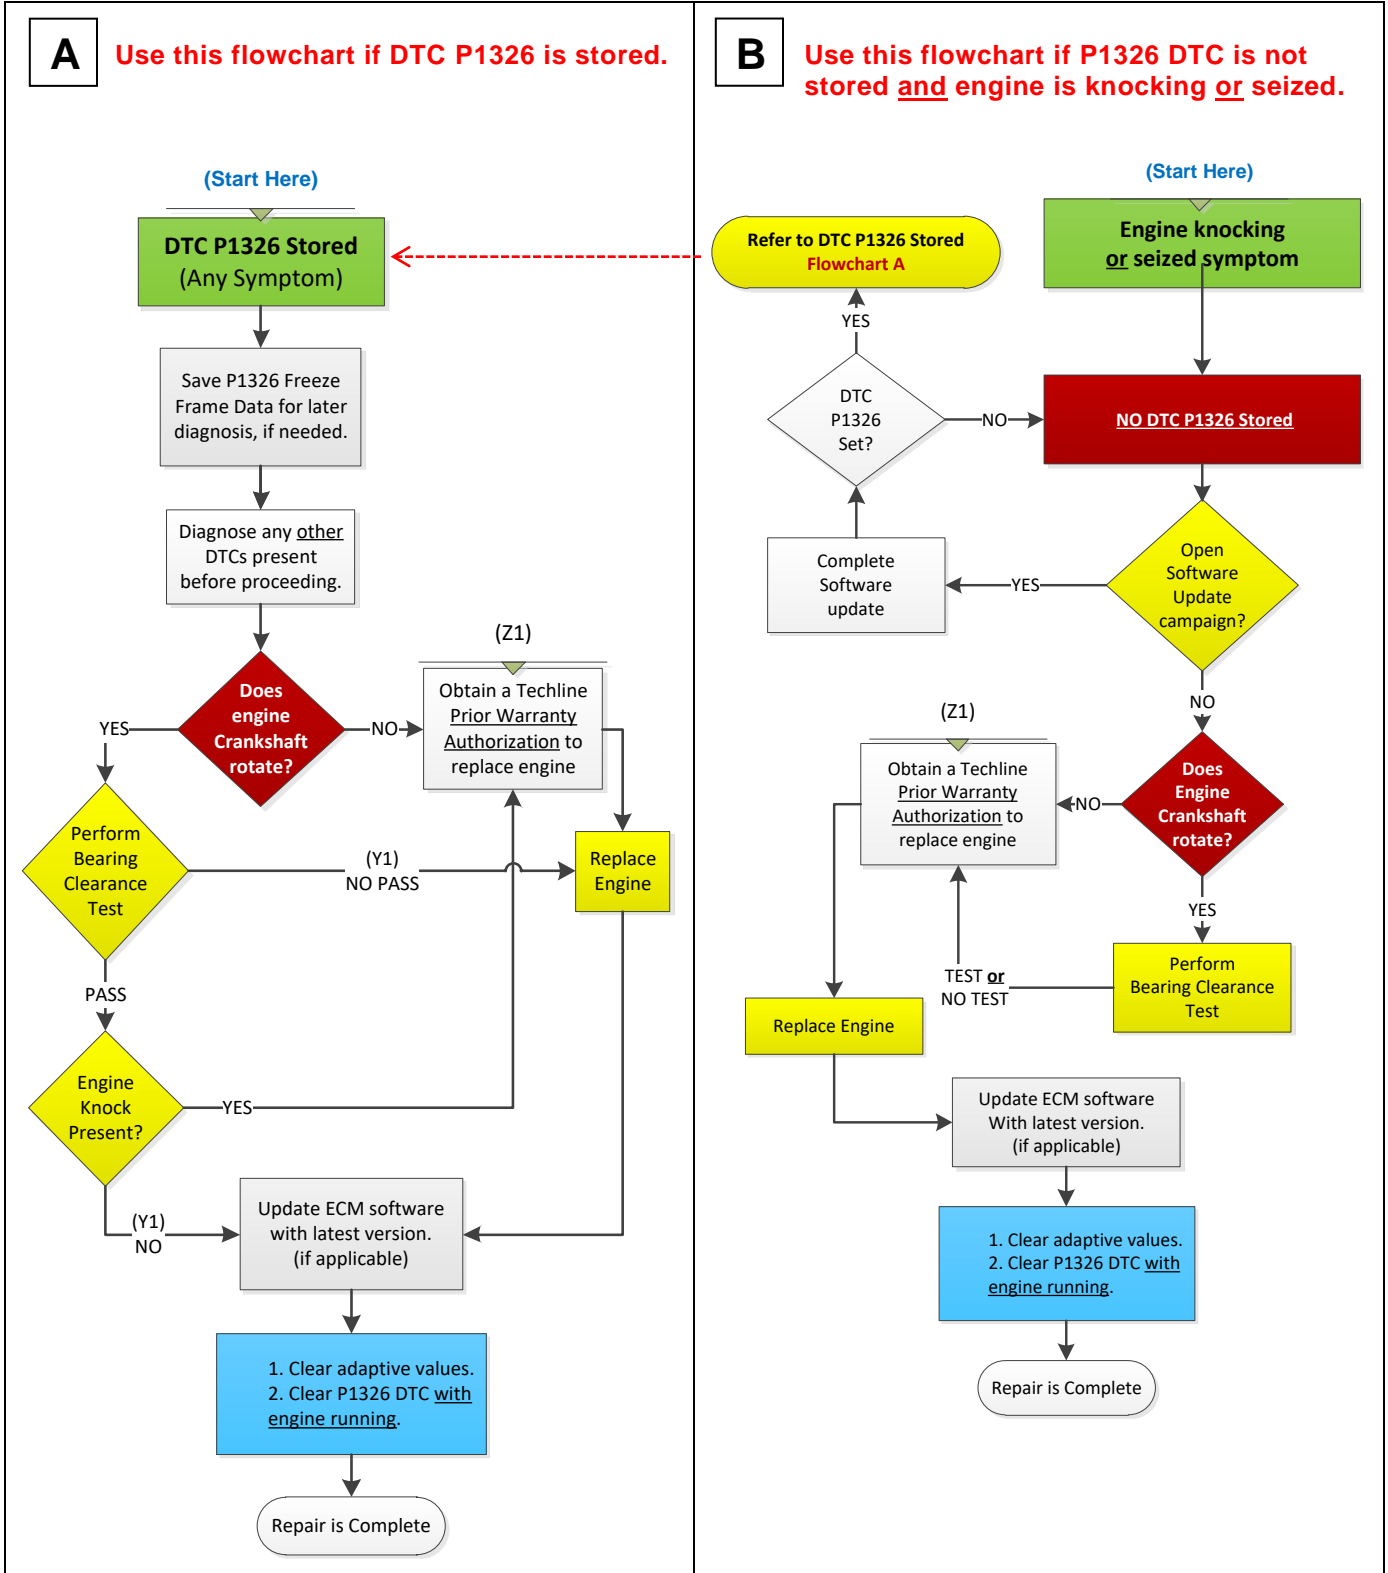
Choose the applicable flowchart based on the initial inspection:

- **Scenario 1** – Vehicle is in with DTC P1326 stored (A).
- **Scenario 2** – Vehicles is in with no DTC P1326 stored but engine is knocking or seized (B).
- **Scenario 3** – Vehicle is in with DTC P1326 stored and also engine is making noise or seized (A).

Note: If any concerns arise after completing the flow chart, open a Techline case online.

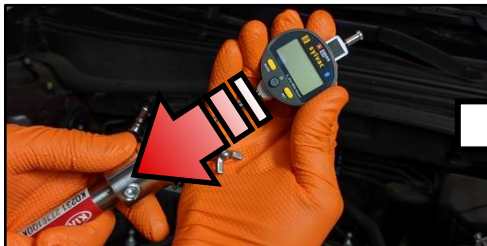
- 7. Install the Dial Gauge fully into the Probe Rod and secure together by hand tightening the locking wingnut.

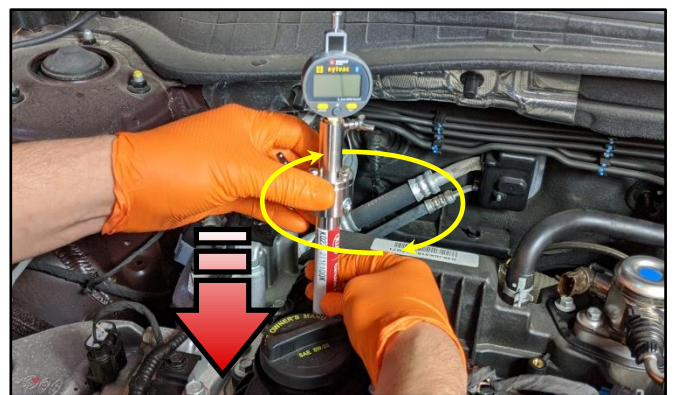
- 8. **Carefully**, insert the assembled SST Probe Rod and Dial Gauge into the Cylinder 1 spark plug hole and **carefully** turn the SST Crankshaft Rotator **by hand** clockwise until hand tight.

CAUTION
Damage to cylinder head can occur if spark plug hole is cross-threaded. DO NOT use a wrench to tighten the SST rod.

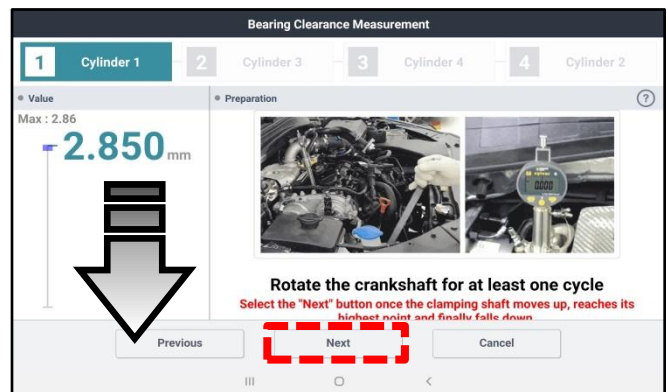
15. Once the ‘Max’ value is reached (sample shows Max: 2.86mm), continue to turn just past the ‘Max’ value reading and STOP rotating the crankshaft (sample shows 2.850mm value decreasing).

Note: The KDS may prompt to rotate the crankshaft ‘counterclockwise’ if needed.

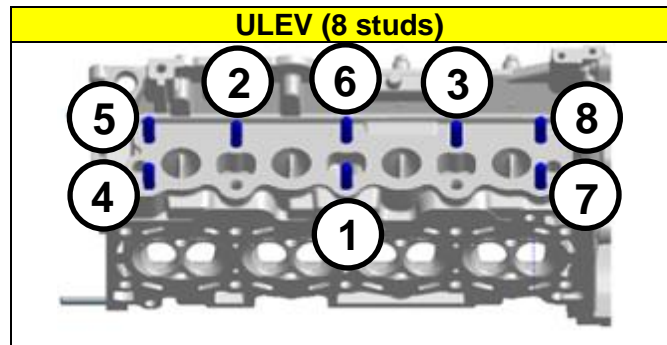
- All engines supplied under this Product Improvement Campaign have the exhaust manifold studs configured for SULEV engines.
- Using the pictures to the right, check the exhaust manifold stud location and quantity. Relocate as required for ULEV engines and obtain one (1) extra from the removed engine.
- Prior to installation, replace the exhaust manifold gasket and front muffler gasket.
- Torque nuts in the sequence shown.

36.2 – 39.7 lb.ft (49.0 – 53.9 N.m,
5.0 – 5.5 kgf.m)

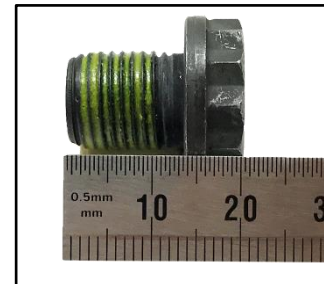
Drive Plate Bolt (A/T)

- Replace all seven (7) drive plate (AT) bolts.

**86.8 – 93.9 lb.ft (117.7 – 125.5 N.m,
12.0 – 13.0 kgf.m)**
