LATEST VEHICLE CONCERN FIXES POWERTRAIN

19MY Onward RR Evoque

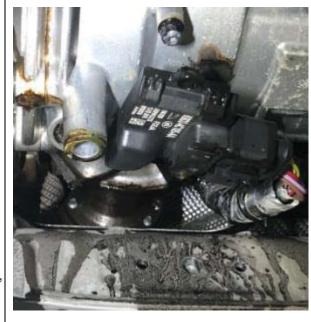
There is a smell of fuel from the vehicle.

- No issues or leaks are identified from the fuel system.
- The front PTU is found to be leaking from the pinion seal.

- Check for radial play in the pinion.
- Perform a thorough inspection of the driveshaft on the vehicle including joints and the center bearing, note any anomalies.
- Confirm mounting and alignment of original PTU, note any anomalies.
- Collect the full oil contents from the original PTU and store safely for return/analysis.
- Create an EPQR and include detailed information about the customer complaint, findings from inspecting the vehicle, and contact information for someone who can support return of the original PTU for evaluation.
