Technical Service Bulletin

87 Unpleasant odor from heating and ventilation system

87 20 05 2010146/15 April 29, 2020. Supersedes Technical Service Bulletin Group 87 number 18-89 dated July 30, 2018 for reasons listed below.

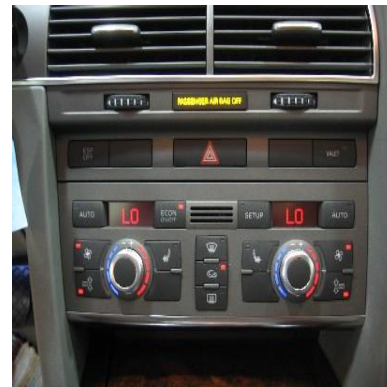
Figure 1. Climate control settings.

1. If the vehicle is equipped with an in-cabin pollen filter (such as in the A3, A6, and Q7), remove the pollen filter element and reinstall its cover before proceeding.
2. Start the engine.
3. Adjust the following climate control settings (Figure 1):
 - Set the temperature to its lowest setting.
 - Set the fan speed to its lowest setting.
 - Set the airflow direction to the dash vents only.
 - Activate recirculation and ECON modes.

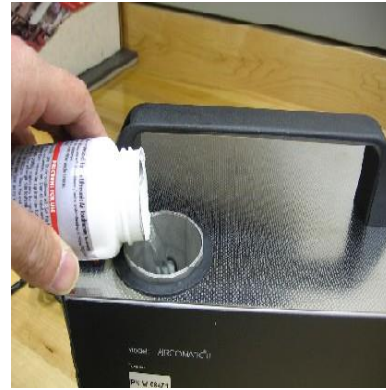
Figure 2. Pouring the treatment into the filling chamber.

4. Thoroughly shake a 100ml bottle of treatment and empty it into the filling chamber (Figure 2).

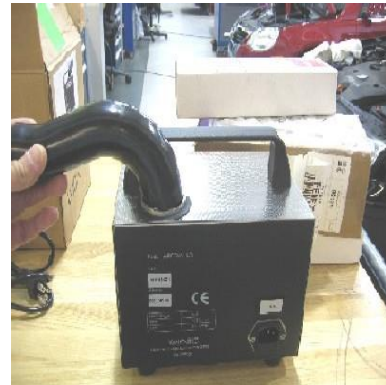
Figure 3. The connected outlet tube.

5. Connect the outlet tube (Figure 3).

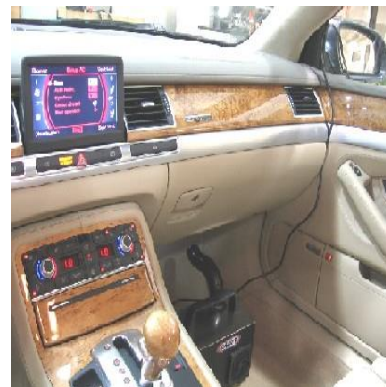
Figure 4. The window is slightly open so that the cord can pass through.

6. Place the cleaning unit into the passenger side footwell, ensuring that the unit is as level as possible.
7. Connect the unit power cord, and route it through one of the windows, which should be slightly open (Figure 4). All other windows and the sunroof should be completely closed.

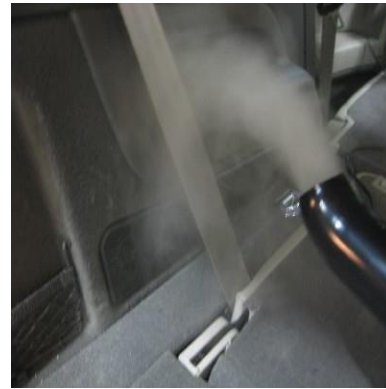
Figure 5. Correct positioning of the outlet tube on a Q7.

8. Turn the unit on and position the outlet tube so that the vapor is drawn into the recirculation air intake (generally in the passenger side footwell area; see appropriate repair information for exact location).
9. Close all doors. The atomized cleaning fluid will begin to come out of the vents. After 15-20 minutes, the treatment is complete and the machine stops automatically.
10. If the vehicle is equipped with a four-zone climate control system with 2 evaporators (such as Q7 and A8), repeat the procedure for the rear A/C unit before proceeding. Use the same A/C settings listed above. Position the outlet tube toward the fresh air inlet vent for the rear unit. The configuration of the Q7 is shown to the right (Figure 5).
