Release Date	04/28/2020	Technical Service Bulletin	
72K4 UPDATE

Checking Outer Backrest Frame – (NVLW)

Applicable Vehicles			
Model(s)	Year	VIN Range	Vehicle-Specific Equipment
Q7	2019	See Campaign/Action screen in Elsa	See Campaign/Action screen in Elsa

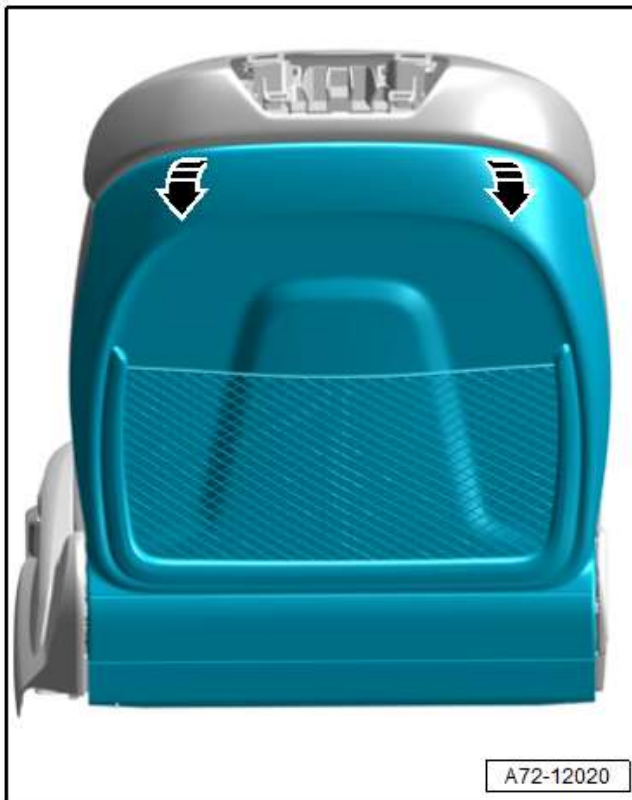
- Remove the backrest cover panel on the left front seat:
  - See ELSA Repair Manual: *Repair manual > Body Interior > 72 Seat Frames > Front Seats > Backrest Cover, Removing and Installing*

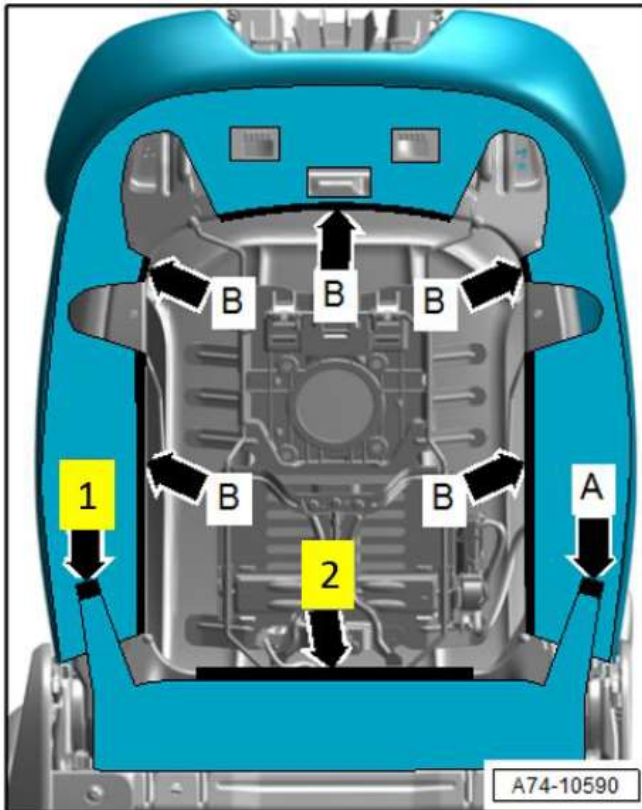
- Disengage left coupling hook <arrow 1> on side of outer backrest frame.
- Disengage piping <arrow 2> on outer backrest frame.

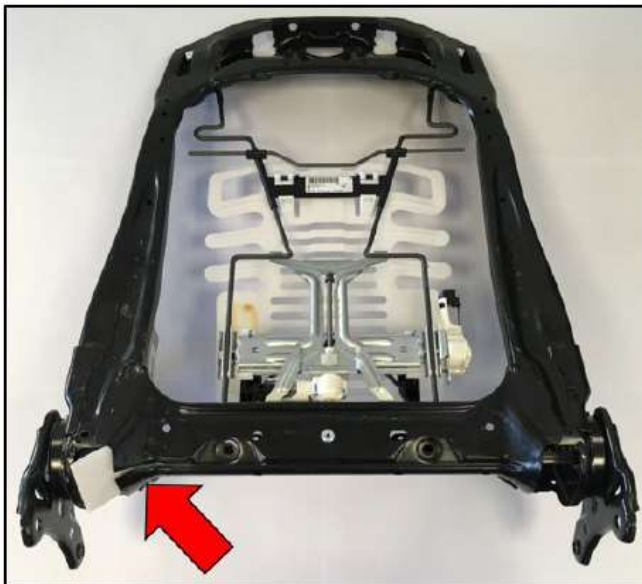
- Inspect the backrest frame in the area shown <arrow>.

Backrest frame shown completely removed for clarity. The frame does not need to be completely removed.

This Update has been proactively released to prevent the following condition(s) from occurring in the vehicle:	
Criteria	Technical Background
4M	Cracks may, in isolated cases, occur in the cross member of the front seat backrests. This may result in the wiring harness becoming damaged on the sharp edge of the crack on the left seat. Diagnosis would detect the damaged wiring harness. A crack in the cross member for the front seat backrests does not constitute a structural problem.

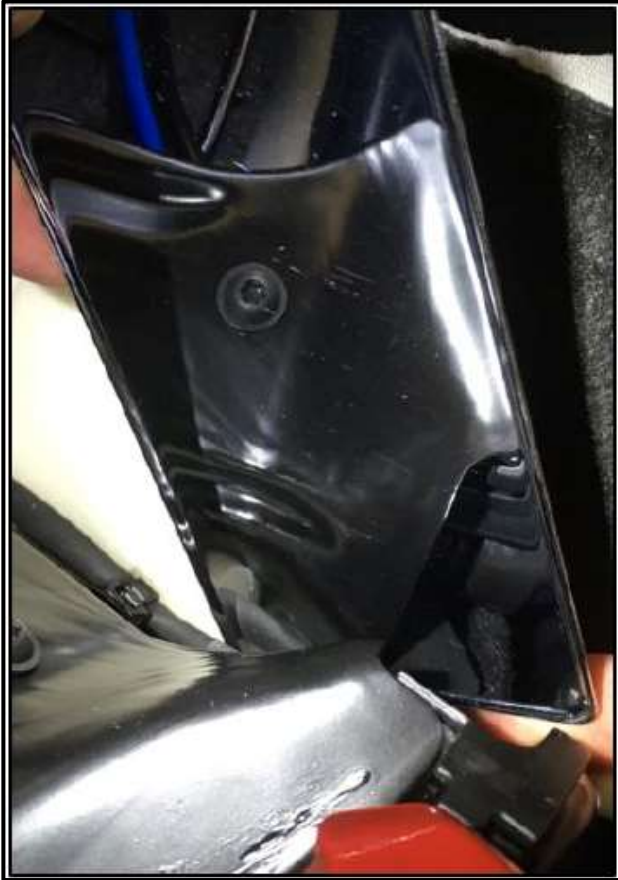
- Check outer backrest frame with an inspection mirror.

Avoid checking the component by feel with your hand, as there may be sharp edges in the area of the crack. These edges may constitute an injury risk.

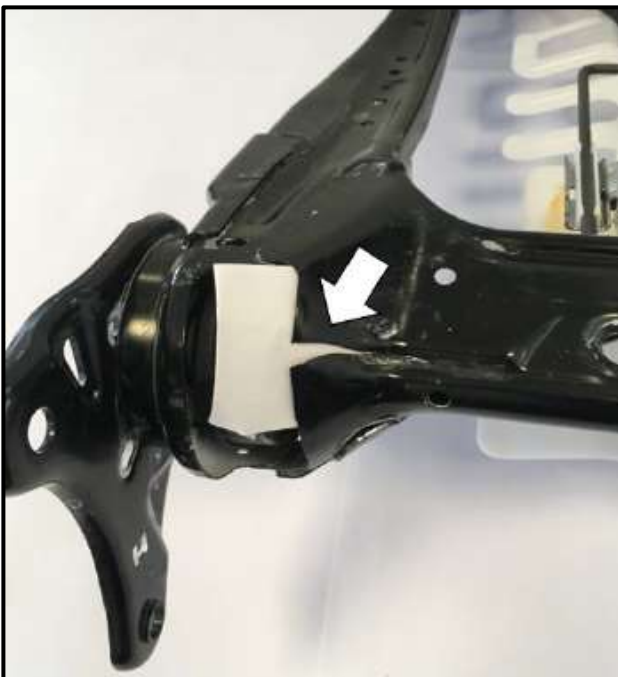
- If there are no cracks present:
  - Outer backrest frame does not require replacement.
  - Reassemble vehicle in the reverse order of disassembly.
  - Work is complete.
- If cracks are present:
  - Outer backrest frame must be replaced.

Criteria	Remedy
4M	Inspect the left front seat backrest frame and replace if necessary.
