2020 FIT G101 Inspection

Inspection Procedure :

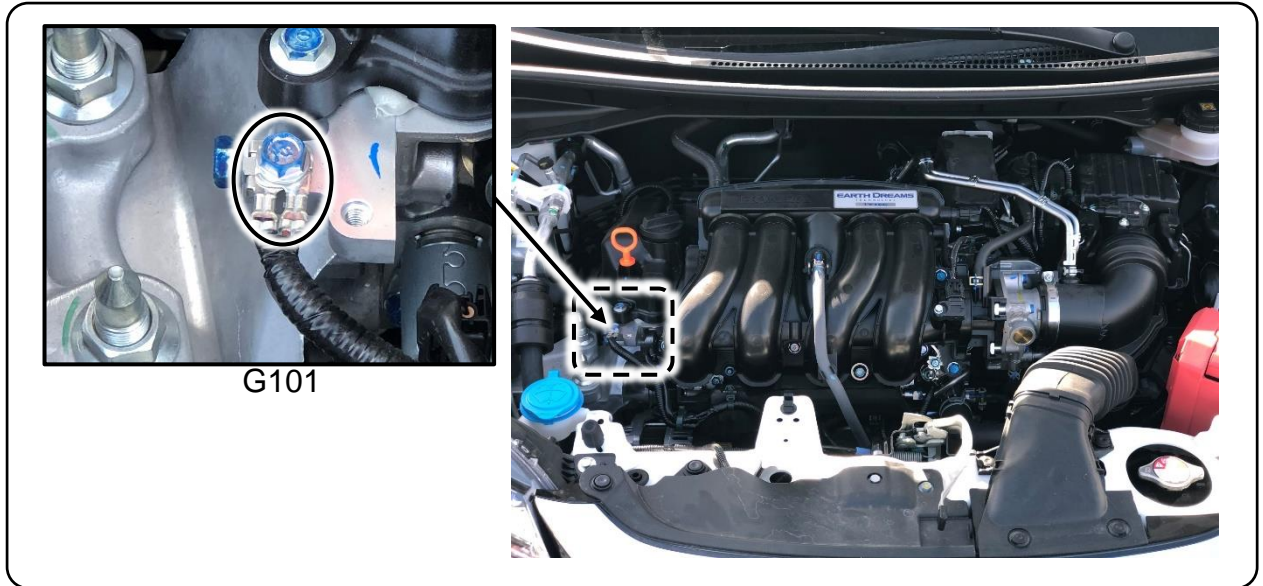
1. With both engine and vehicle off, open the hood and locate ground terminal lug for G101.

2. Visually inspect the ground terminal (see next page for visual inspection criteria):
3. If a **NO GOOD** condition is found, take a photo to document your findings, then contact AHM TRS by sending the photo, VIN and your contact information to trs@ahm.honda.com for further instruction. **DO NOT ATTEMPT A REPAIR** until receiving further instruction from AHM TRS.
4. If **OK**, no further action is required. Please see the warranty information for the inspection on page 3.

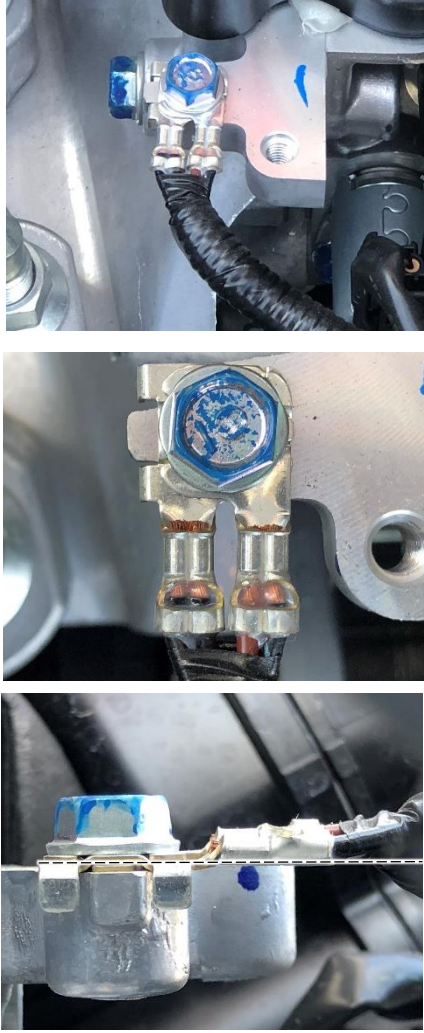
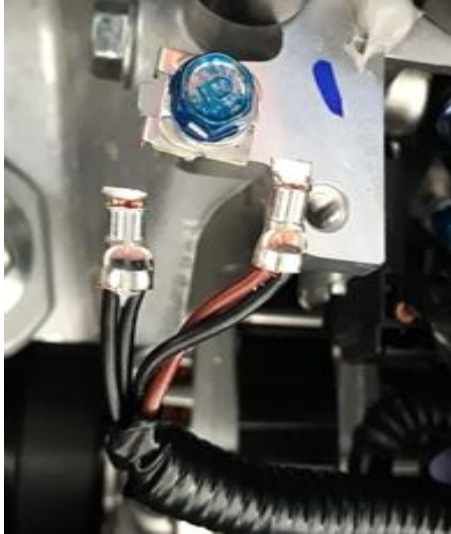
| | Inspection Criteria | |
|---|--|--|
| <p>G101 Terminal Lug</p> | <ul style="list-style-type: none"> • Tape is securely wrapped around harness loom • Ground terminal lug secure and in place • Ground terminal lug is relatively straight • No visible crease(s) or bend(s) on ground lug terminal | <ul style="list-style-type: none"> • Harness loom and tape pulled back • Ground terminal lug broken at crimp <ul style="list-style-type: none"> - and/or - • Visible crease(s) or bend(s) on ground lug terminal |
