CAMPAIGN BULLETIN

Wheel Replacement Dealer Inventory

Reference: PM946
Date: April 8, 2020

PM946 - 2020 SENTRA WHEEL REPLACEMENT

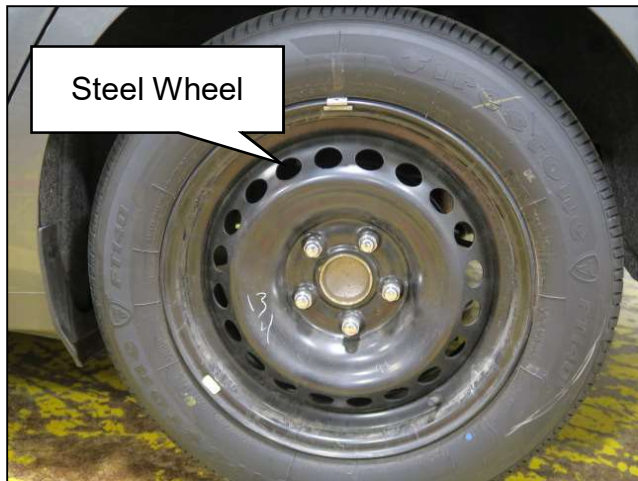
Figure 1

- Does the vehicle have steel wheels (Figure 1) or aluminum wheels (Figure 2) installed?

- If the vehicle is equipped with **Steel Wheels**, continue to **Step 2** for wheel replacement.
- If the vehicle is equipped with **Aluminum Wheels**, No action is necessary.

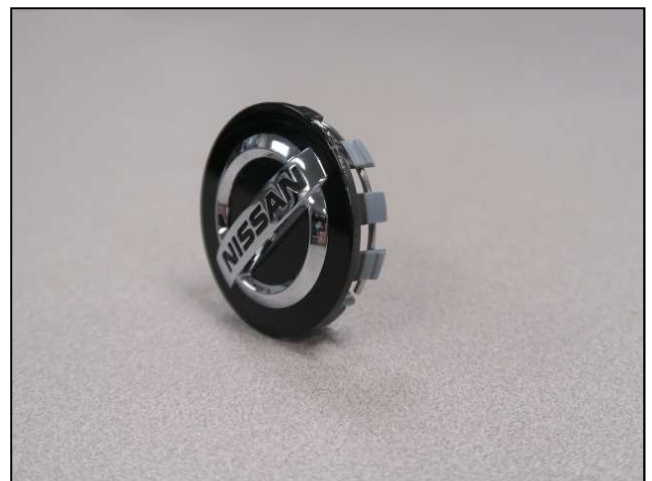
Figure 3

2. Inspect the interior of the vehicle for center caps for the aluminum wheels. (Figure 3)

- If the center caps are NOT in the vehicle, use the part number found in the parts section and order NEW center caps (ORNAMENT - DISC WHEEL)
