| <b>HYUNDAI</b><br><b>Technical Service Bulletin</b> | <b>GROUP</b><br><b>Body</b> | <b>NUMBER</b><br><b>20-BD-010H</b> |
| <b>SUBJECT:</b> TRUNK LATCH BASE REPLACEMENT | | |

**Description:** The trunk latch base can be ordered separately from the trunk latch assembly. This bulletin describes the procedure to replace the trunk latch base.

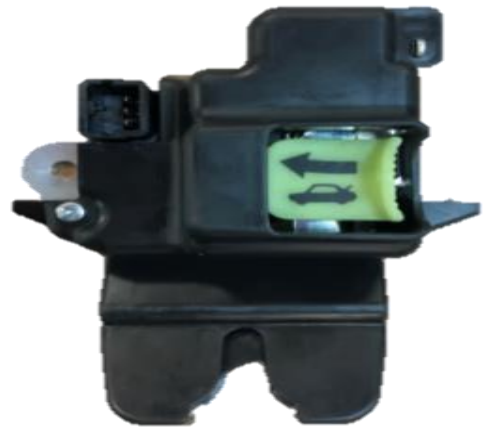
1. Remove the trunk latch assembly according to the applicable vehicle shop manual.

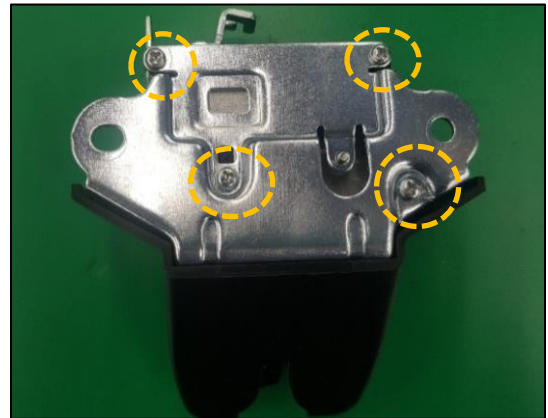
2. Remove the four trunk latch assembly screws.

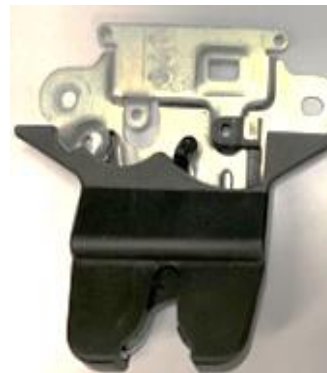
3. Replace the trunk lid latch base and reuse the actuator.

When reusing the actuator, do not contaminate the motor area.

Latch Base

Actuator
