Countries: CANADA, UNITED STATES **Document ID:** IK2200147
Availability: ISIS, Bus ISIS, IsSIR **Revision:** 0
Major System: BUS BODY **Created:** 4/13/2020
Current Language: English **Last Modified:** 4/17/2020
Other Languages: NONE **Author:** Brandon Akridge
Viewed: 65

Title: CE Bus fuel sending access hole in wrong location

Applies To: CE Bus with feature 47AEU built between 5/7/19 and 2/19/20

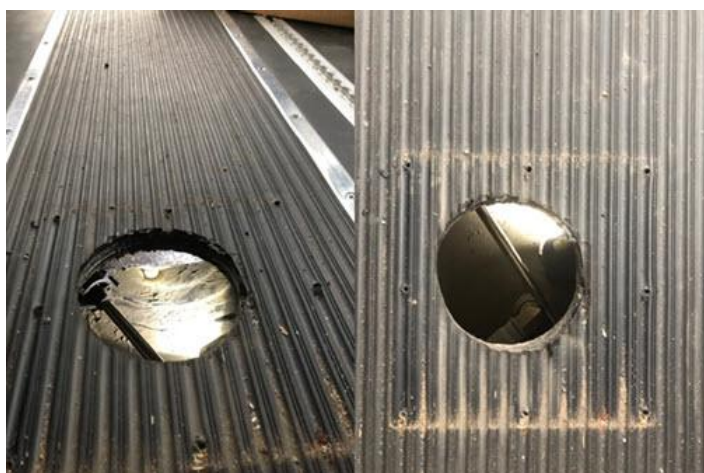
When removing the inspection plate, the fuel sender is not located directly below the access hole.

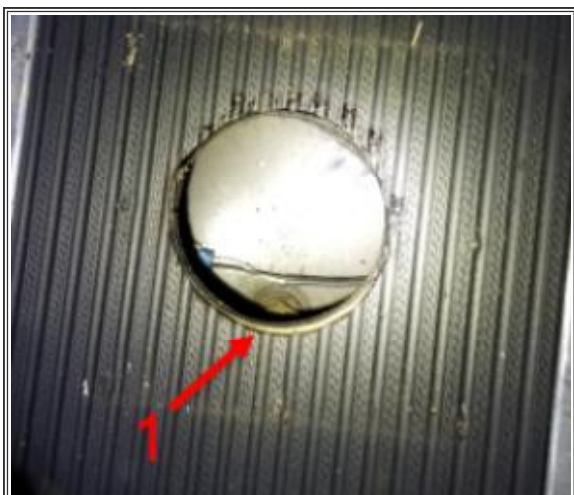
Figure 1: Fuel Sending access hole

Some CE buses were built with the fuel sender inspection hole installed in the wrong location.

Item 1: Fuel Sending access hole

Step	Action	Decision
1	<p>DIAGNOSTIC:</p> <p>Is the fuel sending hole located in the proper location? See Figure 1 for incorrect hole location.</p>	<p>Yes. No further action is needed.</p> <hr/> <p>No. Proceed to repair steps.</p>
