HYUNDAI
Technical Service Bulletin

GROUP DRIVESHAFT AND AXLE	NUMBER 20-DS-001H
DATE APRIL, 2020	MODEL(S) Sonata (DN8)

SUBJECT: CV BOOT KIT-DIFF SIDE, RH REPLACEMENT

Description: Certain 2020MY Sonata (DN8) vehicles may exhibit a grease leak coming from the right side, inner CV axle boot area. This bulletin describes the procedure to replace the right side CV axle boot on the differential side (inner) on certain 2020MY Sonata (DN8) vehicles.

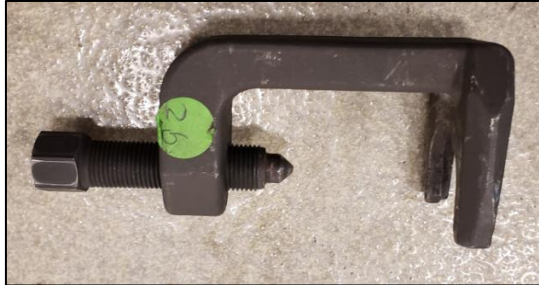
A black metal ball joint remover tool with a green sticker on the handle.	09568-2J100
Gear Puller

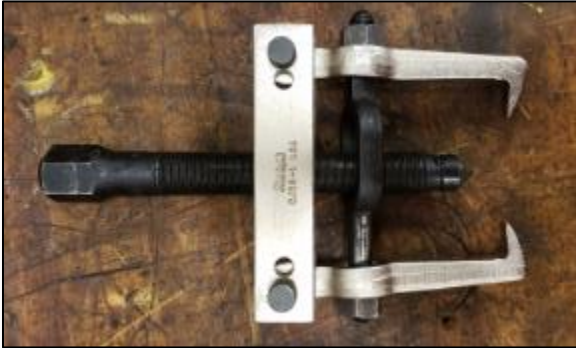
A Snap-on CJ66-1 gear puller tool with a black handle and silver metal body.	Snap-on CJ66-1 (Any alternative pullers are acceptable)
CV Band Clamp Tool

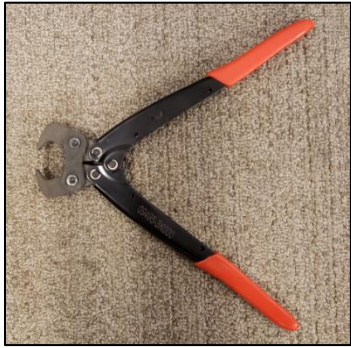
A CV band clamp tool with black handles and orange tips.	09495-3K000A

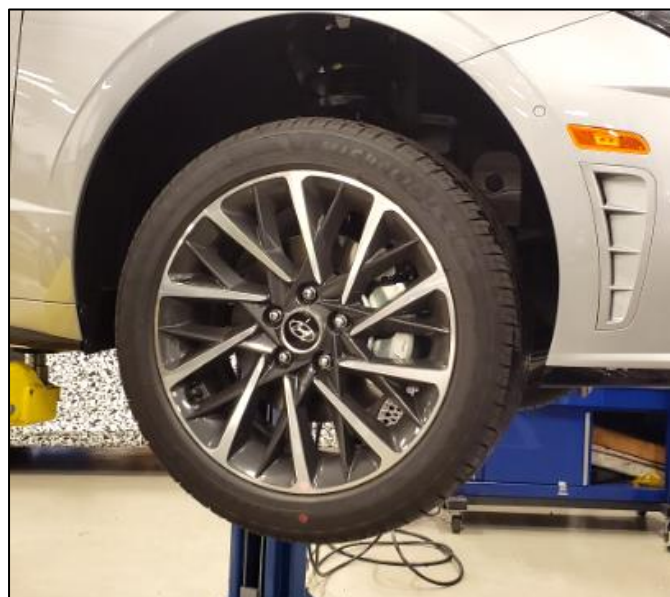
1. Lift the vehicle and remove the front right wheel.

Tightening torque:

lb-ft • 79.6-94.0

kgf.m • 11.0-13.0

N.m • 107.9-127.5

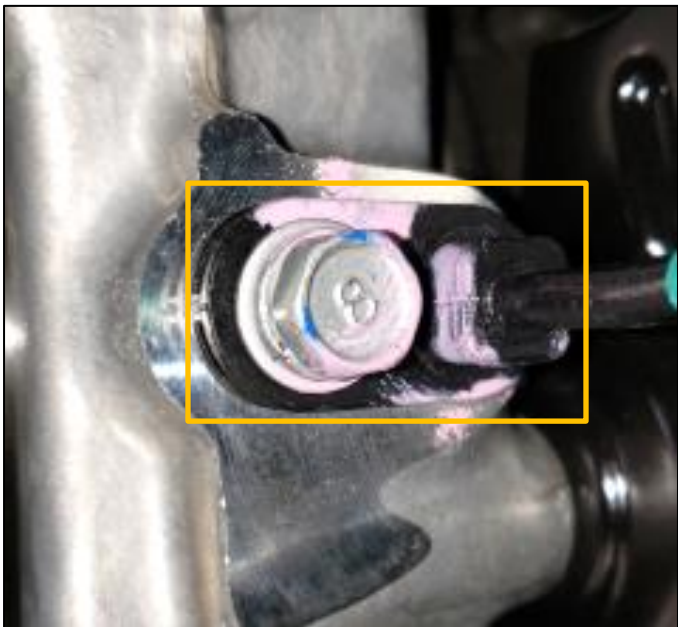
4. Remove the bolt for the front right wheel speed sensor, and remove the wheel speed sensor from the knuckle assembly.

lb-ft	• 5.1-8.0
kgf.m	• 0.7-1.1
N.m	• 6.9-10.8

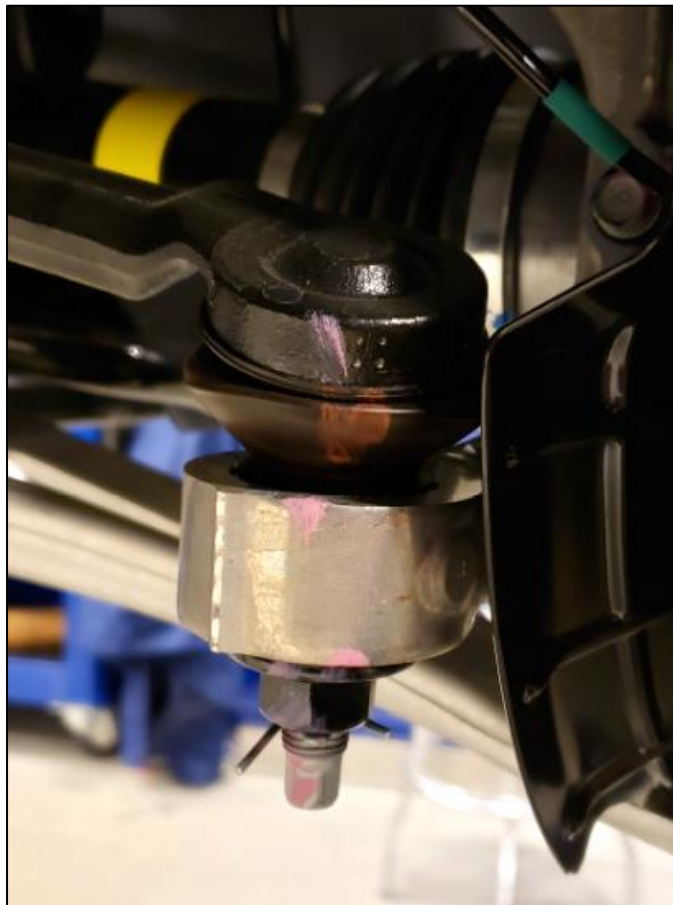
5. Remove the right side tie rod end cotter pin and castle nut.

Tightening torque:

lb-ft • 72.3-86.7

kgf.m • 10.0-12.0

N.m • 98.0-117.6

Use a new cotter pin during re-assembly.

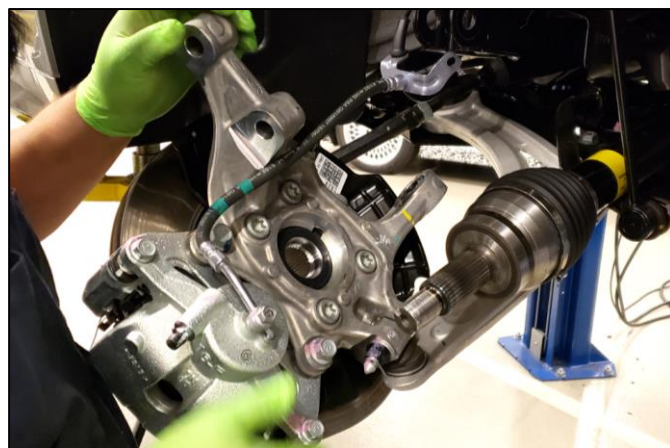
8. Remove the splined end of the CV joint from the knuckle assembly by pushing it inwards while maneuvering the knuckle assembly outwards.

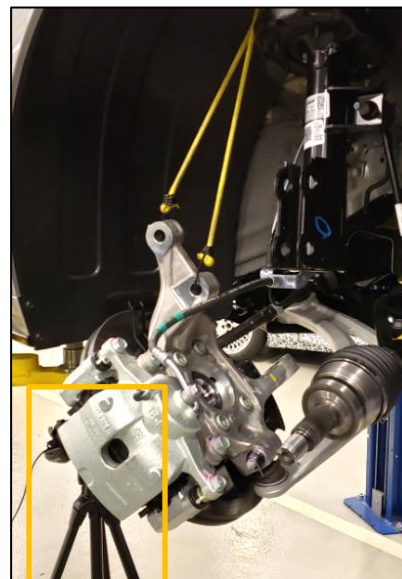
9. Support the knuckle assembly using a bungee cord, hanger, or similar to minimize strain on the brake caliper line.

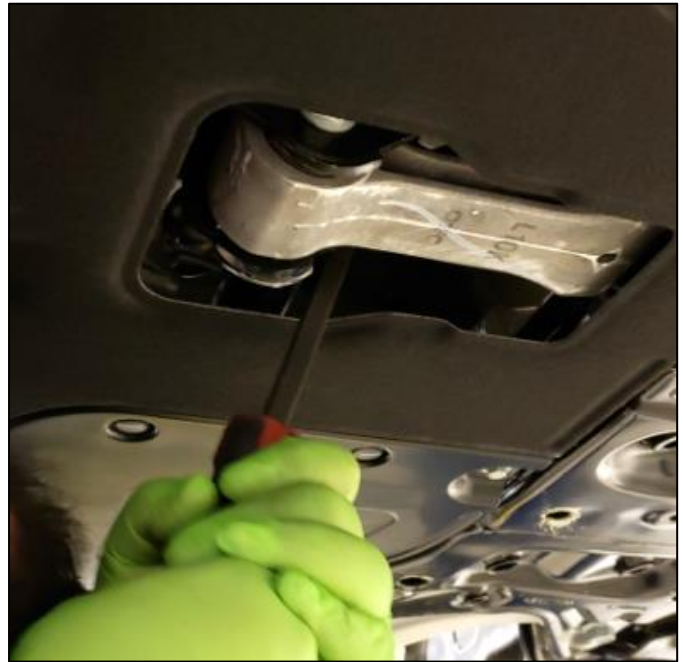
10. Use a pry bar to carefully release the CV axle from the transmission.

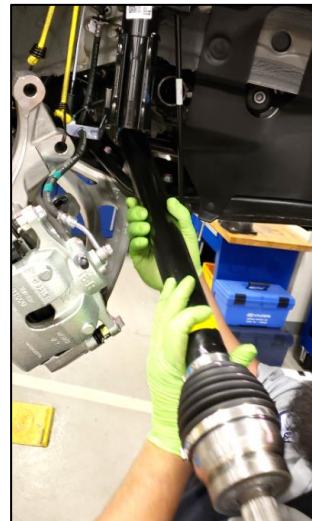
11. Remove the CV axle assembly from the vehicle.

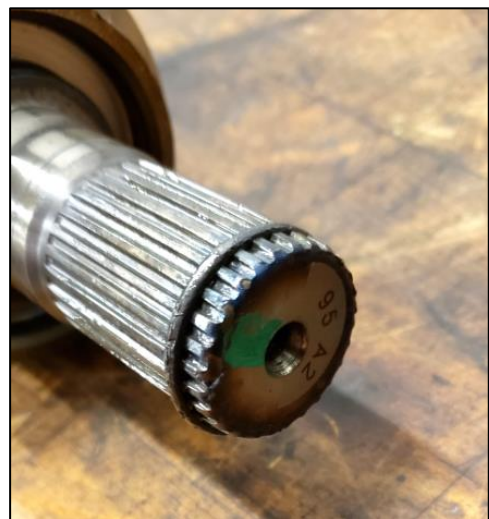
12. Remove the circlip on the end of the axle shaft, transmission side.

Use the provided new circlip during re-assembly.

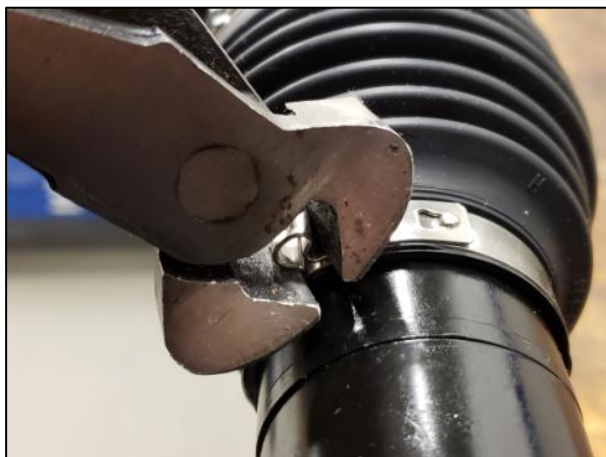
13. Remove the small band clamp using pliers.

Use the provided new small band clamp during re-assembly.

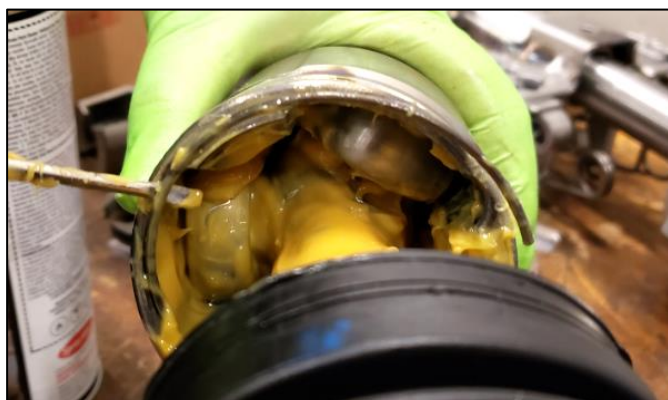
15. Pull the CV boot back to expose the circlip inside the cup. Remove the circlip.

Use the provided new circlip during re-assembly.

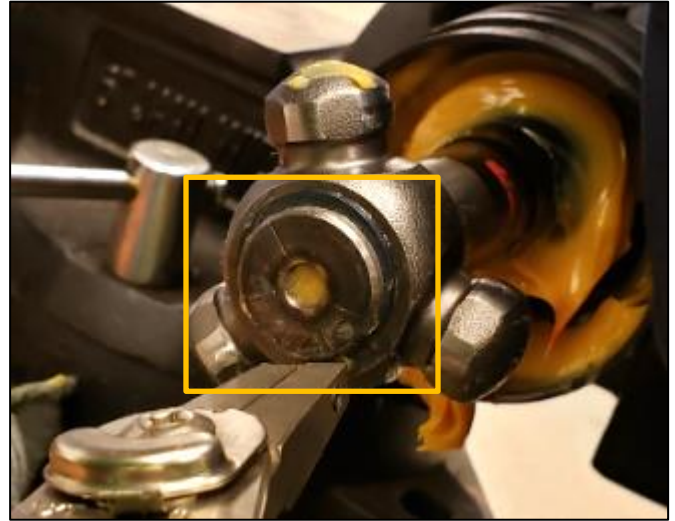
17. Use a pair of snap-ring pliers to remove the snap ring from the CV shaft.

Use a new snap ring during re-assembly.

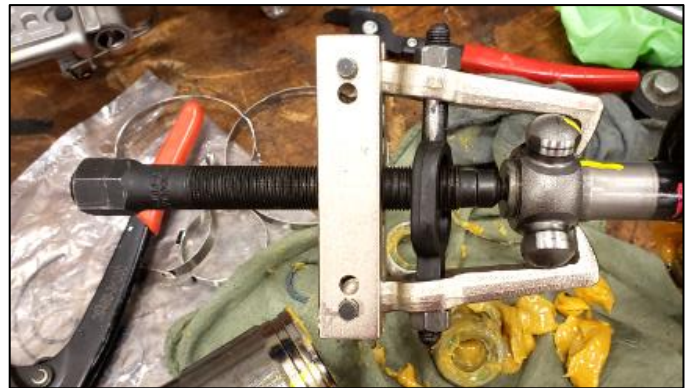
18. Use a puller to remove the spider assembly from the CV shaft.

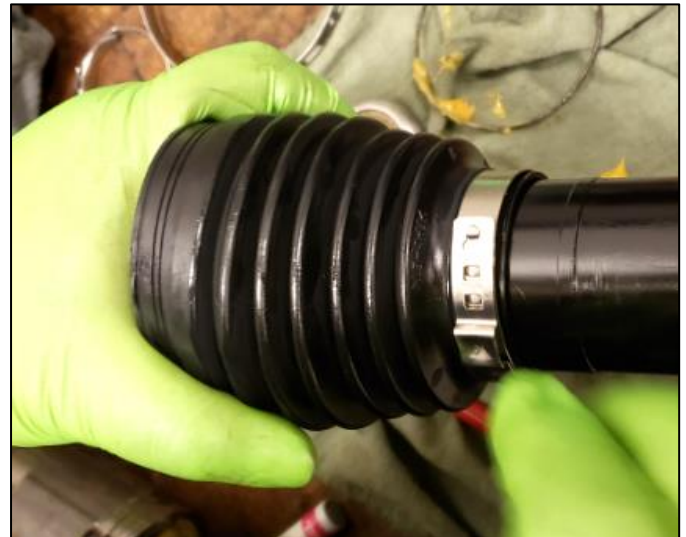
20. Loosely position the new small band clamp onto the new CV boot, then slide the boot onto the CV shaft.

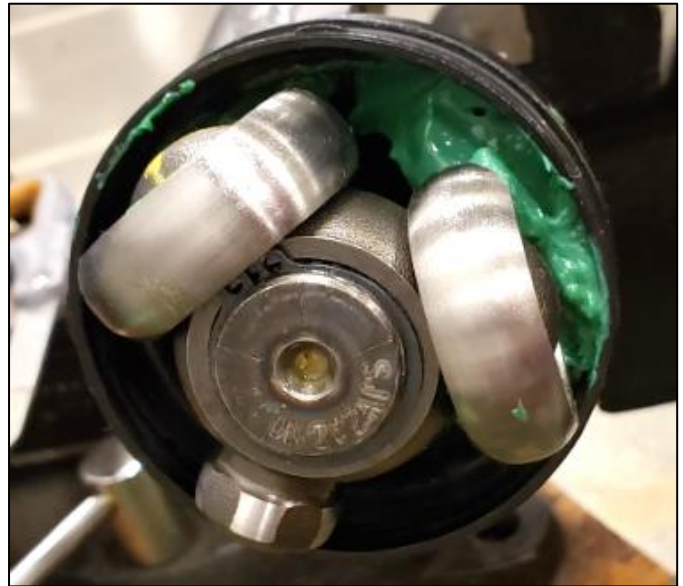
21. Using the alignment marks made previously, install the spider assembly back onto the CV shaft. Secure the assembly using a new snap-ring.

Apply the grease from one of the two provided bags to the spider assembly.

Apply the grease from the second bag into the cup.

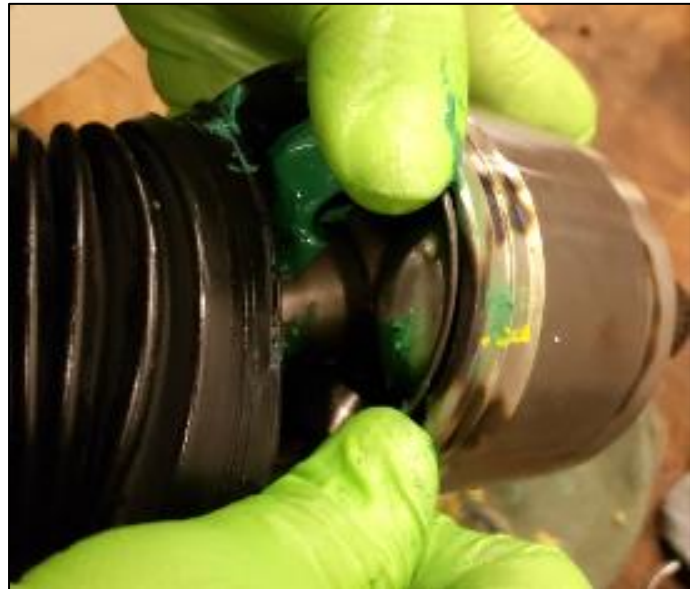
22. Install a provided new circlip into the CV cup.

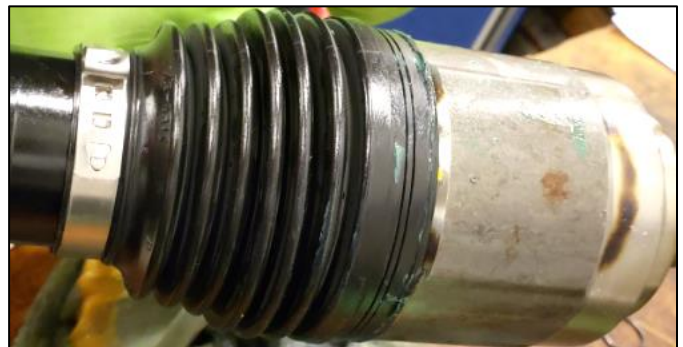
23. Seat the CV boot onto the cup.

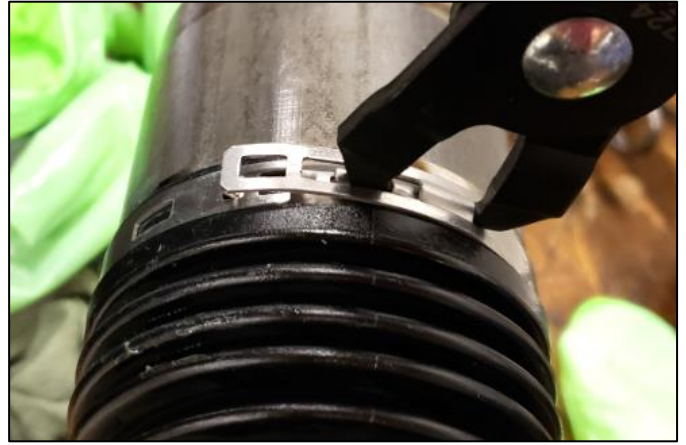
24. Install a new large CV band clamp.

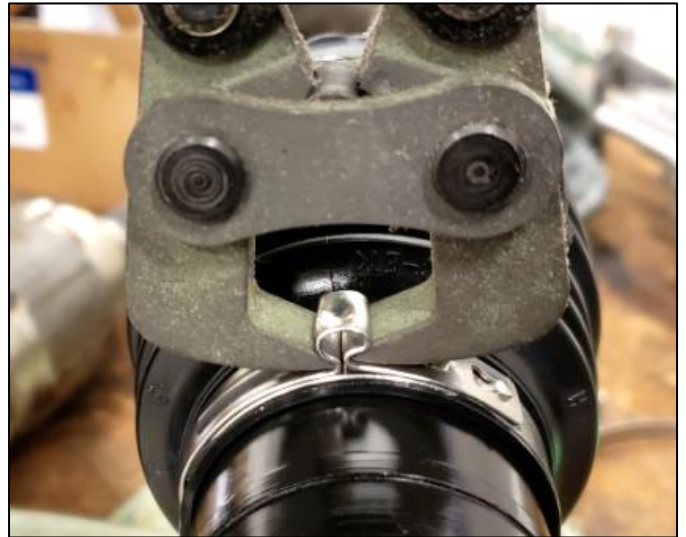
25. Secure the small CV band clamp using CV Band Clamp Tool SST 09495-3K000A by pinching the ear together.

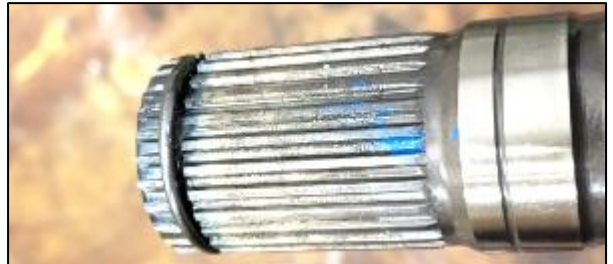
26. Install a provided new circlip onto the end of the CV shaft.
