| <b>Tesla, Inc.</b><br>Service Bulletin | | <b><i>Install Occupant Classification System (OCS) Filter Module</i></b> | |
| <b>SB-19-20-003 R1</b><br>April 28, 2020 | <b>R1</b> | | |

On some Model 3 and Model Y vehicles, the Occupant Classification System (OCS) signal might be affected by electrical interference in the seat harness, causing the airbag indicator to display on the touchscreen.

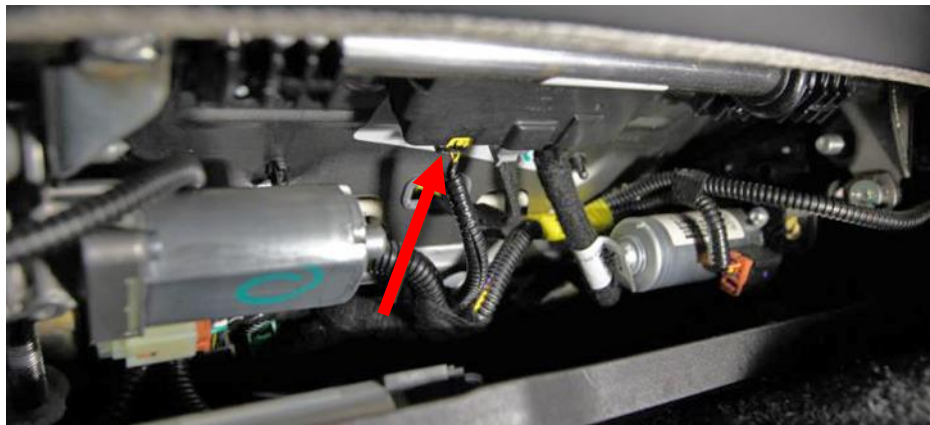
**Figure 1**

3. Locate the OCS module underneath the front passenger seat towards the front, and then disconnect the seat electrical harness from the OCS module electrical connector (Figure 1).

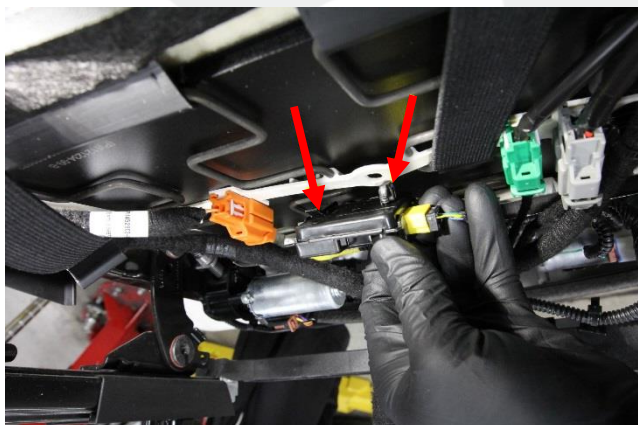
6. Attach the OCS filter module to the bottom of the seat and secure it with the clip (Figures 4 – 6).

**TIP:** Slide the tab of the OCS filter module over the white bar before securing the clip.

**NOTE:** Make sure the seat electrical harnesses are properly routed so that there is no tension in the cables.
