# Technical Service Bulletin

## 60 Noises in the sunroof mechanism

60 20 41 2050904/3 May 6, 2020. Supersedes Technical Service Bulletin Group 60 number 18-23 dated December 5, 2018 for reasons listed below.

Model(s)	Year	VIN Range	Vehicle-Specific Equipment
A3	2018	000001 - 050429	Not Applicable

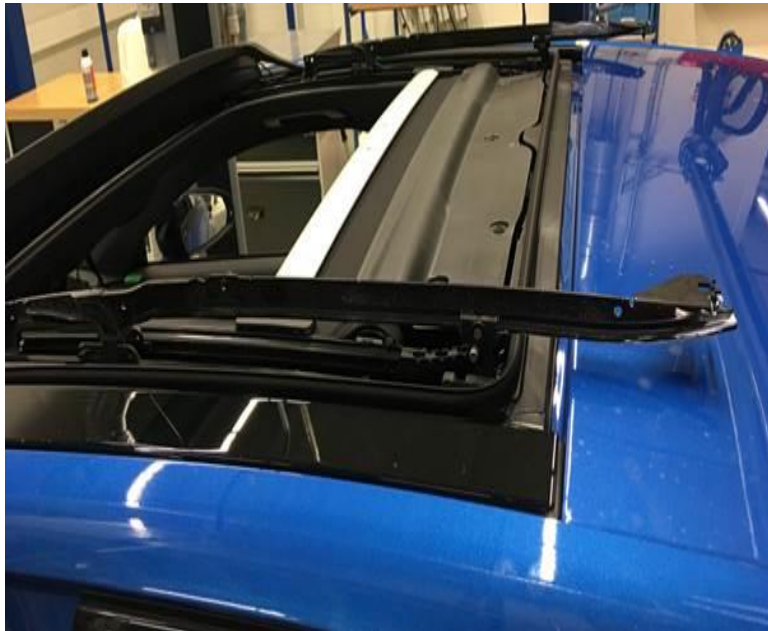
During a certain production period, the sunroof mechanism sliding rails were contaminated with a lubricant incompatible with the approved lubricant. When the correct approved lubricant was applied to these contaminated areas the correct lubricant did not adhere to these areas. These areas were then susceptible to noises when in contact with adjacent components of the sunroof mechanism.

**Figure 1.** Sliding rails exposed showing the area of contamination.

1. The areas of contamination will need to be thoroughly cleaned and dried, then the correct lubricant can be applied. Open the Panoramic sunroof fully. While Figure 1 shows the glass panel removed for clarity, the glass panel does not need to be removed to perform this operation.

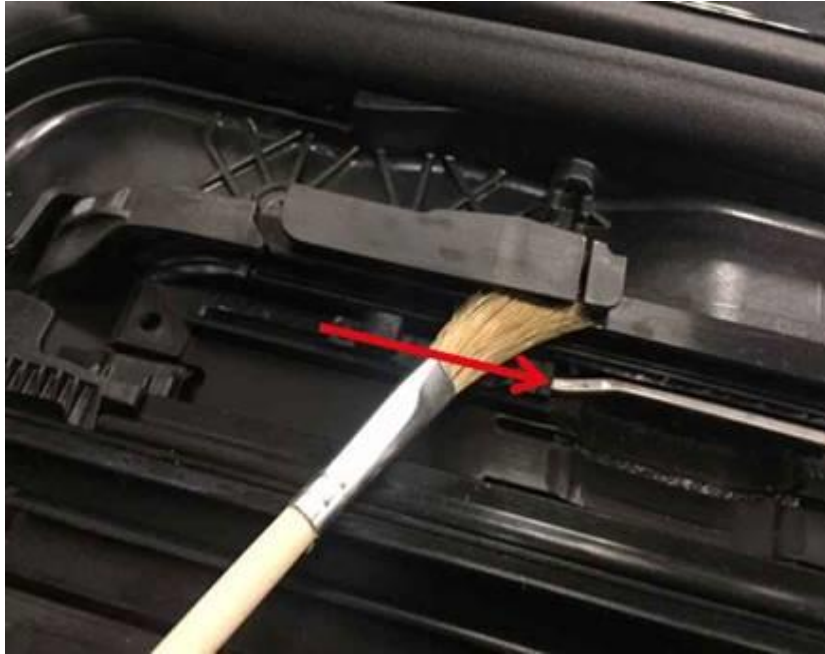
*Figure 5. How to apply the grease.*

6. Apply a pea-size amount of grease on a small brush. Use the special paste **G 052 141 A2**. Move the brush (as shown in Figure 5) **from front to back** through the locking mechanism.

**Tip:** The direction of the movement is very important, otherwise, major damage could be caused to the roof system and the body.

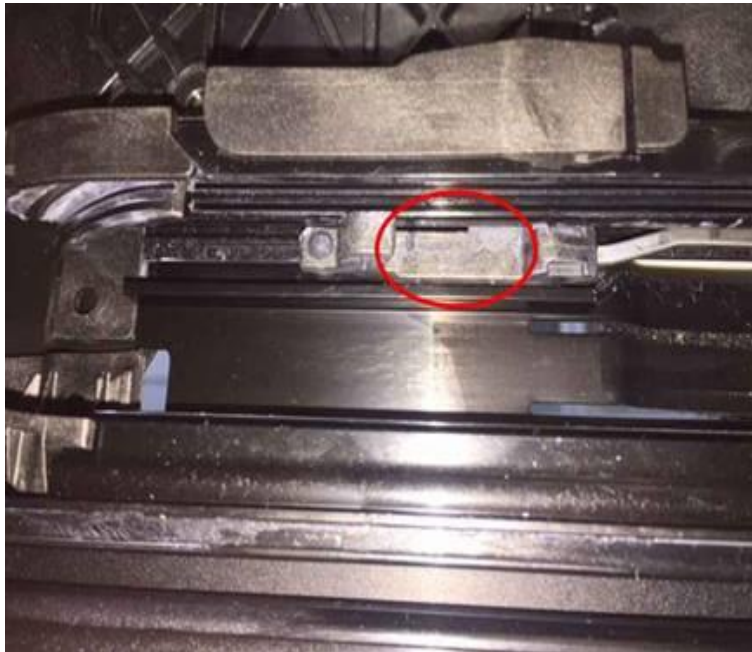
*Figure 6. Unlocked mechanism.*

7. The next picture (Figure 6) shows the mechanism unlocked.
