STAR ONLINE PUBLICATION

Case Number: S2008000023

Symptom/Vehicle Issue: No Crank, No Start

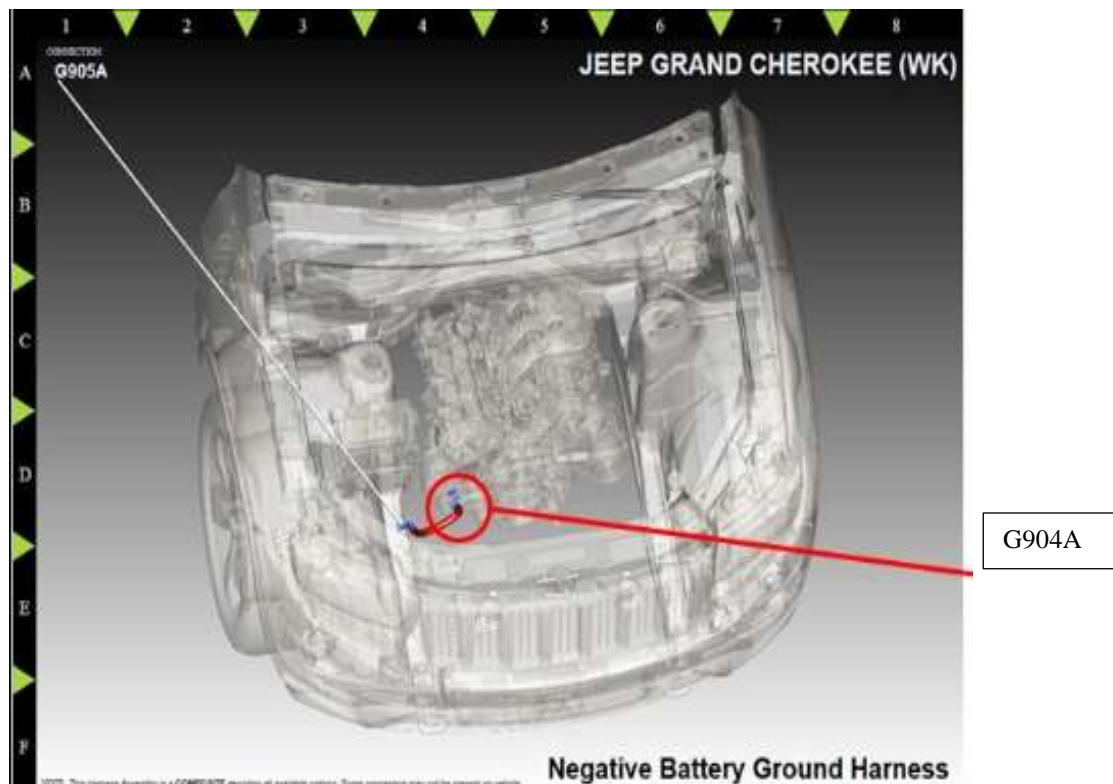
Fig 1

Customer complaint/ technician observation: Owner complains vehicle does not start. Technician observed the vehicle has a no crank, not start condition.

Repair Procedure: Inspect all engine to frame grounds (G904A,G905A). Clean and secure frame side and engine side as needed Fig 1, 2.

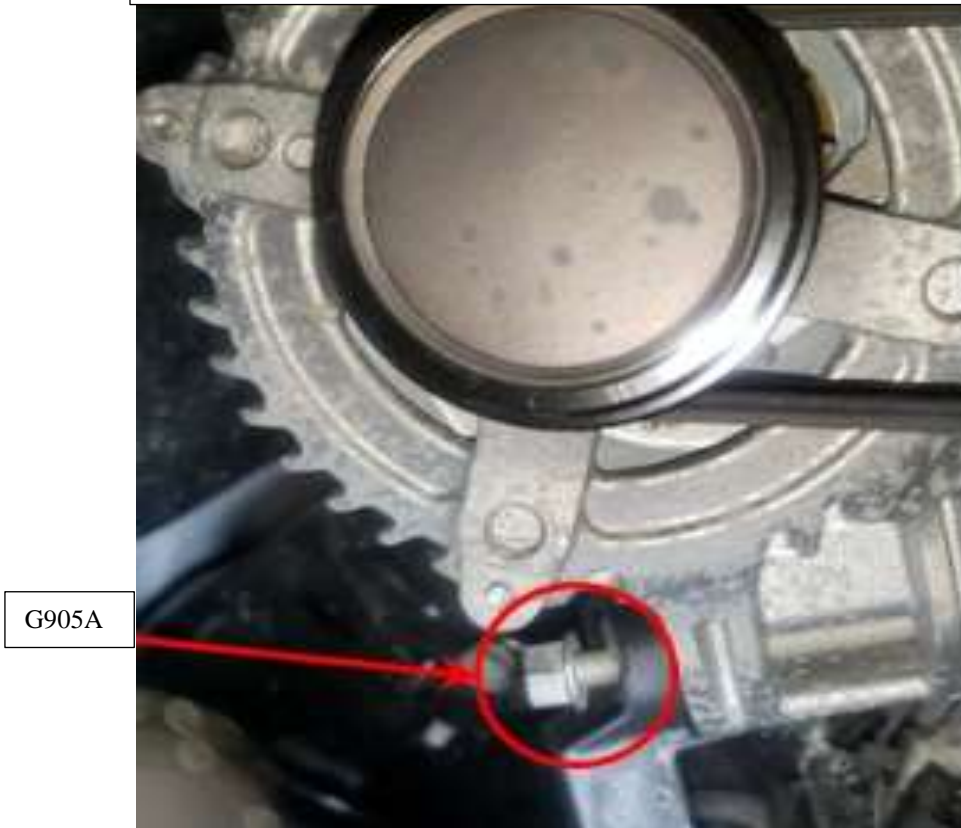
Fig 2

G904A Engine location, Z904 circuit
