SIB 11 07 16

Diesel Engine: Intake Manifold Damaged

N47T Engine EGR Cooler Diagnosis and Determining the Condition of the Intake System

N57T Engine EGR Cooler Diagnosis and Determining the Condition of the Intake System

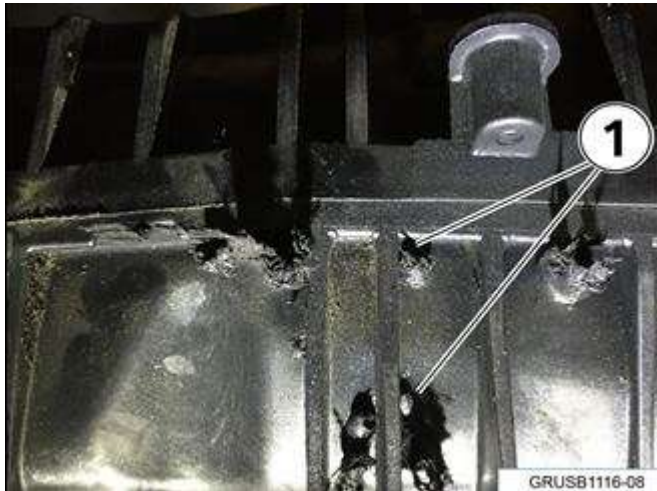
1. Remove the engine cover and inspect the intake manifold and venturi pipe to the throttle for holes or cracks.

Are there visible signs, on the intake manifold and venturi pipe, of overheating, similar to the illustration (1)?

- YES – go to step 4.
- NO – continue with step 2.

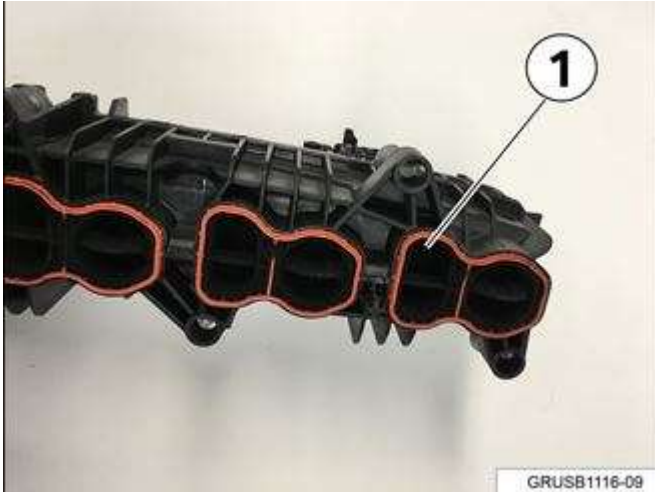
6. Check all swirl flaps for damage or melted/missing parts (1).
Are any swirl flaps damaged?
YES- Continue to step 7.
NO - Go to step 8.

Note: N57T is pictured, N47T is similar.

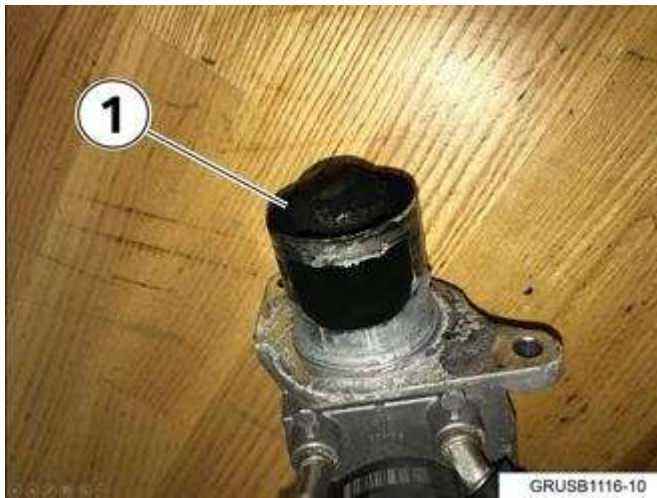
8. Remove the EGR valve and check for jamming (valve is normally sprung closed).
Is the EGR valve jammed or stuck open?
 YES- continue to step 10.
 NO – go to Step 9.

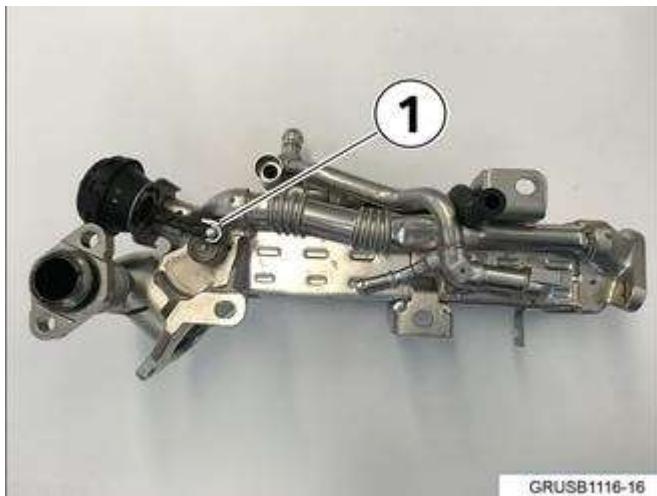
9. Check the bypass flap on the EGR cooler.
Is the flap binding?
 YES- Replace the cooler (with EGR valve).
 NO – Reinstall the EGR valve and continue to Step 11.

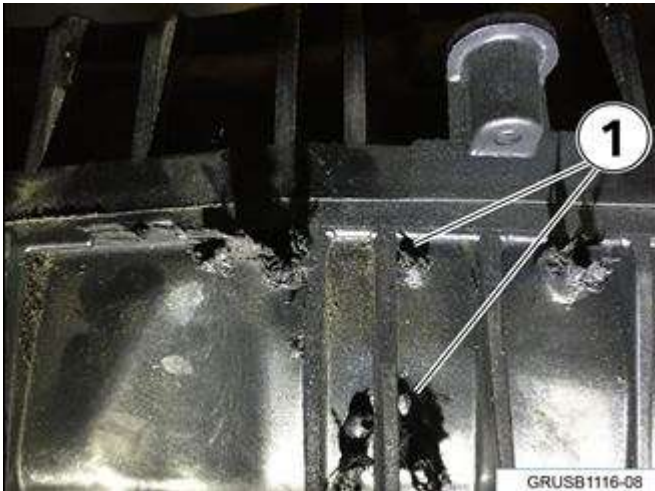
1. Remove the engine cover and inspect the intake manifold and venturi pipe to the throttle for holes or cracks.

Are there visible signs, on the intake manifold and venturi pipe, of overheating, similar to the illustration (1)?

- YES – go to step 5.
- NO – continue with step 2.

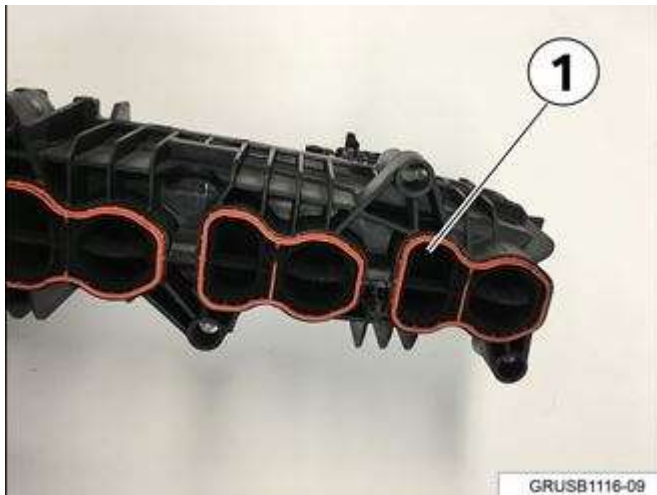
6. Check all swirl flaps for damage or melting/missing parts (1).

Are any swirl flaps damaged?

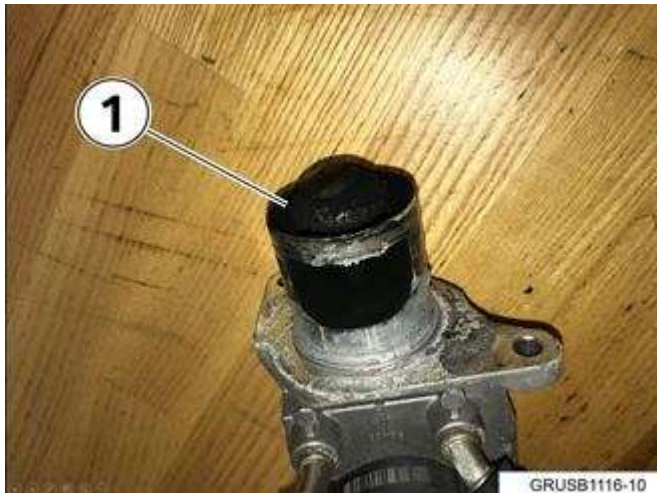
8. Remove the EGR valve and check for jamming (1) (valve is normally sprung closed).

Is the EGR valve jammed or stuck open?

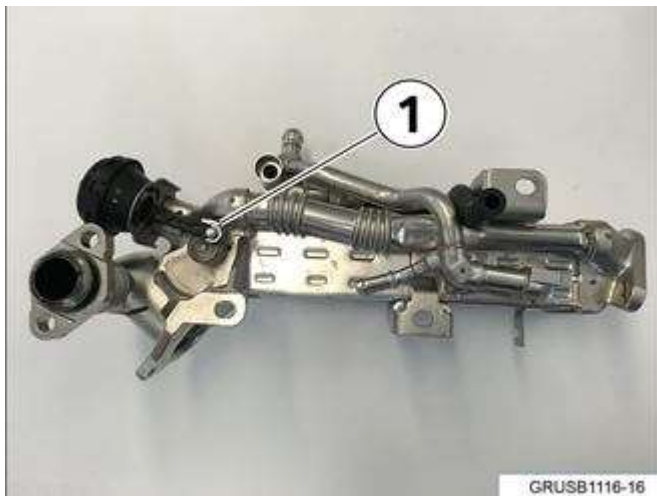
9. Check the bypass flap on the EGR cooler.

Is the flap binding?

YES- Replace the cooler (with EGR valve).

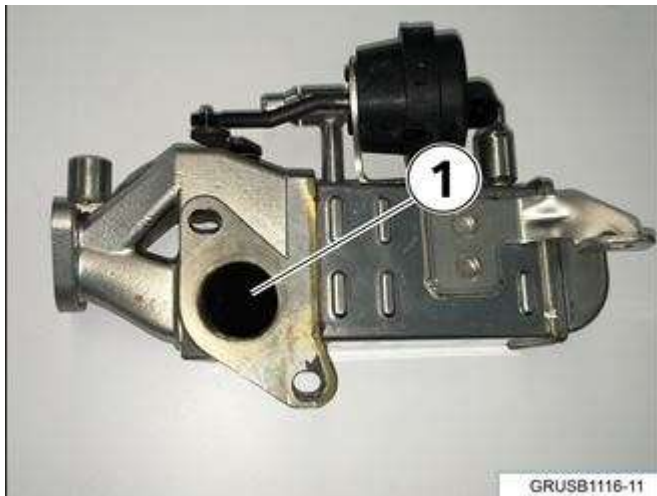
12. Inspect the cooler by-pass flap (1).

Is the flap intact?

NO (flap missing or damaged) – Replace the cooler and continue to step 13.

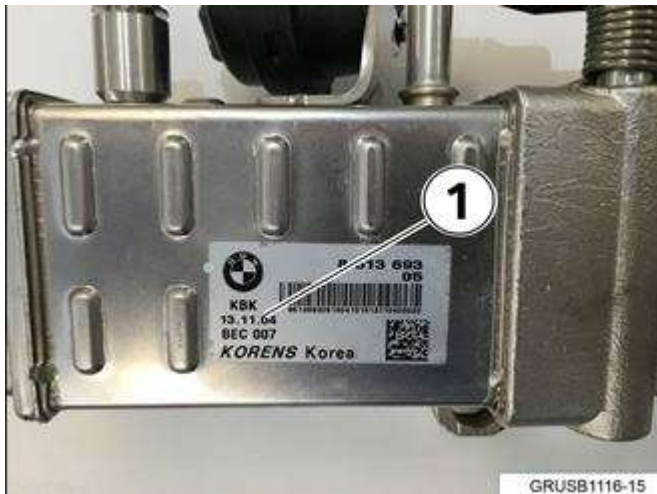
YES- Check the production date of the cooler (1). If the production date is before 15.02.20 (YY.MM.DD or February 20, 2015) replace the cooler. If the production date is newer – reinstall the cooler.
