87-18-02 - Air Conditioning Does Not Cool and / or Compressor is Noisy

Release date: 5/12/20

Applicable Vehicles					
Model(s)	Year	Eng. Code	Trans. Code	VIN Range From	VIN Range To
Golf/GTI	2015-2017	All	All	AU_FM000001	AU_HM009117
Golf SportWagen	2015-2017	All	All	AU_FM500001	AU_HM506396

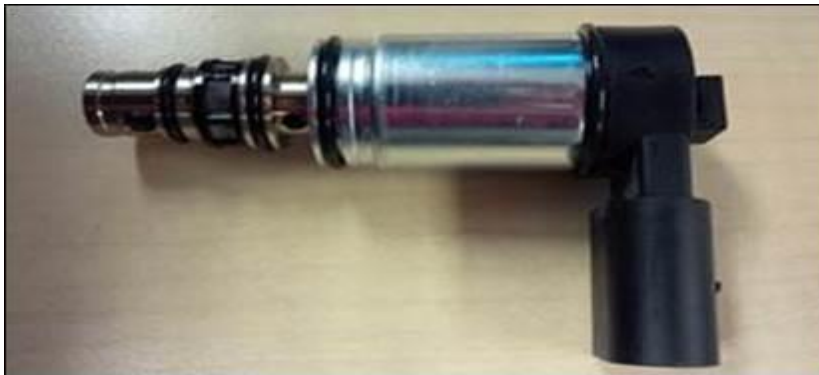
Figure 1 N280 Refrigerant Regulating Valve 5Q0260839A

The condition may be caused by a faulty A/C compressor regulator valve N280 (Sanden). The internal components of the valve can be obstructed and incapable of full function. This loss of refrigerant regulation from **-N280-** can cause noise from the air conditioning compressor and/or affect the HVAC cooling (Figure 1).

Improved **-N280-** valve for the Sanden A/C compressor CW34/16.

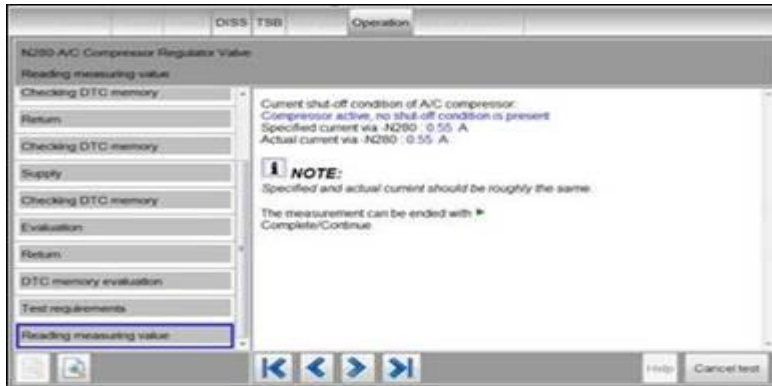
Figure 3. Checking N280 signal value Measuring Value Block.

Monitor the measuring value for the air conditioner compressor regulating valve N280 signal (Figure 3).

The actual and specified values will be plausible and will show a normal regulating range of current for cooling request (0.400 A – 0.820 A).

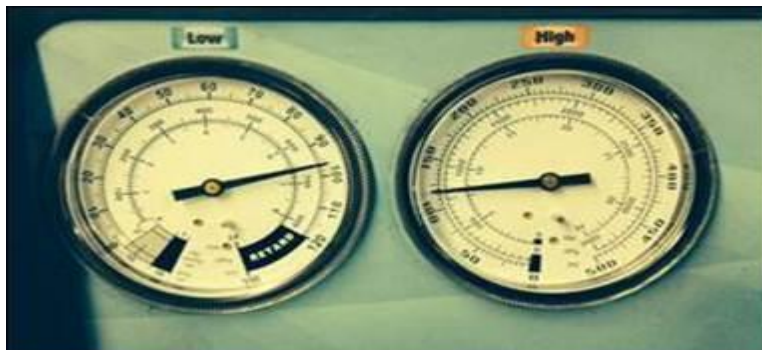
Figure 4. Equalized pressure condition. No pressure generated from compressor.

After verifying the compressor should be on and operating check the gauge readings on the Robinair® service station. If the gauges show no pressure generation from the compressor continue to the next step.

(Example of no pressure generation is when the pressure readings on the high and low sides are equalized in Figure 4).

Note: If the gauge readings are showing normal compressor operation per the Elsa Repair Manual, this bulletin does not apply and further diagnosis is required.

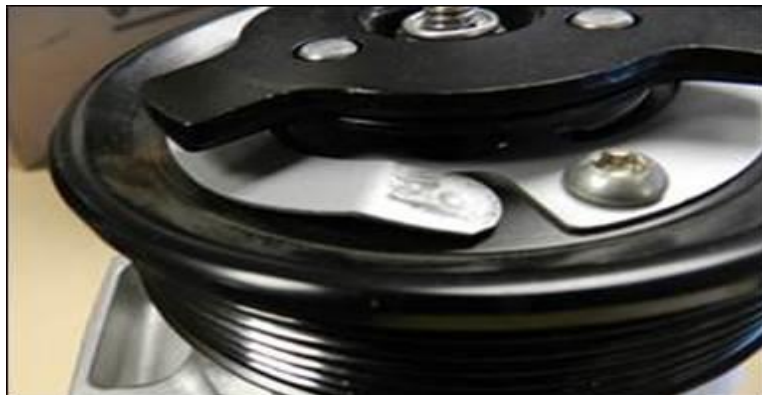
Figure 5a. Example of torque limiter over load protection

Check that the compressor torque limiter has not been activated (Figure 5b).

Note: If the torque limiter has been released the N280 regulating valve is not at fault. The compressor needs to be replaced.

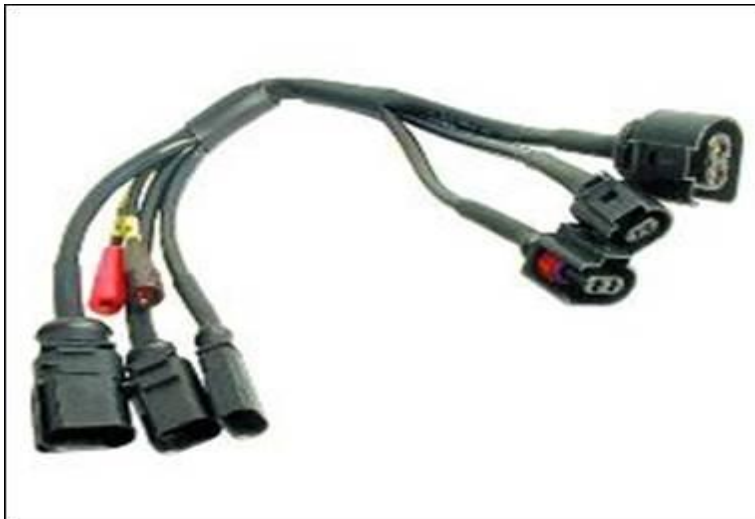
Figure 6. VAS 5256 breakout harness.

Shut off the engine. Connect the breakout harness VAS 5256 (Figure 6) between the N280 valve and its connector.

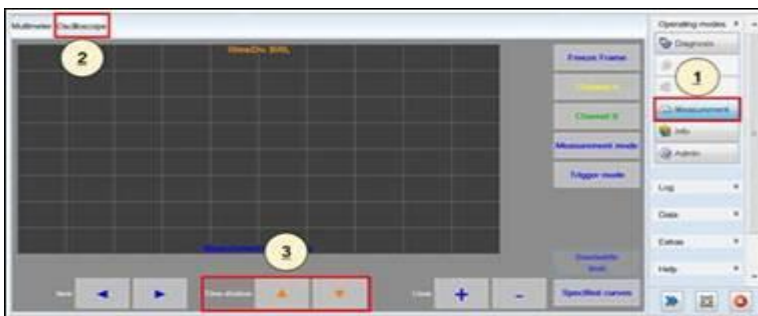
Figure 7. Select Measurements from operating mode menu”.

Go to Operating Mode "Measurements" to check the N280 signal from the control module.
Select Measurements.
Select oscilloscope.
Change time division to 2ms/Div (Figure 7).

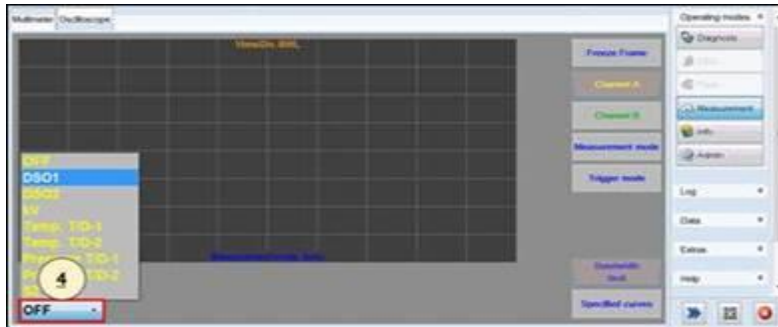
Figure 8. Setting up DSO channel”.

Select the correct DSO channel according the test leads hooked to the vehicle (Figure 8).

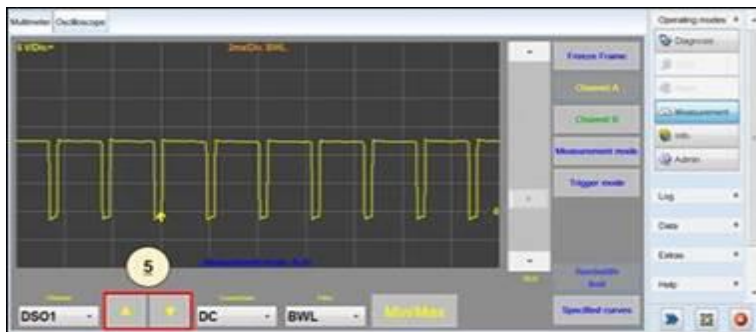
Figure 9. Checking the N280 signal wave form.

Change the voltage to 5VDiv.

Check the signal wave form (Figure 9). The square wave signal should be between 75% and 100%.

If the wave form signal is good, the mechanical integrity of the N280 valve needs to be inspected.

GO TO: Removing/Installing the N280 Regulating valve.

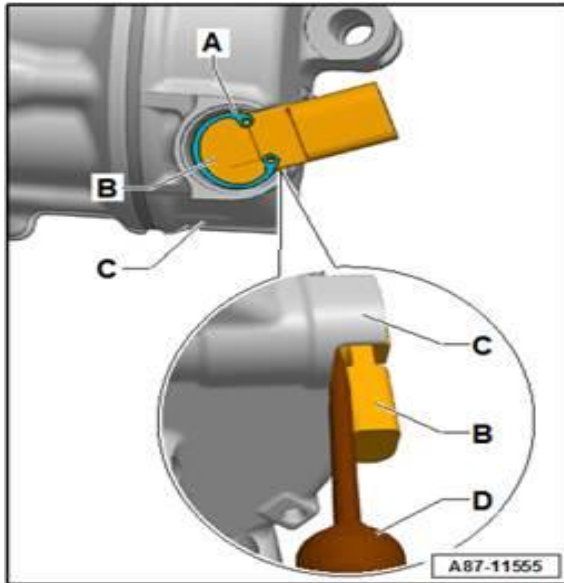
Figure 10. Circlip / N280 removal

1. Remove circlip-A- carefully.

2. Carefully remove the A/C Compressor Regulator Valve -N280- -B- from the A/C compressor mount -C-, using a suitable screwdriver -D-, for example (Figure 10).

Circlip must be reused.

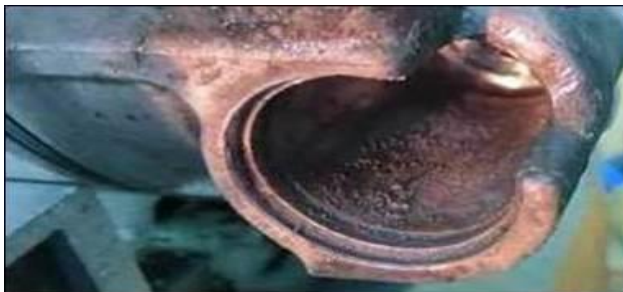
Figure 11. Corrosion in the N280 valve bore.

Assess the condition of the N280 valve bore and the valve filter screen (Figure 11). If severe contamination is found in valve bore there is a risk of damaging the replacement valve on installation. In these cases the A/C compressor must be replaced.

A slight amount of debris or corrosion does not present a risk and does not justify replacement of the AC compressor.

- If little or no corrosion or contamination is found perform Repair Procedure A: Replacing the N280 regulating valve.
- If corrosion and contamination is found, perform Repair Procedure B: A/C compressor replacement.
- Document the all workshop findings of this procedure on the repair order.

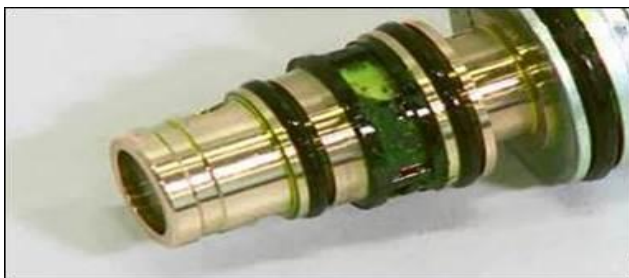
Figure 12: Severe contamination at the N280 valve filter screen.

Should severe contamination be found at the valve filter screen (Figure 12) and A/C compressor replacement becomes necessary, ensure that the refrigerant circuit is flushed in the course of repair.

Small random particles on the filter screen does not constitute "severe" contamination and does not justify replacement of the A/C compressor.

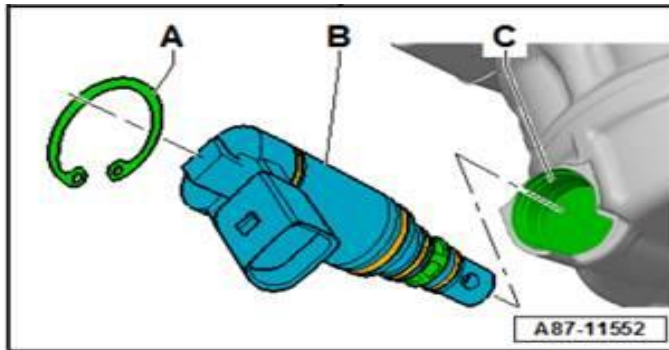
**Figure 13:** Prepare mount for N280 installation.

Risk of damaging another N280 Valve or compressor may result due to dirt contamination or damage to the sealing surfaces in the mount.

- If necessary, carefully clean the A/C compressor mount -C- using only a clean, lint-free cloth (do not use compressed air).
- Make sure while cleaning the mount -C- that no dirt gets into the area underneath the O-ring sealing surface -F- or the existing channels and none of the mount sealing surfaces become damaged.

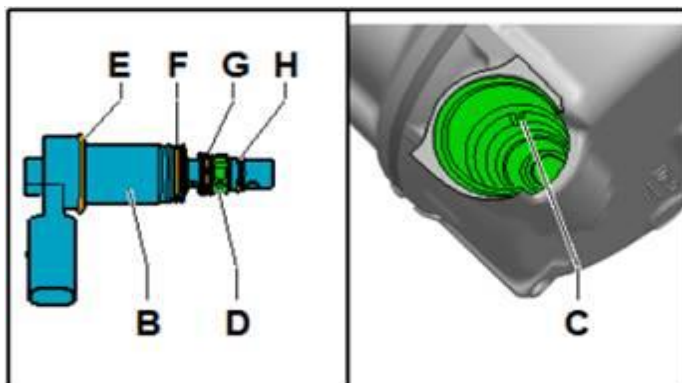
**Figure 14.** Check and prepare N280 o-rings

1. Check the O-rings -F-, -G-, -H- and -E- (if applicable) of the A/C Compressor Regulator Valve - N280- -B- for damage.
2. Coat the O-rings -F-, -G-, -H- and -E- (if applicable) of the A/C Compressor Regulator Valve - N280- -B- lightly with refrigerant oil and check for proper seating (Figure 14).

3. Insert the A/C Compressor Regulator Valve -N280- -B- until the stop in the A/C compressor mount -C-.
4. Re install circlip -A-.

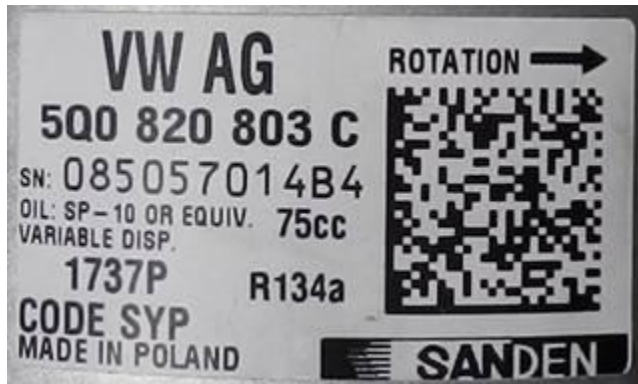
Figure 15. Example of compressor label

When the N280 is replaced a photo copy of the A/C compressor label must be attached to the repair order and uploaded to WISE for supplier traceability (Figure 15).

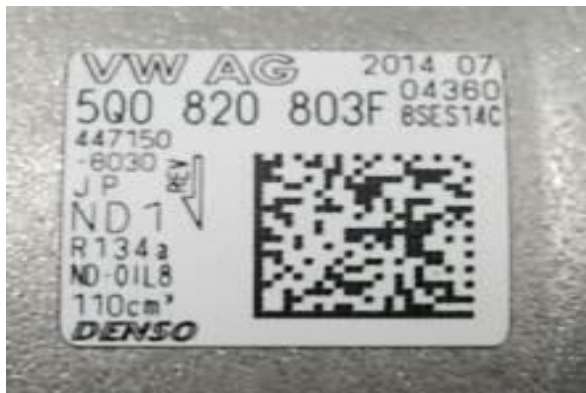
Figure 16: Denso compressor 5Q0820803F

MY2015 GTI/Golf, SportWagen production have Sanden® compressors 5Q0820803C, 5Q0820803E and 5Q0820803G.

The replacement compressor is Denso 5Q0820803F

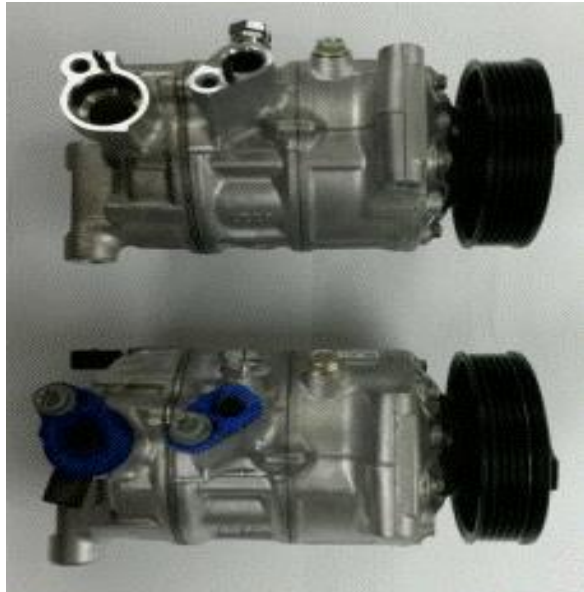
**Figure 17**

When installing a new compressor transfer the compressor shipping caps to the original compressor as shown in Fig 17.

All replaced compressors must have the shipping caps re-installed before being returned to the WPRC.

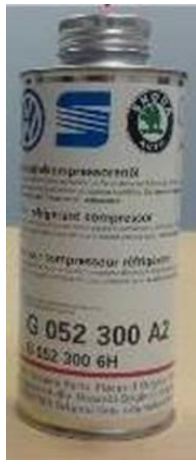
**Figure 18:** Denso compressor manufacturer PAG oil G 052 300 A2.

The replacement Denso® compressor will come with the specified type of PAG oil G 052 300 A2 (Figure 16).

The compressor comes with a full charge of oil for the entire refrigerant circuit. However the amount of PAG oil supplied with the replacement compressor may not be the exact amount to replenish the refrigerant circuit. Drain and measure the PAG oil in the replacement compressor to determine the required amount. If the amount needs to be adjusted, do so using the correct type of PAG oil specified in ETKA. Refer to Elsa for the correct oil capacity for the compressor being installed.

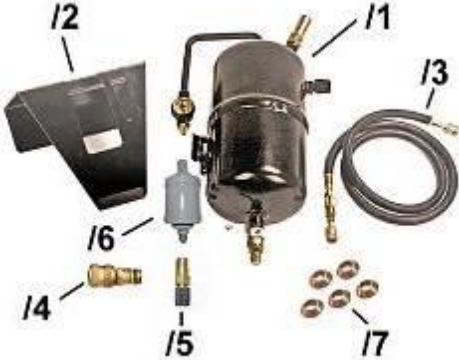
<p>ROB134APF Or latest machine version</p>
<p>Air Conditioning System Flushing Device</p>

<p>17707 Kit, Flusher Filter</p>
