STAR ONLINE PUBLICATION

Case Number: S1823000029

Symptom/Vehicle Issue: Water Leak Carpet Wet At Front And Or Rear Seats

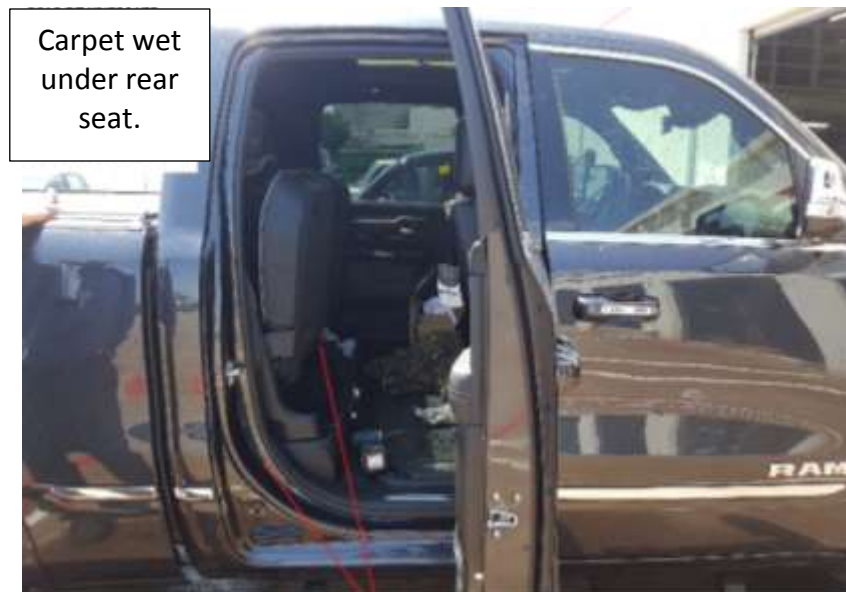
Inspection area for water entry rear cabin wall.

Sunroof drain tubes, connections and grommets should be inspected for kinks, and proper attachment for all 4 tubes.

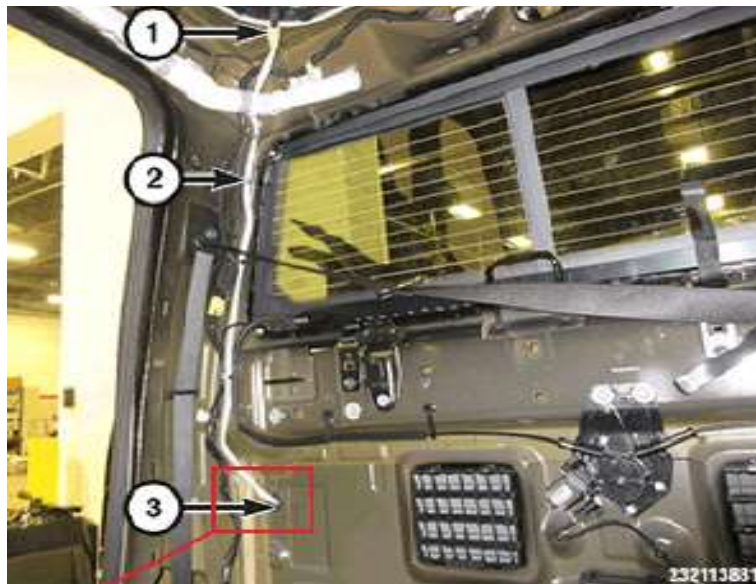
Rear Cabin Wall Drain Tube Grommet Not Flush To Wall, Secure To Complete

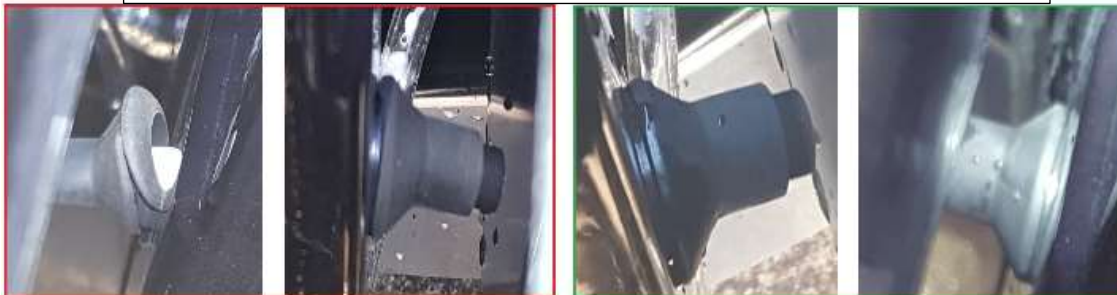
SUNROOF REAR DRAIN GROMMETS NOT INSTALLED IN BODY,
WATER LEAK INTO CAB

GROMMETS IN POSITION, WATER LEAK ELIMINATED
