NUMBER: 23-012-20 REV. A

Park Brake Pedal Doesn't Fully Return

This bulletin involves inspecting and if necessary, replace the parking brake tensioner and then adjust the parking brake cable system.

2019 - 2020	(D2)	RAM 3500 Pickup
2019 - 2020	(DP)	RAM 4500/5500 Cab Chassis

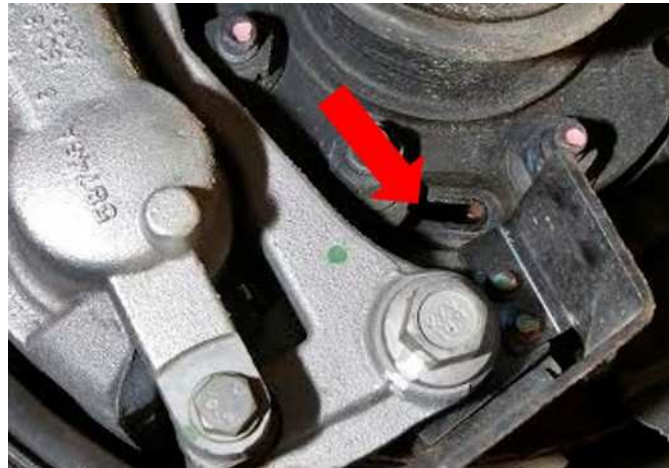
Fig. 1
Support Plate Access Hole

1. Place the ignition in the "on" position.
2. Engage the parking brake pedal 50-76 mm (2-3 in.) from the fully disengaged position.
3. Release the parking brake.
4. Place the ignition in the "off" position.
5. Raise and support the vehicle so the rear wheels can be rotated freely. Refer to the detailed service procedures available in DealerCONNECT/Service Library under: Service Info>04 - Vehicle Quick Reference/Hoisting/Standard Procedure.
6. Remove the support plate access hole plug from each access hole in the brake backing plates (Fig. 1) .

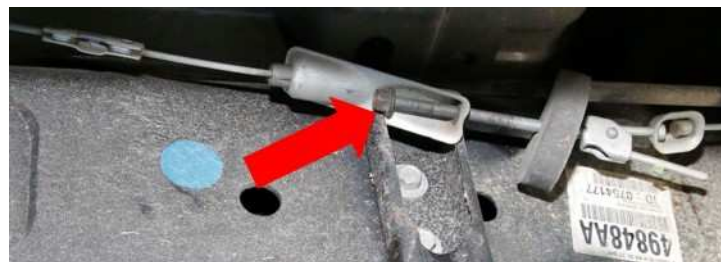
Fig. 2
Cable Tensioner Adjusting Nut

7. Loosen the park brake cable adjustment nut until there is slack in the front cable (Fig. 2) .

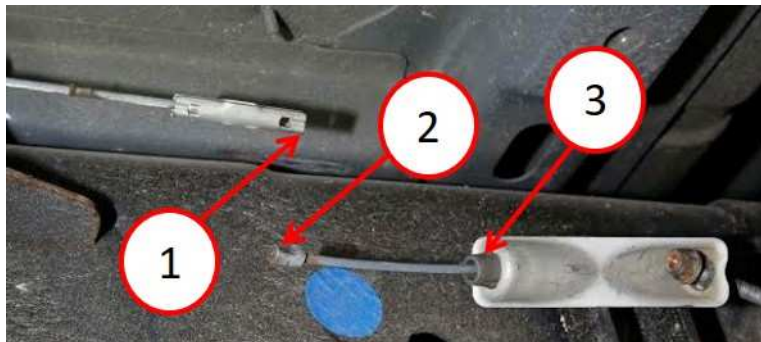
Fig. 3
Cables

10. For **D2** vehicles, insert the adjustment tool through the brake backing plate access hole and engage the tool in teeth of the adjusting screw star wheel four clicks **toward the axle for the right side** and four clicks **away from the axle for the left side**. Proceed to the [Step 11](#).
11. Install the support plate access hole plugs.
12. Remove the parking brake tensioner by backing off the cable tensioner adjusting nut [Step 12](#) to create slack in the parking brake cables.
13. Disconnect the front cable from the rear cable at the connector clip ([Fig. 3](#)) .

- 1 - Front Cable With Connector Clip
 - 2 - Rear Cable End
 - 3 - Cable Plastic End-Fitting On Tensioner
-

14. Remove the right hand parking brake cable plastic end-fitting from the tensioner ([Fig. 3](#)) .
15. Remove the left hand parking brake cable button end-fitting from the tensioner ([Fig. 4](#)) .

16. Install the new tensioner by connecting the left hand parking brake cable button end-fitting on the tensioner.
17. Connect the right hand parking brake cable plastic end-fitting on the tensioner ([Fig. 3](#)) .
18. Connect front and rear parking brake cables on the connector clip ([Fig. 3](#)) .

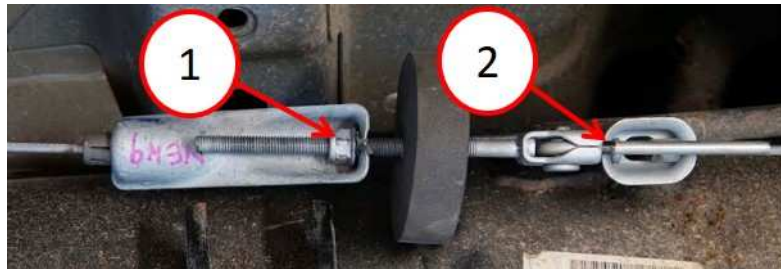
**Fig. 5
Tensioner Assembly**

21. Tighten the adjusting nut on the tensioner until the mark is no longer visible (Fig. 5) .

- 1 - Cable Tensioner Adjusting Nut
- 2 - Adjusting Mark

NOTE: Do not loosen, or tighten the tensioner adjusting nut for any reason after completing adjustment.
