## STAR ONLINE PUBLICATION

**Case Number:** S1923000010

**Symptom/Vehicle Issue:** Floor Console Center Storage Bin Door Inoperable And Or Stuck Closed.

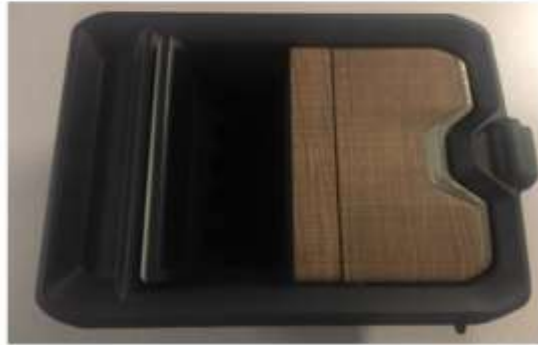
**Figure 2**

Sliding bin high with lodged contaminate now out of vehicle
