87-18-06 - Air Conditioning, Cleaning of the Refrigerant Circuit (U.S. Only)

Release date: 5/12/20

Debris can be dispersed throughout the refrigerant circuit after A/C system component damage. In order to maintain A/C operating efficiency, it is important to flush the refrigerant circuit after A/C component repairs.

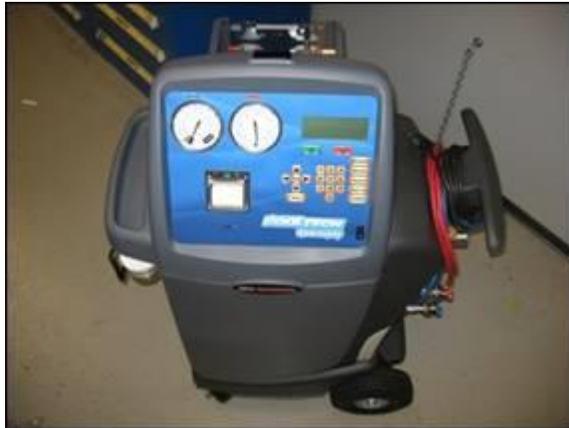
Figure 1. The ROB134APF Air Conditioning Service System with VAS 6337/1A Air Conditioning System Flushing Device.

- Use the **ROB134APF Air Conditioning Service System with VAS 6337/1A Air Conditioning System Flushing Device** (Figure 1) Used for effective refrigerant handling and air conditioning circuit flushing after air conditioning component failure.
- Now air conditioning system refrigerant recovery, evacuation, recharge and refrigerant circuit cleaning after component failure can be performed with a single servicing station.

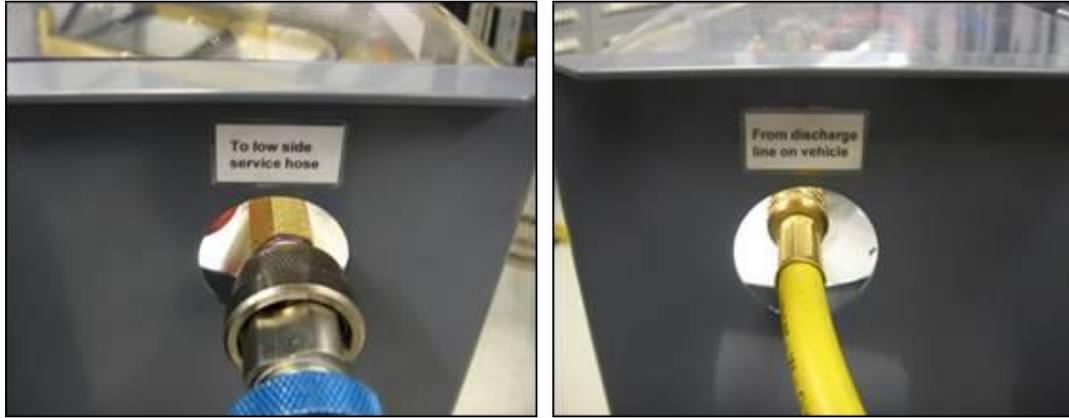
Figure 2. Example of a flushing attachment port.

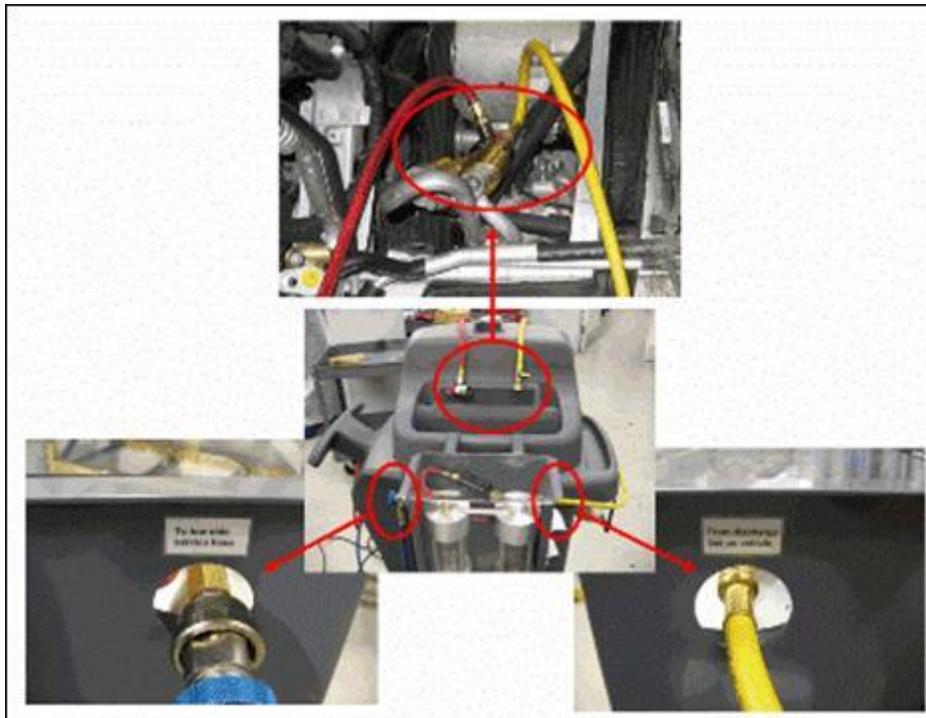
- This connection strategy allows for a system flush *in the opposite* direction of the normal refrigerant flow (Figure 3).

Figure 3. Connection strategy: Vehicle to service station to flushing device.

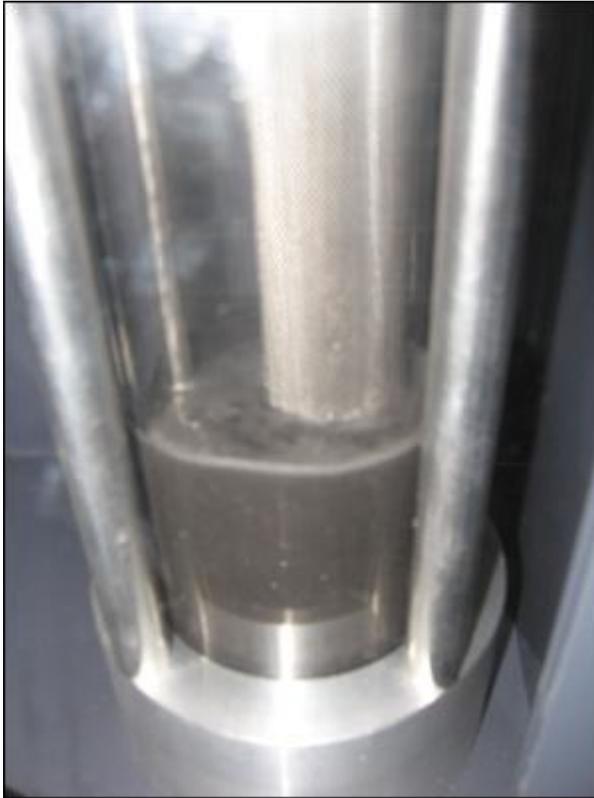
Figure 4. The first cycle.

- The flush program will begin with an evacuation of the system and a rate of rise test. This is necessary to test the integrity of the connections before the flush cycles begin. If the rate of rise test passes, the program will proceed into the flush cycles. (Figures 4 – 6). These cycles will occur automatically in succession.

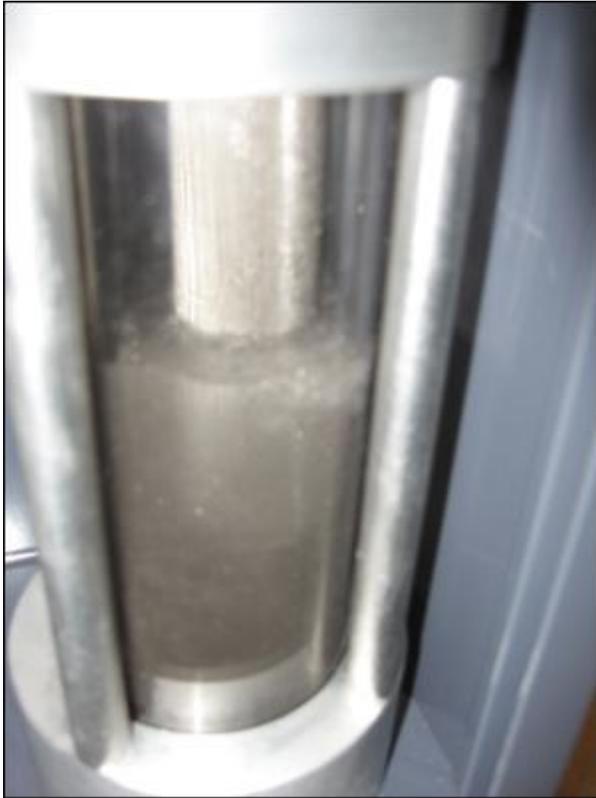
Figure 5. The second cycle.

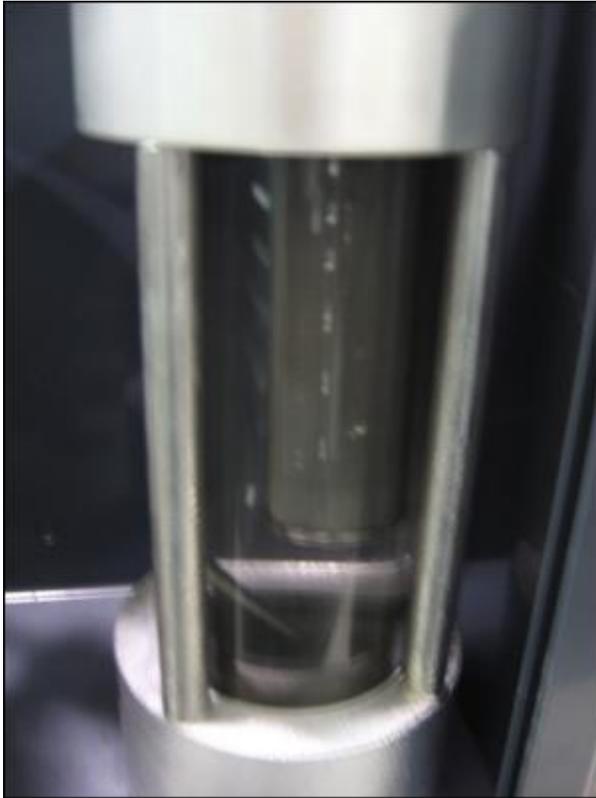
Figure 6. The third cycle.

- The debris is then rinsed from the circuit and contained within the filtration in the flusher. After the flush program, the system will be evacuated.
5. After the system is evacuated, remove any adapters that were installed from the VAS 6338/1.
 6. Replace Expansion Valve (if equipped), Receiver-drier and Restrictor (if equipped).
 7. Connect the station in the usual manner through the service fittings and perform the normal evacuation and refrigerant recharge operations.
 8. Print a log of the job and attach to the repair order.

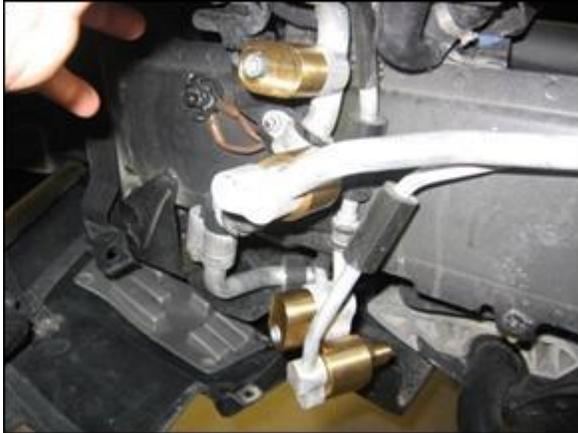
Figure 7. The location of the connections inside the left front wheelhouse on a Touareg with four zone climate control.

1. Separate the front and rear air conditioning systems for individual rinse operations (Figure 7).

The VAS 6338/1 contains the necessary adapters to separate the systems for the individual rinse operations.

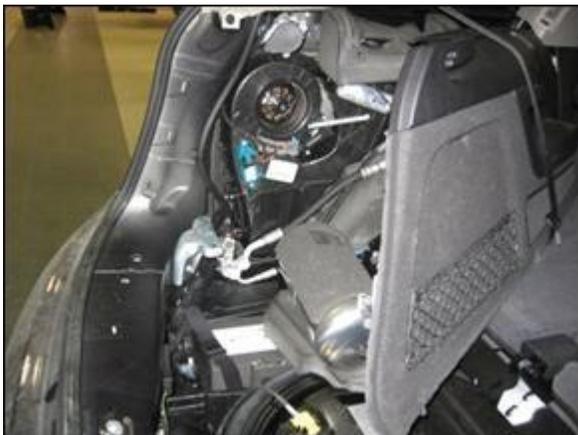
Figure 8. Location of rear air conditioning unit and expansion valve.

2. Bypass the rear expansion valve with an adapter (Figure 8).

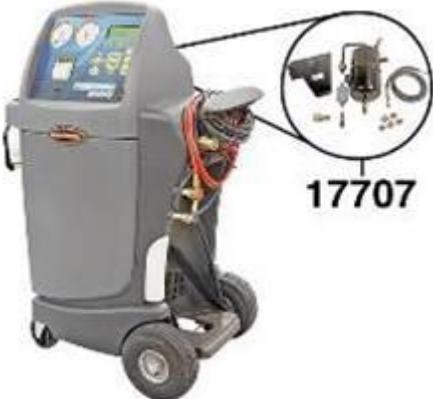
<p>ROB134APF Or latest machine version</p>

Tool Description	Tool No:
<p>Air Conditioning Service System.</p>

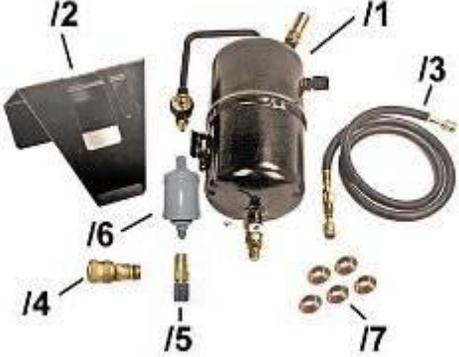
<p>Air Conditioning System Flushing Device</p>

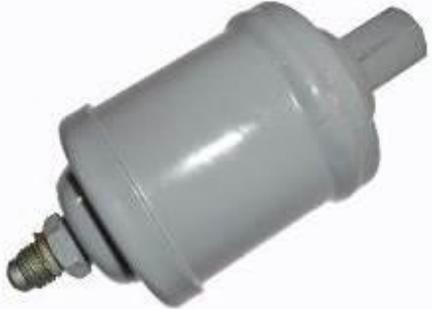
<p>Bosch – 17707-6</p>
<p>Air Conditioning System Flushing Device Filter (For previous version of Behr VAS 6337/1A)</p>

<p>12 11 13 16 14 15 17</p>	<p>17707 Kit, Flusher Filter</p>
<p>Air Conditioning System Flushing Device Filter</p>

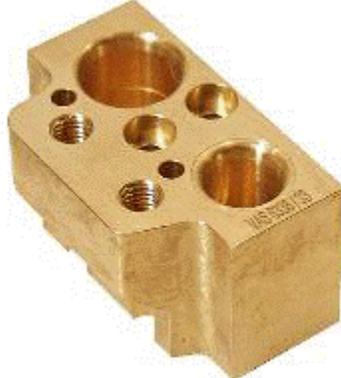
<p>VAS 6338/33</p>
<p>Additional refrigerant circuit adapter 36</p>

<p>VAS 6338/1</p>
<p>Additional adapter 33 for bypass of the front expansion valve for Touareg</p>

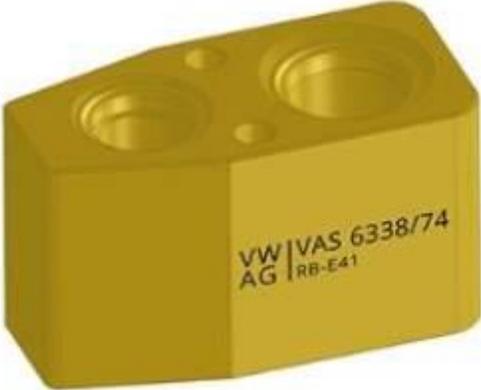
<p>VAS6338/38</p>
<p>Refrigerant Circuit Adapter 74</p>

<p>VAS 6338/74 MY 2016-2017 Passat and Beetle MY 2016-2018 Jetta</p>
<p>Additional refrigerant circuit adapter</p>

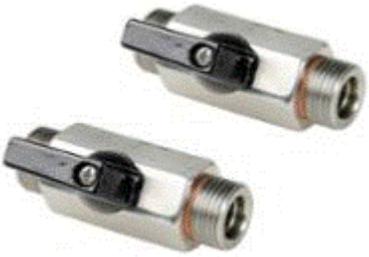
<p>VAS6338/42</p>
---	-------------------

<p>Additional refrigerant circuit adapter</p>
