Eliminating Symptoms in Body Interior: Reworking Seat Cover on Seats With Seat Ventilation - Spots on Seat Cover (04/11)

Model Line: **Boxster/Cayman (981) / 718 Boxster/Cayman (982)
911 Carrera (991) / 911 Carrera (992)
Panamera (970) / Panamera (971)
Macan (95B)
Cayenne (92A) / Cayenne (9YA/9YB)**

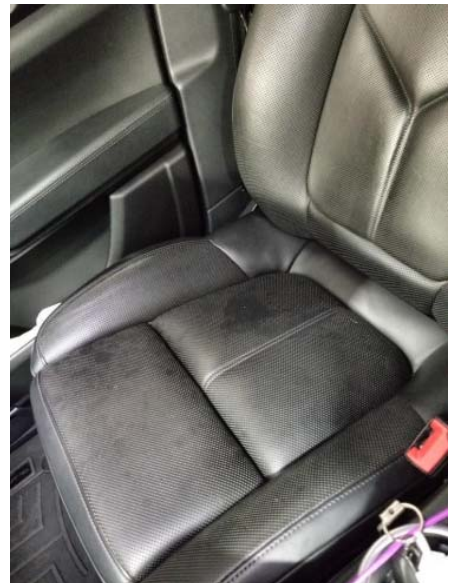
Figure 1 - Seat spots

Symptom: **Dark "spots" can appear near the perforations on seats with seat ventilation under certain conditions.**

Information: **On perforated seat covers, the pre-dyed color can become darker near the perforations as a result of dampness or rain water.** This can look like spots under certain lighting conditions and when viewed from certain angles.

- These "spots" are not damaged areas on the seat cover and do not therefore constitute defects from the point of view of the warranty.
- Perforated leather becomes darker following contact with moisture.

- Wipe off the complete seat surface and backrest surface using a clean, fine-pore sponge and distilled water. Make sure that the water does not soak right through to the back of the perforated leather.
- Leave the seat cover to dry completely at room temperature and away from direct sunlight. Do not switch on seat heating and seat ventilation.
- Once the seat cover is dry, rub it down with a dry, lint-free cloth.
