Technical Service Bulletin

GROUP Body	NUMBER 20-BD-015H
DATE May, 2020	MODEL(S) Sonata (LFa)

SUBJECT: TRUNK LID TORSION BAR SERVICE GUIDE
AND WARRANTY EXTENSION (TXXF)

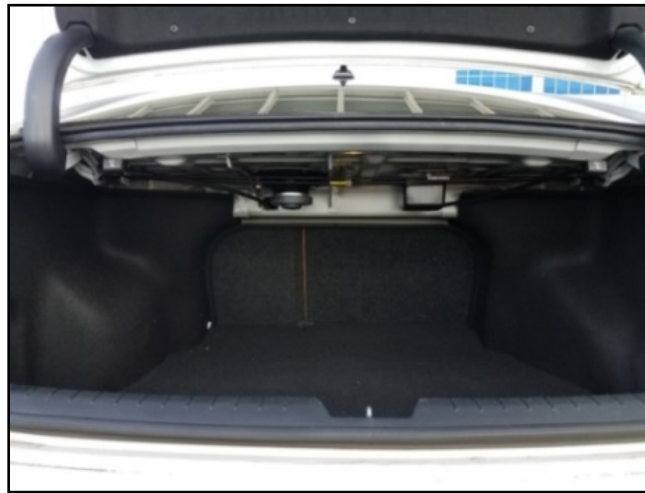
Description: On certain Sonata (LF) vehicles equipped with smart trunk, the trunk lid may not open to the desired height when using the smart trunk feature. Follow the procedure in the bulletin to inspect the trunk lid opening height, and replace the torsion bars if required.

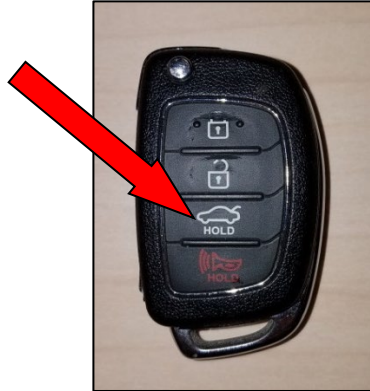
1. Using the key fob, perform an open and close cycle of the trunk lid ten times.

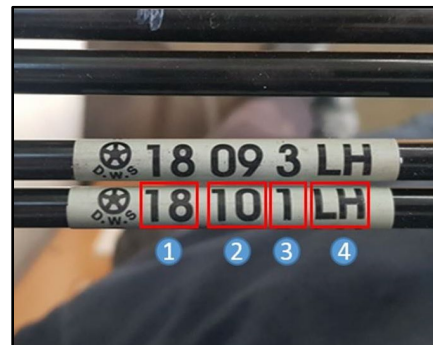
4. Before removing the torsion bars from the vehicle, inspect the labels on the replacement torsion bars to verify their production date.

Verify that the replacement torsion bars were produced after February 2019.

Do not use replacement torsion bars produced before February 2019.

1. Production year
2. Production month
3. Production sequence
4. Left / right side

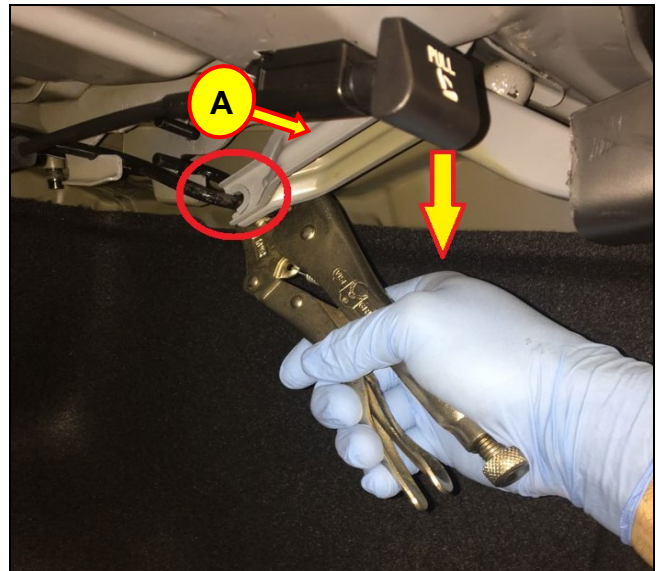
6. Pull the vice grips downward to release the hinge (A) from the torsion bar, and push the hinge toward the outside of the trunk.

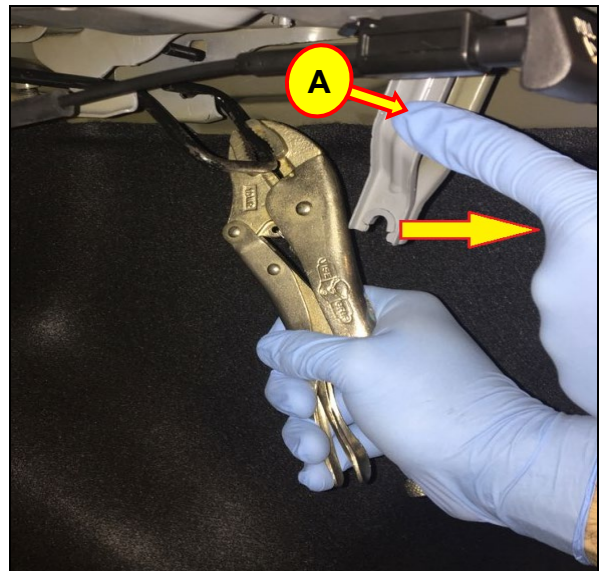
7. After releasing the hinge (A) from the torsion bar, slowly lift the torsion bar held by the vice grip and release the vice grip.

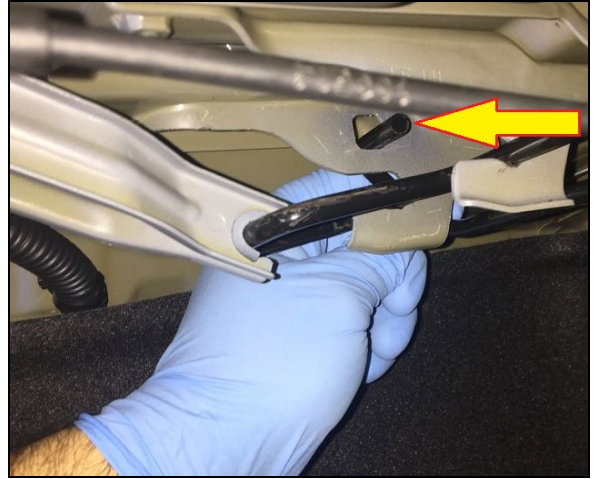
9. Remove the loose torsion bar from the mounting point on the opposite side, and then remove from the vehicle.

After removing the first torsion bar, place a prop rod that is approximately 5 feet long to hold the trunk lid open while performing the procedure.
