HYUNDAI

Technical Service Bulletin

GROUP CAMPAIGN	NUMBER 20-01-020H
DATE MAY, 2020	MODEL(S) SONATA HYBRID (LF HEV)

SUBJECT: AIR FILTER KIT AND NVLD REPLACEMENT
(SERVICE CAMPAIGN T4W)

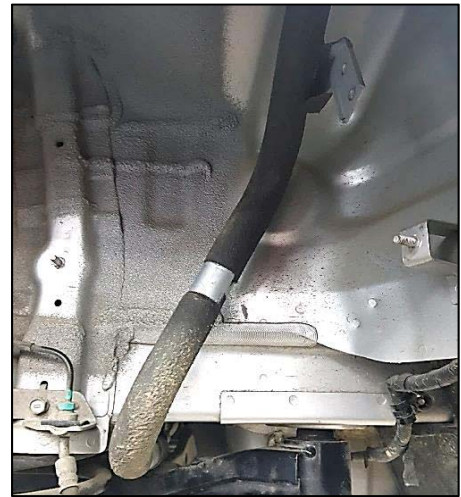
9. Remove the filler neck vent line, upper hose and air filter.

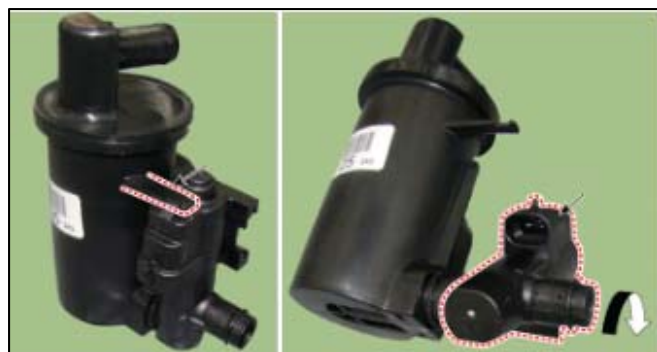
Require to separate and reuse the CCV which is part of the removed air filter.

Lift up the locking lever, rotate CCV 30 degrees and then pull away to release the CCV.

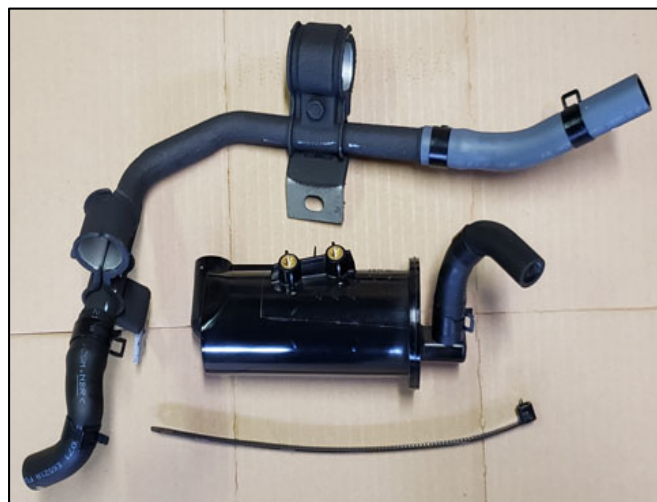
13. Install the new air filter KIT and reinstall the removed parts, including CCV, in reverse order of removal.

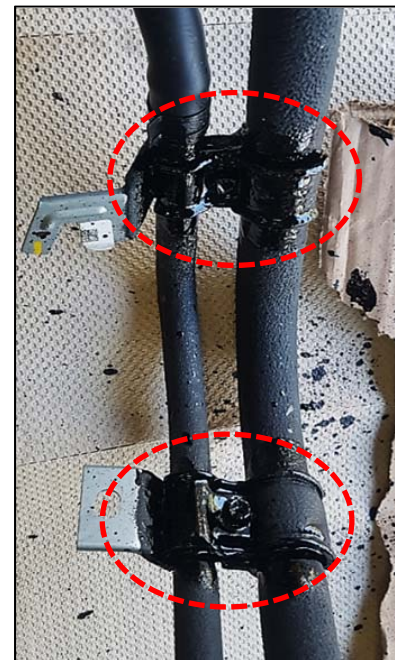
14. Spray the black undercoating aerosol evenly to each vent line bracket for approximately 10 seconds.

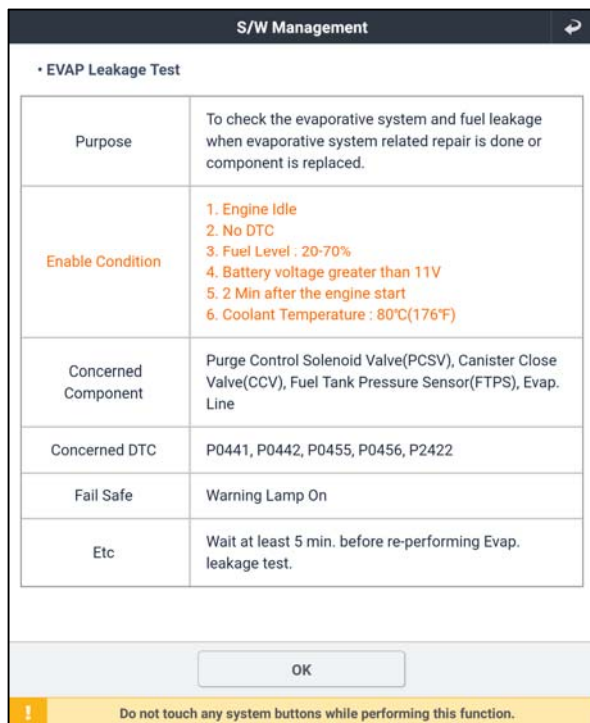
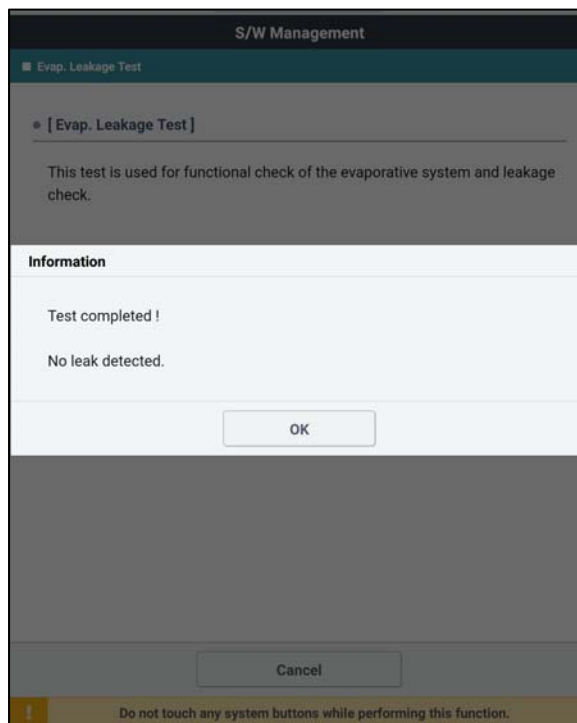
Follow GDS instructions and perform GDS Evap Leakage Test to confirm parts and hoses are installed properly.

17. Check for installed parts and hose connections if EVAP leakage is detected.

After making corrections, clear the DTC(s) and perform GDS Evap Leakage Test again.

Repair procedure is completed if EVAP Leakage Test doesn't detect any leakage.
