**Campaign code:**  
L636-A.02.20

**Campaign Name:**  
Wheel hub housing verification

**Model:**  
Urus

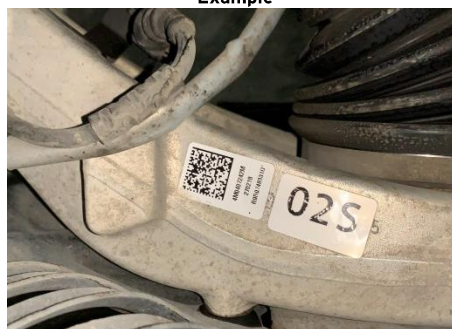
**For both above operations (A and B) it is mandatory to attach in the Service claim a clear picture of the label (see example below).**

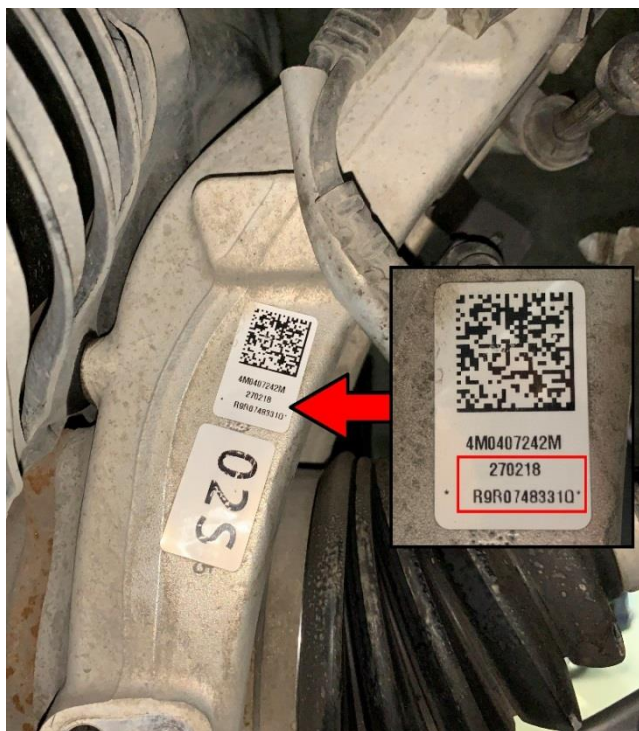
2. Find the serial number of the right hub holder located on the front of the component.

Check the exact correspondence with the serial number:

291019  
R9R0735501L

If the serial number corresponds, the hub holder must be replaced, proceeding with the operation B as described in the following paragraphs.

If the serial number does not correspond to the one indicated, ignore the following operations and consider the activity completed.
