**SIB 51 13 18**

**LIN BUS FAULTS WITH EXTERIOR REARVIEW MIRROR GLASS  
DAMAGE**

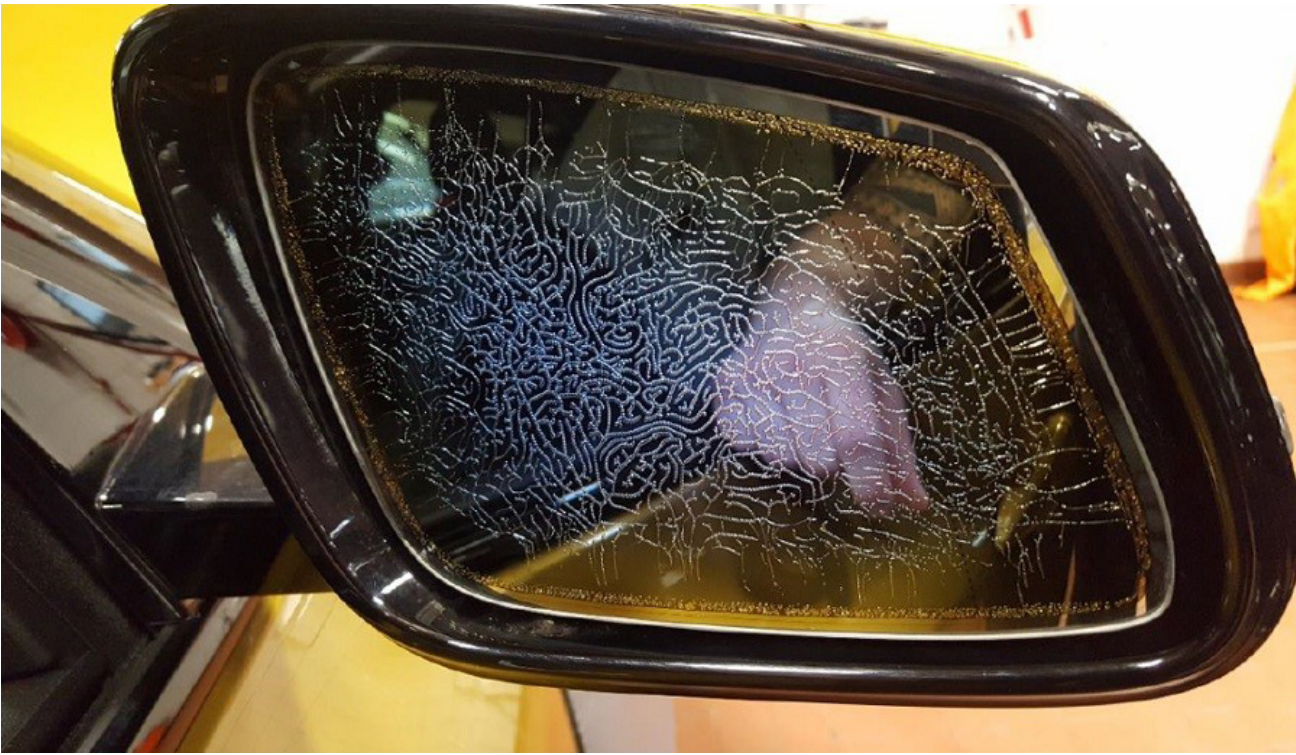
- A. The exterior rearview mirror glass is discolored or cracked
- B. The power windows and folding mirrors may not operate
- C. One or more of the following LIN bus faults are stored in the BDC (Body Domain Controller):

Faulty exterior rearview mirror electronics have created a short on the LIN bus, damaging the mirror glass and causing functional errors in power window and exterior mirror operation.

Replace the mirror electronics in the exterior mirror.

1. Test the operation of the power windows, side rearview mirror adjustment, and side rearview mirror folding functions. Inspect the side rearview mirror glass on both sides for damage as shown in the photo above.

4. Replace the mirror glass, if damaged.

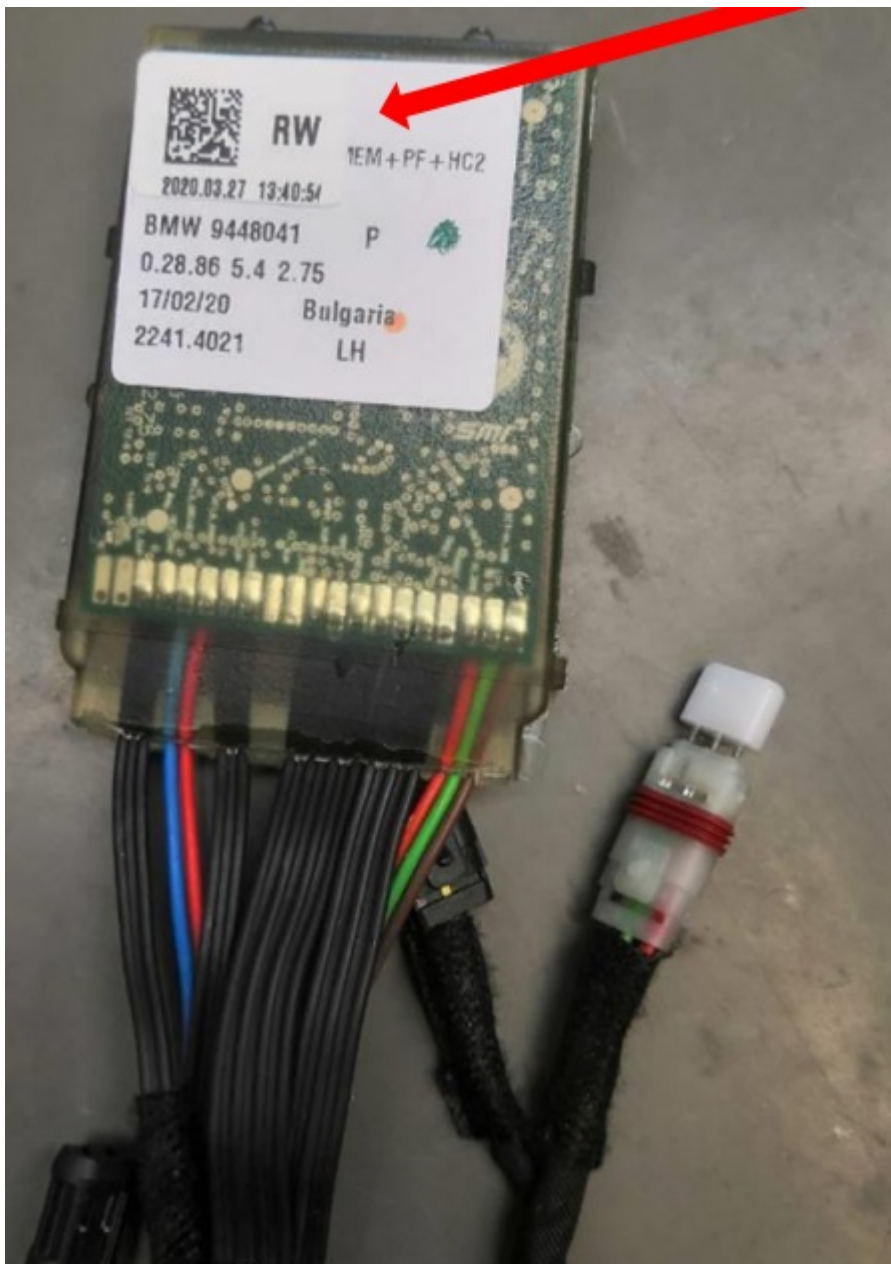
**Note:** Ensure the replacement mirror electronics have the marking “RW” as shown below. Do not install replacement mirror electronics which do not have this marking.

3. Replace the mirror electronics of the affected mirror following repair instructions **REP 67 13 526** “Replacing mirror electronics for electrically adjustable exterior mirror left or right”.
