Beltline/ S-lock Molding Separating

Bulletin Type:	SRP
Bulletin #(s):	19-019
Job Code(s):	**
Flat Rate(s):	**
<i>** If affected unit has warranty remaining, submit your claim following the normal process.</i>

Publication Date:	June 2020
Make(s):	Highland Ridge
Model(s):	Open Range, Mesa Ridge, Highlander
Model Year(s):	2018, 2019

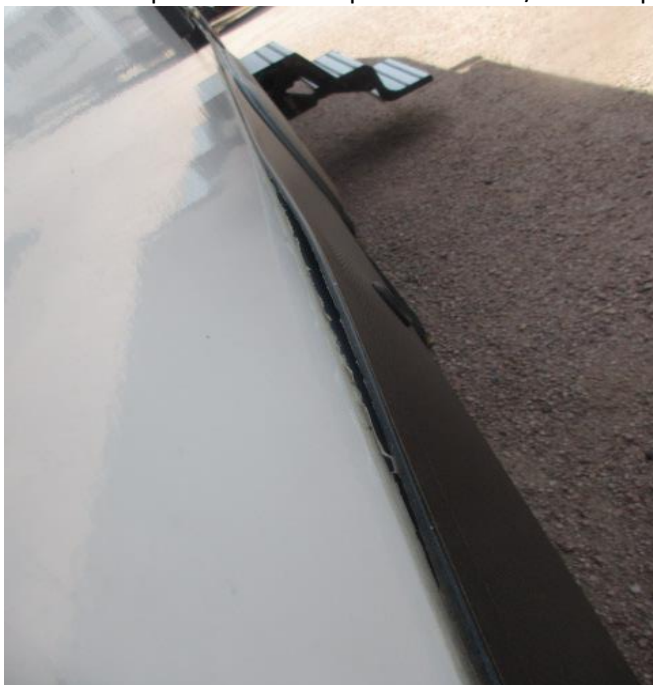
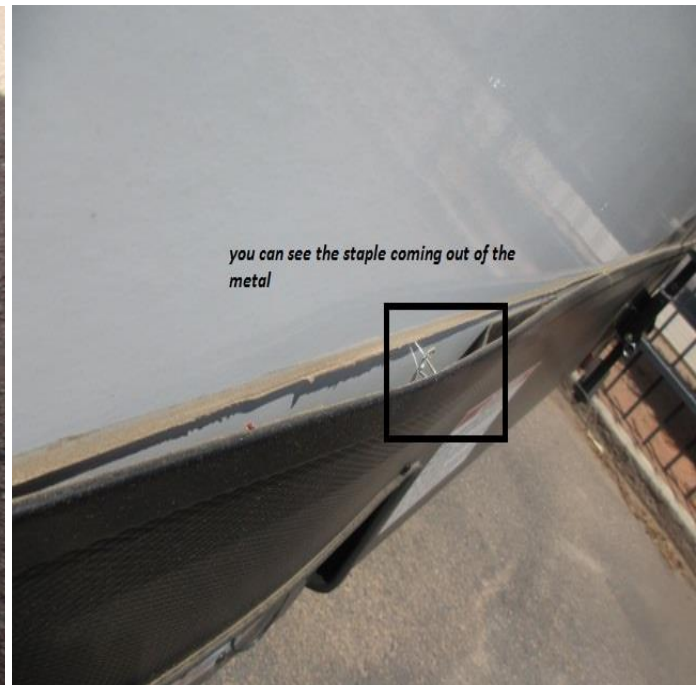
Incident:	Beltline/ S-Lock molding separating from the unit at sidewall.
Misc. Tools & Supplies:	Staple Gun, Quad Sealant
INSPECTION

- Inspect unit to confirm that there are no signs of metal skirt bowing and/or large staple spacing, causing Beltline/ S-lock to separate from sidewall.
- If you determine that the distance between staples securing the skirting range from 24" to 30" and shows separation and/or bowing from sidewall, you will need to perform Beltline/S-Lock repair.
- See pictures of examples of Beltline/S-lock separation below:

- 1) Confirm that backing is present in the sidewalls where the metal skirting is being fastened.
- 2) Remove metal skirting from the area or section that has the Beltline/ S-lock molding separating from the sidewall.
- 3) Place staples approximately every 4" in Beltline/S-lock molding. This will increase the holding strength and limit bowing associated with thermal expansion/contraction. **See Figure 1**
- 4) Reinstall metal skirting.
- 5) Reseal the top of Beltline/S-lock molding if necessary. Repair complete. **See Figure 2**
