## STAR ONLINE PUBLICATION

**Case Number:** S2023000028

**Symptom/Vehicle Issue:** Multi-Function Tailgate Over-slam Bumper Falls Off

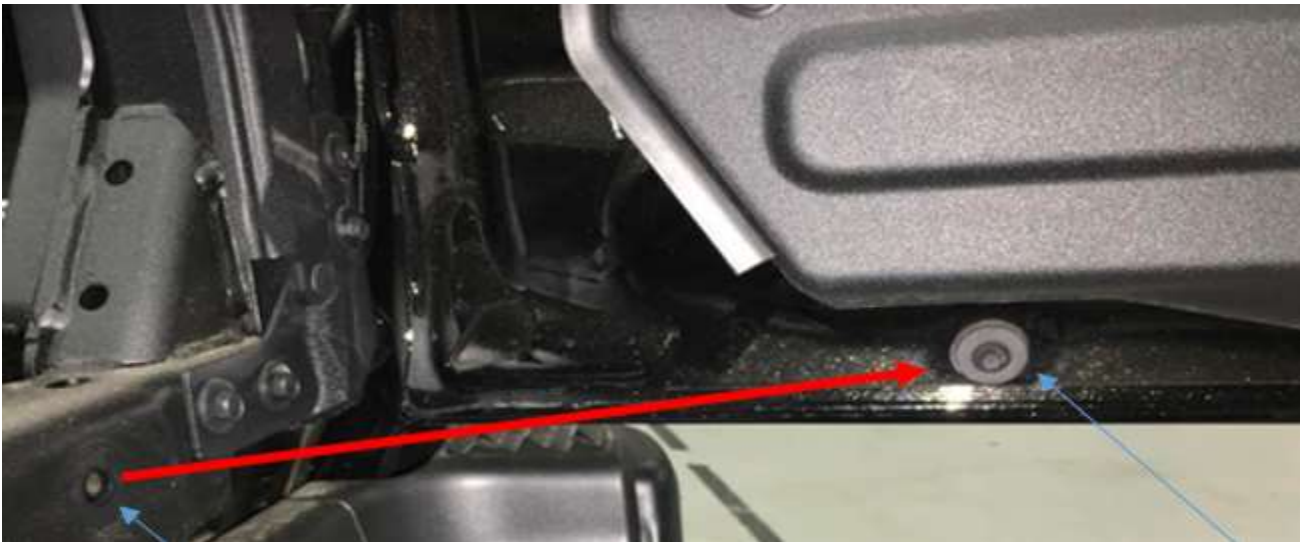
**Discussion:** Vehicle operator may notice when the multi-function tailgate swing door is opened the over slam bumper sticks to the door and pulls out of the U-frame (fig 1). If this has occurred follow the below procedure.

(fig 1)  
**Bumper sticking to tailgate**

Obtain over slam bumpers (68497915AA or newer) to replace any that are missing or damaged. Before installing wipe off the attachment points of U-frame surface and the mating side of the rubber bumpers with alcohol. Apply MOPAR Bond-All gel adhesive 04467709AB sparingly in a circle pattern shown below on the tailgate side of the over slam bumper. Be careful to stay away from the outside perimeter to avoid excess squeeze out of adhesive. Then install the over slam bumper into place on the pickup bed. It is suggested to use the adhesive on all 4 over slam bumper locations

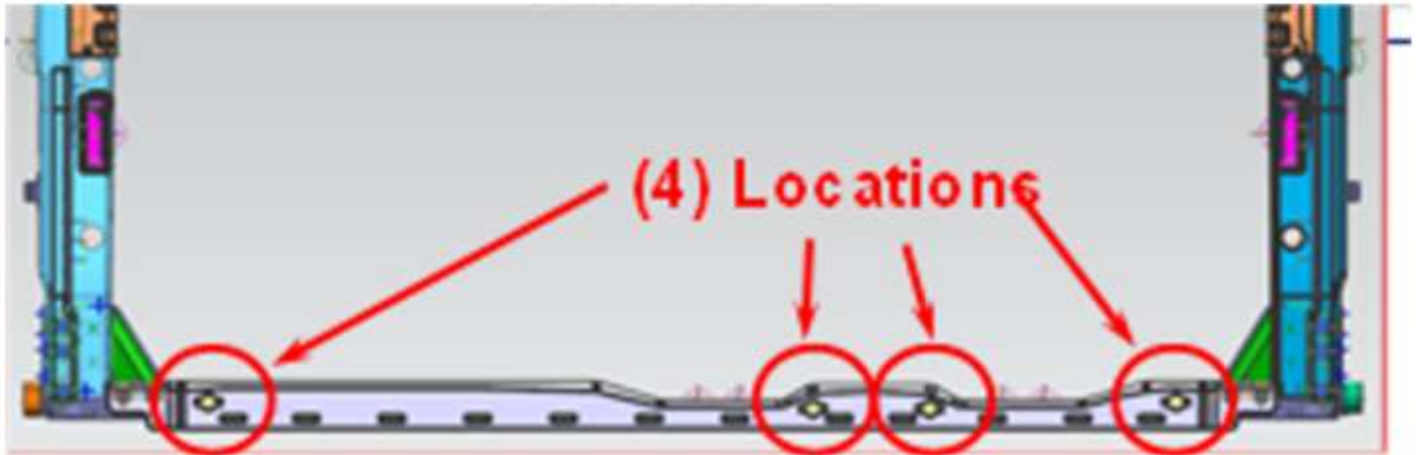
Fig 2

4 bumper locations on the pickup bed. Viewed from rear of truck
