Service Bulletin

Bulletin No.: 19-NA-277

Subject: Poor Fuel Transfer and/or Rear Fuel Tank Collapsed

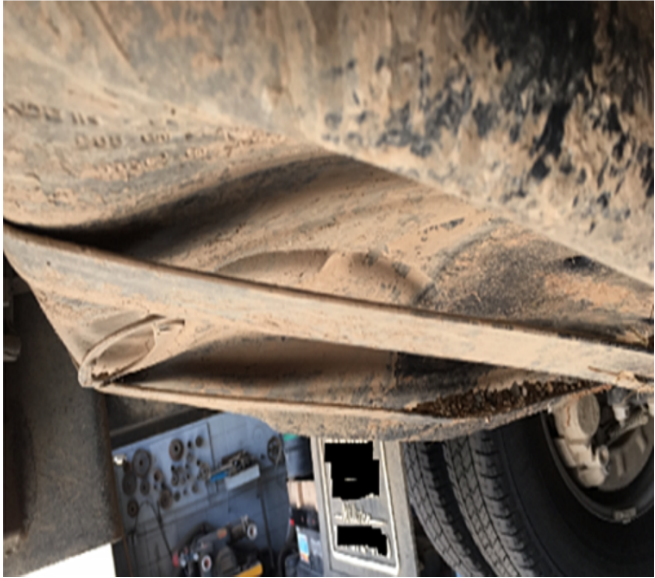
<p style="text-align: right; font-size: small;">5396125</p> <p>Some customers may comment on the rear fuel tank collapsed, as shown in the picture above.</p>

<p style="text-align: right;">5397974</p> <p>This condition may be caused by dirt and/or debris collecting on the top of the rear tank (1), plugging the vent causing the sending unit to draw air and bend the fuel tank fuel pump (2), as shown in the picture above.</p>
<p>Correction</p>	<p>Replace the fuel tank, fuel tank fuel pump module and install a piece of fuel hose to the vent and route down the fuel feed line and secure with zip ties, following the procedure listed below.</p>
