**\* \* TECHNICAL INFORMATION NOTICE \* \***

DATE: May 21, 2020  
TO: Mitsubishi Motors US & Puerto Rico Dealer Service and Parts Managers  
RE: Voltage Measurement on Low Beam Halogen Headlight Bulbs and  
12V Battery for **2014-2020 Outlander (RE) and 2018-2020 Outlander PHEV  
(R-EP)**  
TIN NO. TIN-20-54-001REV

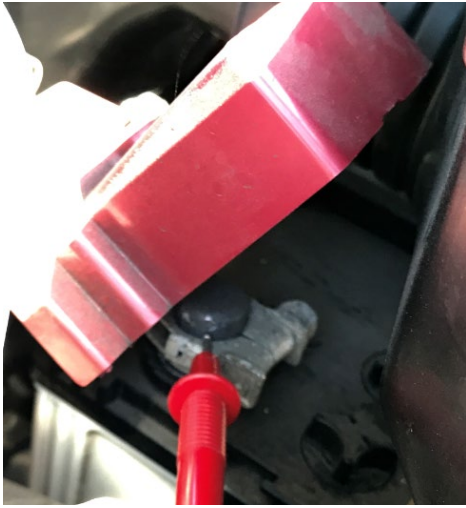
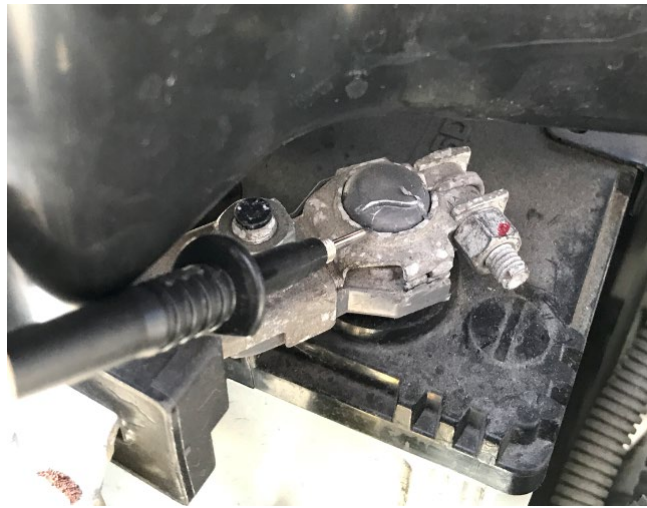
1. Measure and record the voltage at the positive battery terminal and negative battery terminal.
