## Blower Motor Is Noisy, Runs Slowly, or Intermittently Stops Working

### AFFECTED VEHICLES

Year	Model	Trim Level	VIN Range
2014-18	RLX	ALL	ALL
2014, 2016-18	RLX Sport Hybrid	ALL	ALL

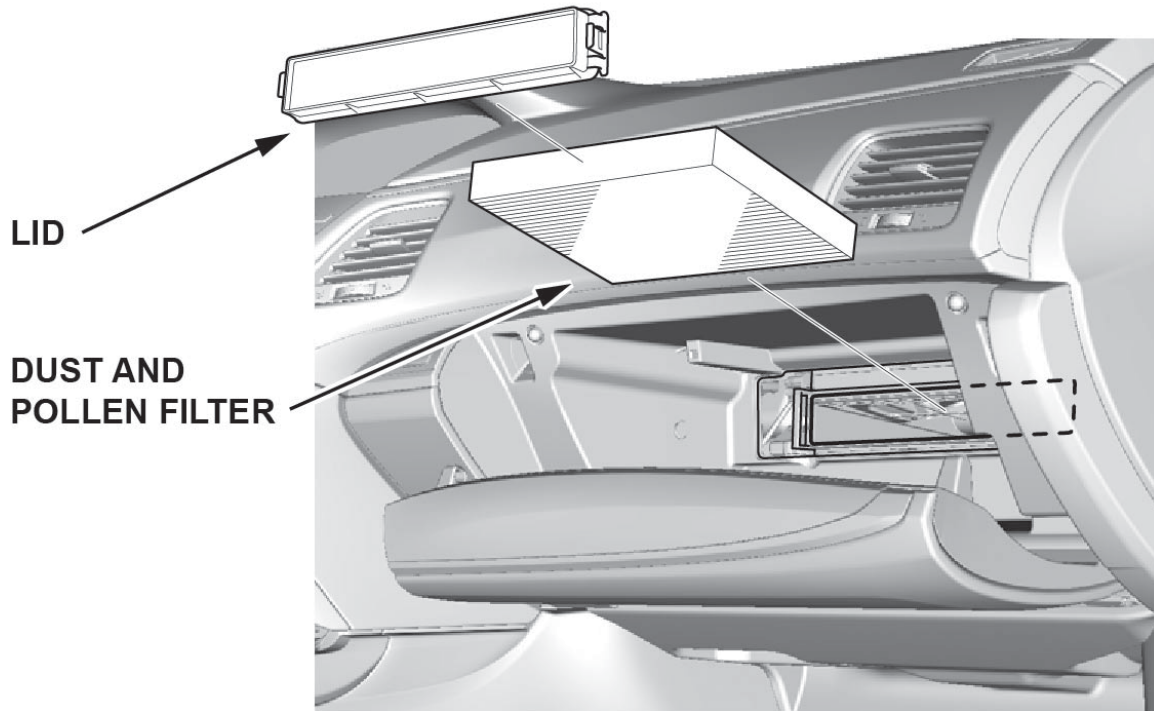
4. Remove the maintenance lid.

5. Remove the lid, then the dust and pollen filter.

- If the filter is not an activated charcoal filter, replace it with a new activated charcoal filter. Then, go to REPAIR PROCEDURE.
- If the filter is an activated charcoal filter, do not replace it. Just install it. Then, go to REPAIR PROCEDURE.

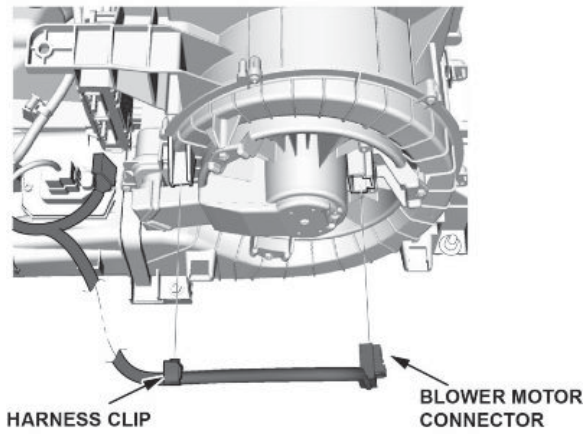
3. Disconnect the footwell light connector.

4. Disconnect the blower motor connector.

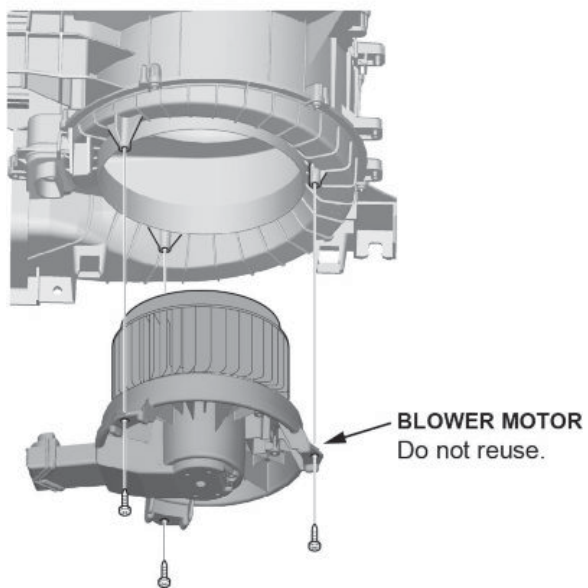
5. Remove the harness clip.
6. Remove the three screws and the blower motor.

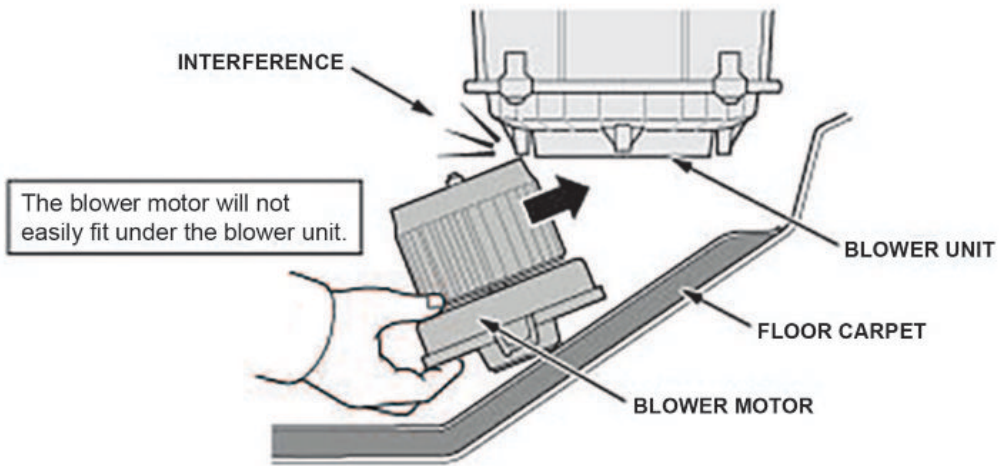
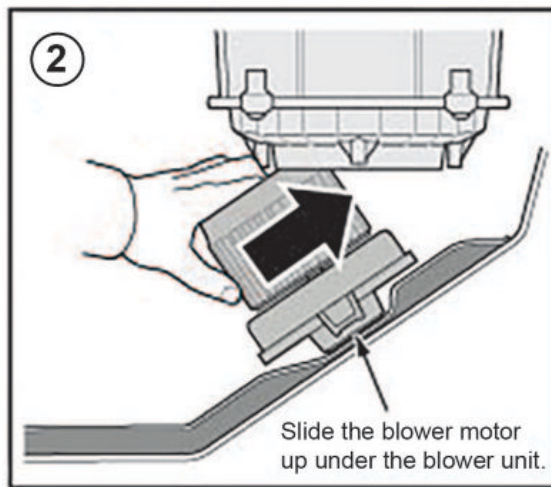
7. Install the new blower motor with the three screws.

8. Install the harness clip, then connect the footwell and blower motor connector.
