Customer Satisfaction Program

N202301190 Transmission Oil Cooler Lines

Condition	Certain 2020 model year Chevrolet Malibu vehicles, equipped with the 4-cylinder, 1.5L gas engine and continuously variable transmission (RPO LFV and MRG), may have a condition in which the transmission oil cooler lines were not properly secured.
Correction	Dealers are to inspect for the connection to the fan shroud and secure if not connected. Also, if the lines show signs of leaking, the dealers will replace if necessary.

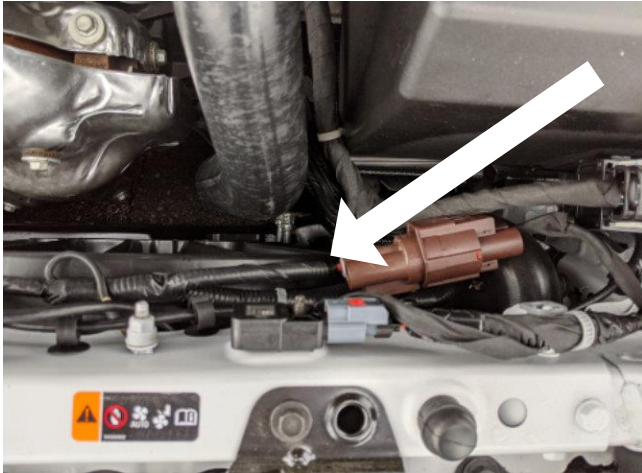
5608846

1. Raise the vehicle hood.

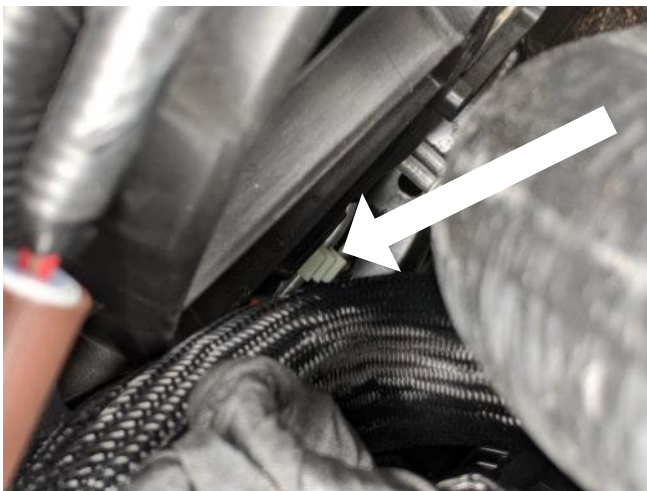
5608847

2. Locate the white clip that secures the transmission oil cooler lines to the driver side of the cooling fan shroud.
