## FT4827 Wheelchair Seat Hardware Loose.

Manual section 12

## MQR 2000 – Wheelchair Hardware Replacement

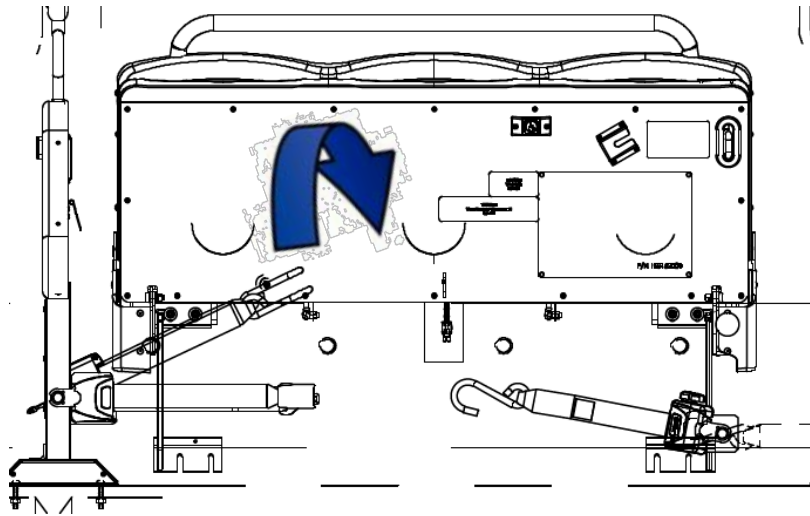
Move the seat by pulling it up and forward (towards the center of the bus)

5. Carefully disconnect the seat from the upper and bottom T-bolts by pulling it up and forward (towards the center of the bus).

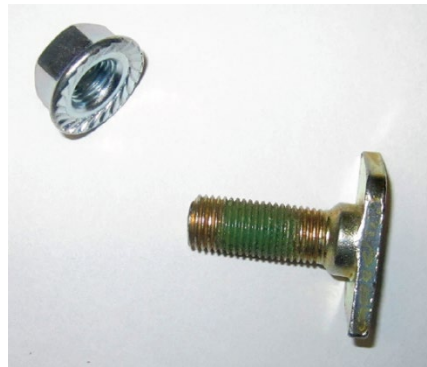
Previous version of T-bolt (one time use only) and flanged nut to be removed and discarded.

6. Remove all T-bolts from the upper and bottom rail channels. They are one time use only.

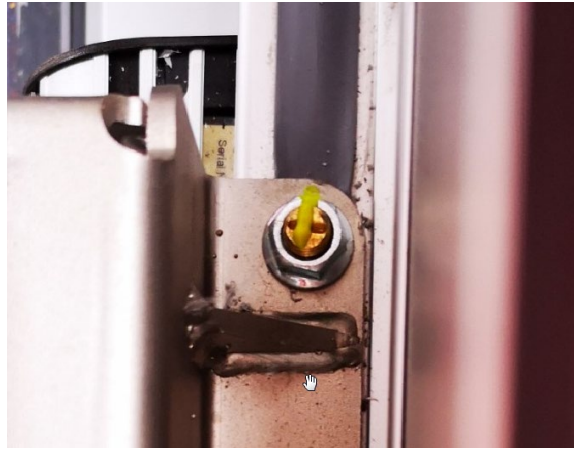
Example of T-bolt with top puncture facing the center of the bus

7. Confirm that neither the upper aluminum rail nor the bottom fiber rail have any damage.
8. Install 4 new T-bolts PN N99199-01 where the previous N44620-01 T-bolts were installed in the upper rail channel, making sure the top puncture mark faces the center of the bus (see Fig.).
9. Install 4 new T-bolts PN N99199-02 where the previous N44620-02 T-bolts were installed in the bottom rail channel, making sure the top puncture mark faces the center of the bus (see Fig.).

10. Insert the upper and lower seat brackets onto the T-bolts. Confirm that the upper and lower brackets are lined up.
11. Insert the new washers N84003 and nuts N0224000. Torque them to 21 N.m (15 lb.ft) with a 9/16" (14 mm) socket. Only use manual tools.
12. Apply torque seal on the nuts.
13. Place the battery switch and the master control switch to the ON position.
