GROUP FUE	MODEL 2017-2019MY Optima (JF HEV)
NUMBER 046	DATE June 2020

TECHNICAL SERVICE BULLETIN

**SUBJECT: COMBINATION TSB / SERVICE ACTION: AIR FILTER
AND NVLD REPLACEMENT (SA421)**

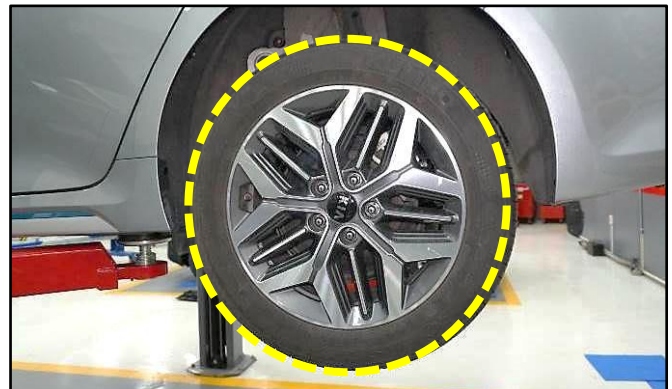
1. Raise the vehicle on a lift and remove the left rear wheel.

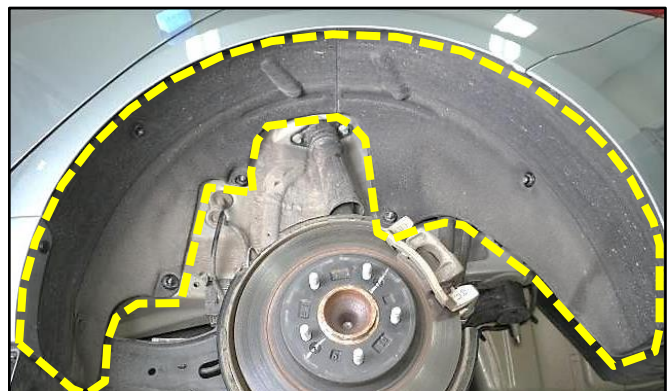
2. Remove the left rear inner fender liner.

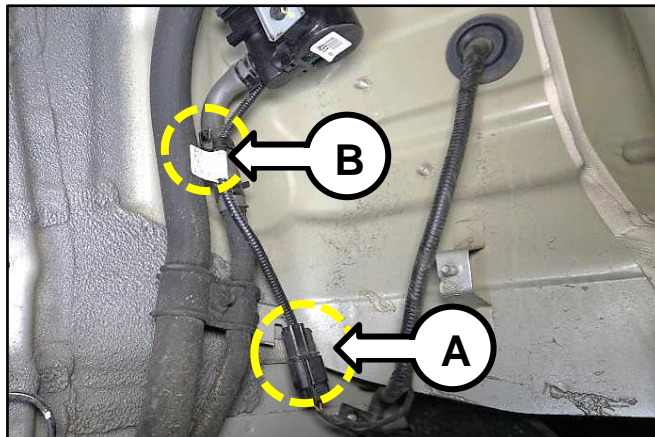
3. Release the fuel tank air filter assembly connector (A), and detach the retaining clip (B).

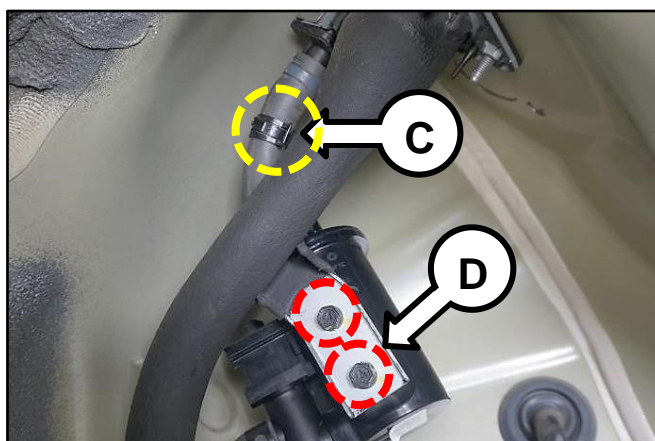
4. Release the upper fuel tank air filter hose clamp (C), and detach hose from the air drain case.

5. Loosen the two (2) retaining bolts (D) to remove the fuel tank air filter assembly.

Torque specification for bolt (D):
2.8 – 5.7 ft.lb. (3.9 – 7.8 N.m,
0.4 – 0.8 kgf.m)

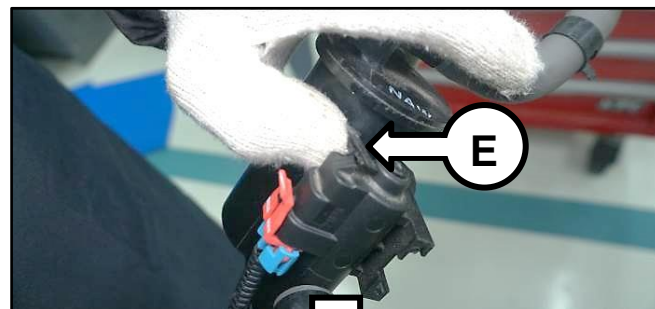
- 6a. Release the canister close valve locking clip (E).

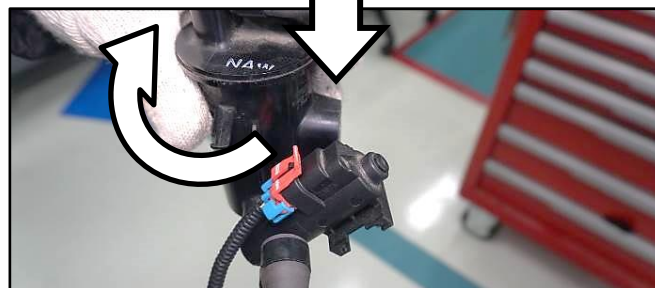
- 6b. Remove the canister close valve from the fuel tank air filter by turning the valve clockwise.

Do Not discard the canister close valve.

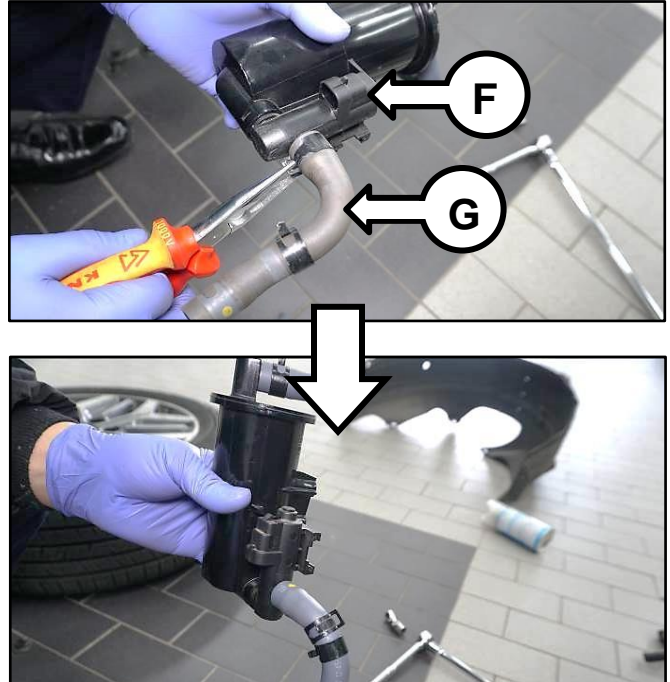
- Attach the removed canister close valve to the new fuel tank air filter assembly (F) and install the new lower hose (G) and secure with clamp.

- Install all removed parts in the reverse order of removal.
- If replacing the NVLD, proceed with NVLD Replacement below.

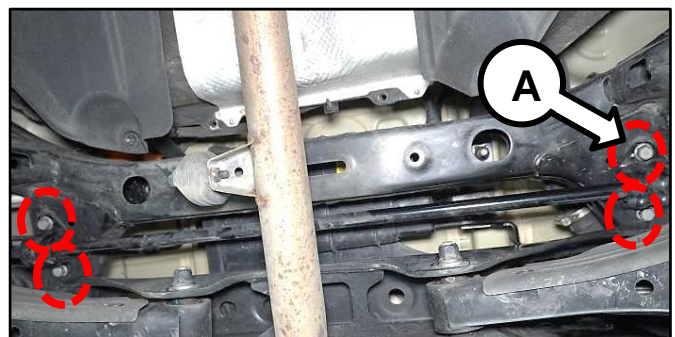
- Remove the four (4) rear stabilizer bar retaining bolts (A).

Torque specification for bolt (A):
72.3 – 86.7 ft.lb. (98.0 – 117.6 N.m,
10.0 – 12.0 kgf.m)

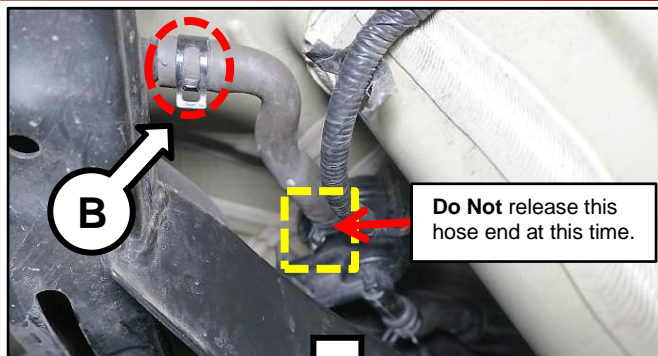
- 2a. Release both upper and lower hose clamps (B) of the NVLD.

Do Not remove the upper hose end attached to the NVLD at this time outlined in yellow.

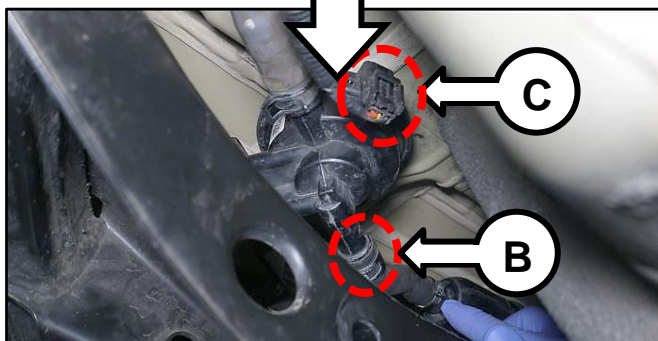
- 2b. Disconnect the NVLD connector (C).

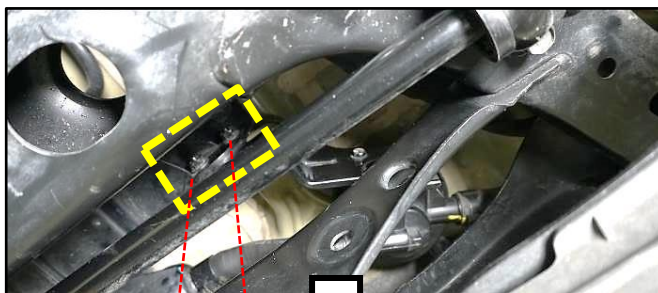
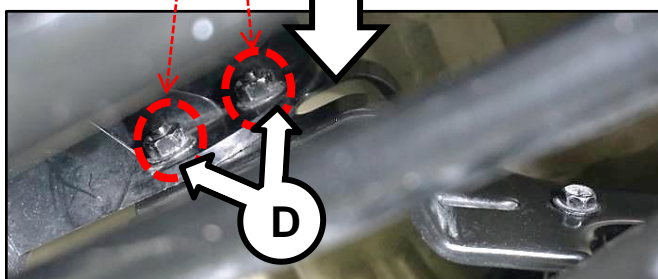
3. Loosen the two (2) NVLD bracket retaining bolts (D).

Torque specification for bolt (D):
2.8 – 5.7 ft.lb. (3.9 – 7.8 N.m,
0.4 – 0.8 kgf.m)

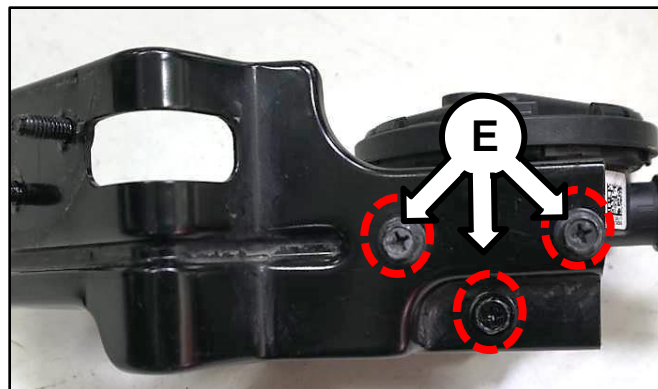
4. Loosen the three (3) bracket bolts (E) to remove the NVLD.

Torque specification for bolt (E):
2.8 – 5.7 ft.lb. (3.9 – 7.8 N.m,
0.4 – 0.8 kgf.m)

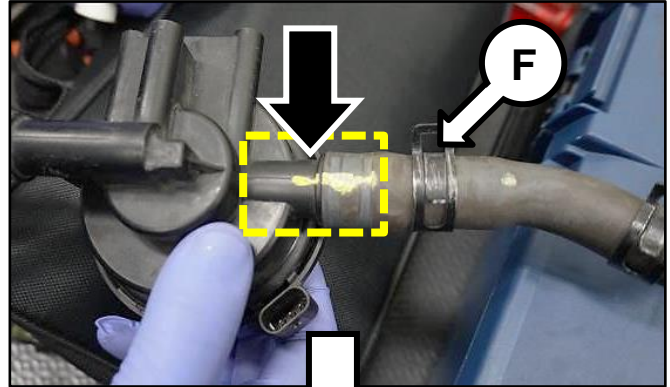
- 5a. Release the NVLD hose clamp (F).
- 5b. Using a paint marker, mark the hose to valve alignment as shown; then remove the hose. **Do Not** discard hose.

Do Not remove the NVLD hose prior to marking.

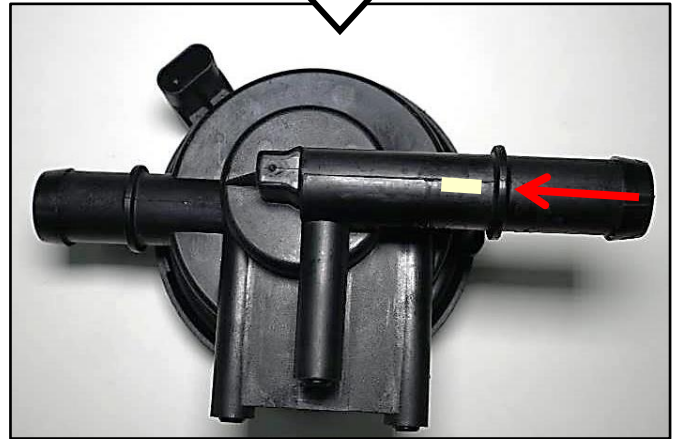
6. Install the new NVLD in the reverse order of removal.

Ensure to match the alignment the removed NVLD hose to the new valve.
