June 2020
SF605A

Subject: LED Step Lighting

Models Affected: Specific Model Years 2020-2021 Freightliner 108SD, 114SD, and Business Class M2 model vehicles, manufactured July 2, 2019, through February 25, 2020.

LED Step Lighting Wiring Modification

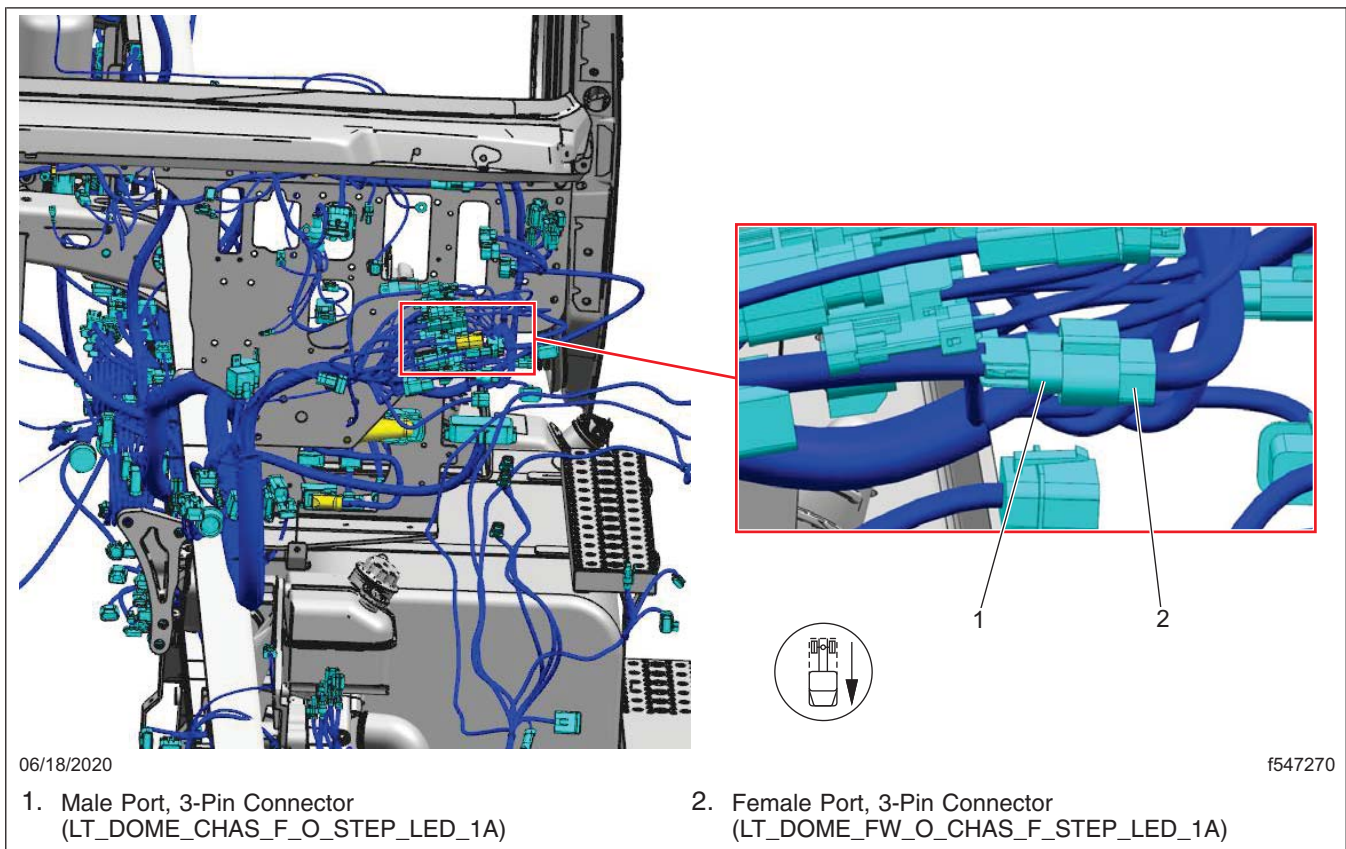
Fig. 1, 3-Pin Connector Location

1. Check the base label (Form WAR259) for a completion sticker for SF605 (Form WAR261) indicating this work has been done. The base label is usually located on the passenger-side door, about 12 inches (30 cm) below the door latch. If a sticker is present for SF605, no work is needed. If there is no sticker, proceed with the steps below.
2. Park the vehicle on a level surface, shut down the engine, and apply the parking brakes. Chock the tires.
3. Disconnect the battery negative cable.
4. Locate the 3-pin connector LT_DOME_FW_O_CHAS_F_STEP_LED_1A for the LED step light harness at the frontwall. The connector is located on the exterior frontwall near the left hood support. See **Fig. 1**.

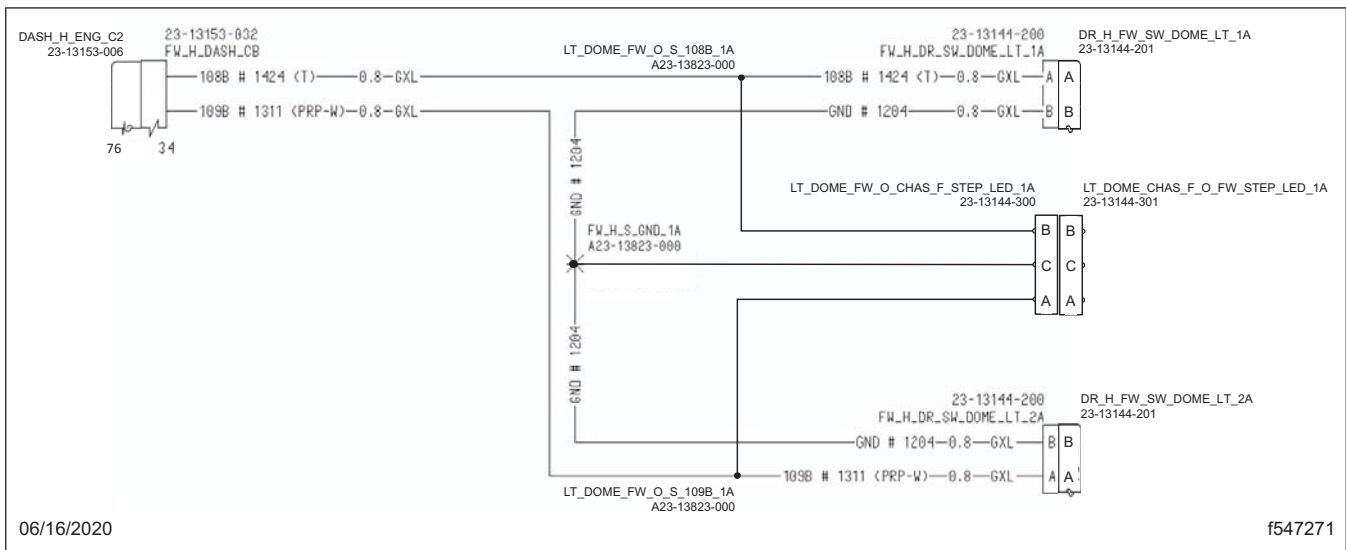
Fig. 2, Circuit Diagram, 3-Pin Connector

5. On the frontwall side of the harness, remove the harness wrap and tape for about six inches to gain access to the wires within the LED step light harness at the 3-pin connector. The frontwall side of the harness connects to the 3-pin connector LT_DOME_FW_O_CHAS_F_STEP_LED_1A (P/N 23-13144-300) containing the female terminals. See [Fig. 1](#).
6. Locate the wires 108B and 109B at pin-B and pin-A of the 3-pin connector respectively. See [Fig. 2](#). Cut the two wires about four inches away from the 3-pin connector. Apply shrink tube on the frontwall harness side of each wire separately in order to seal/protect them and secure sealed wires into harness. The third wire in the 3-pin connector LT_DOME_FW_O_CHAS_F_STEP_LED_1A is the ground (GND) and will remain in the 3-pin connector pin-C.

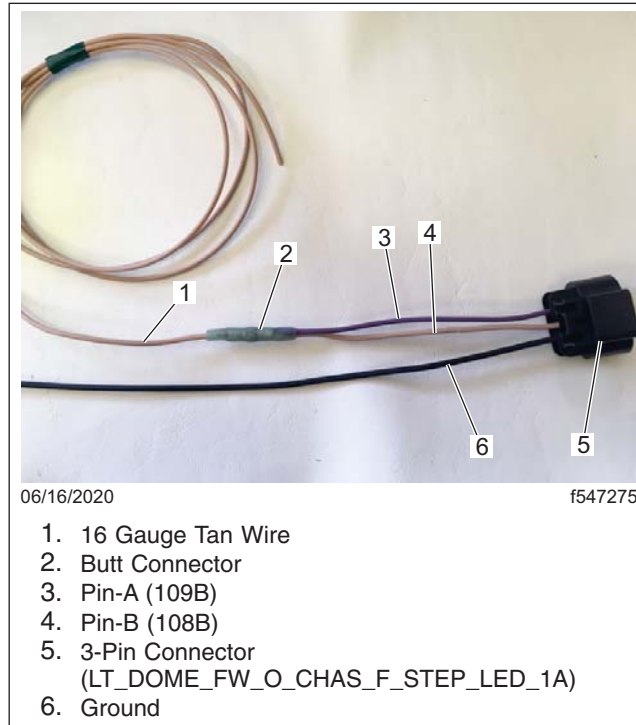
Fig. 3, 3-Pin Connector after Splicing

7. Using a butt connector, splice three feet of 16 gauge tan wire onto wires 108B and 109B from the 3-pin connector. See **Fig. 3**. Follow the instructions below.

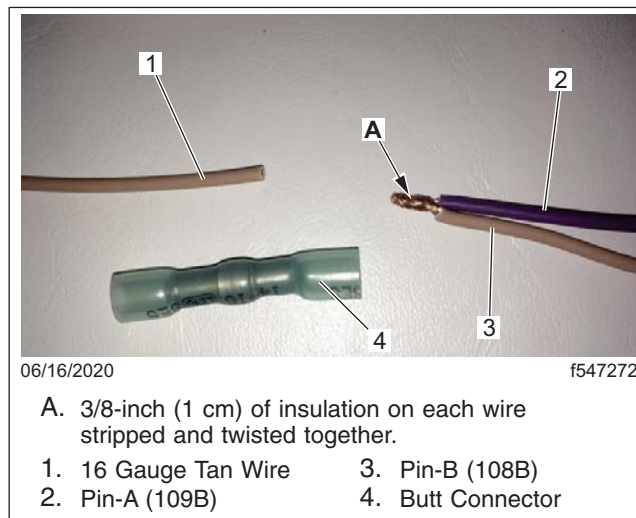
Fig. 4, 3/8-inch Wire Insulation Stripped and Twisted Together

- 7.1 Strip approximately 3/8-inch (1 cm) of insulation from wires 108B & 109B. Twist the two wires together. See **Fig. 4**.

- 10.1 Strip approximately 3/8-inch (1 cm) of insulation from the cut frontwall harness side of the wire 108C and the tan wire from the 3-pin connector. Twist the two wires together. See Fig. 4.

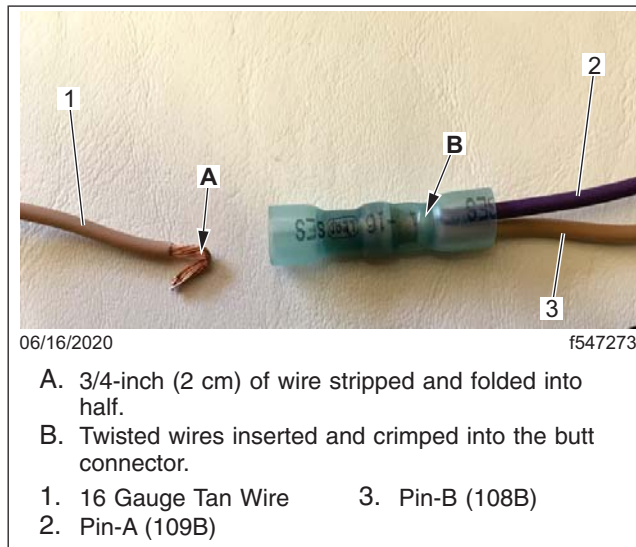
Fig. 5, Crimping Wires into Butt Connector.

- 7.2 Insert the twisted wires into the butt connector PHM 1 1862, then crimp using tool DKIOCHA17003-3. See [Fig. 5](#).
- 7.3 Strip approximately 3/4-inch (2 cm) of insulation from the new section of 16 gauge tan wire, then fold the stripped section of wire into half. See [Fig. 5](#)

- 10.2 Insert the twisted wires into the butt connector PHM 1 1862, then crimp using tool DKIOCHA17003-3. See Fig. 5.
 - 10.3 Strip approximately 3/4-inch (2 cm) of insulation from the cut wire (108C) that is connected to the 4-pin connector, and then fold the stripped section of wire into half. See Fig. 5.

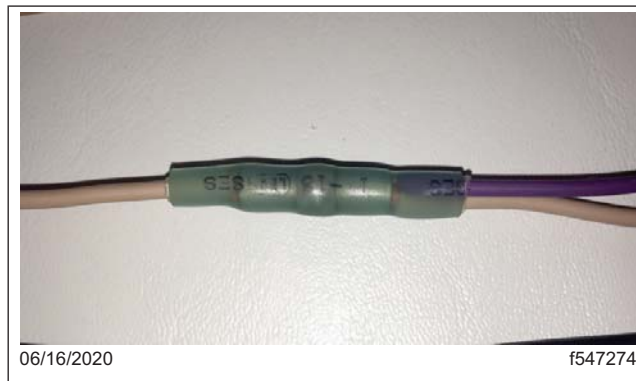
Fig. 6, Butt Connector Heat Shrunk

- 7.4 Insert the folded wire into the butt connector, then crimp using tool DKIOCHA17003-3.
- 7.5 Using a heat gun, carefully heat shrink the butt connector. See [Fig. 6](#).

- 10.4 Insert the folded wire into the butt connector, then crimp using tool DKIOCHA17003-3.
 - 10.5 Using a heat gun, carefully heat shrink the butt connector. See Fig. 6.

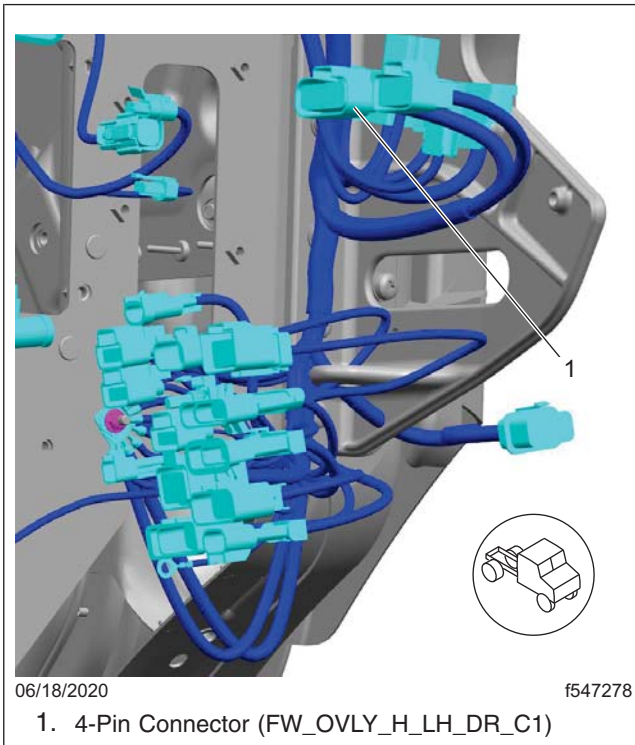
Fig. 7, 4-Pin Connector Location

8. Locate the 4-pin connector FW_OVLY_H_LH_DR_C1 on the exterior frontwall near the left hood support, which connects to the left door harness near the upper outside edge of the cab frontwall.
See **Fig. 7** and **Fig. 8**.

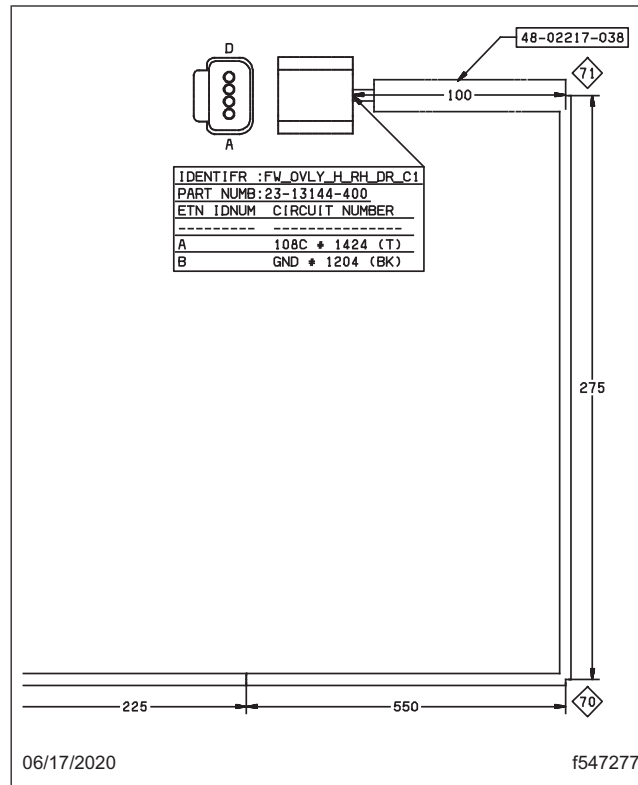
Fig. 9, Circuit Diagram, 4-Pin Connector

9. To access the wires within the A06-67182-000 harness at the 4-pin connector FW_OVLY_H_LH_DR_C1, remove approximately six inches of harness wrap and tape on the frontwall side of the harness. Locate the tan wire (108C). See Fig. 9 for circuit diagram of the 4-pin connector FW_OVLY_H_LH_DR_C1.

10. Cut the tan wire (108C) about four inches from connector FW_OVLY_H_LH_DR_C1. Using a butt connector, splice the new section of 16 gauge tan wire from the 3-pin connector into wire 108C of the 4-pin connector as follows:

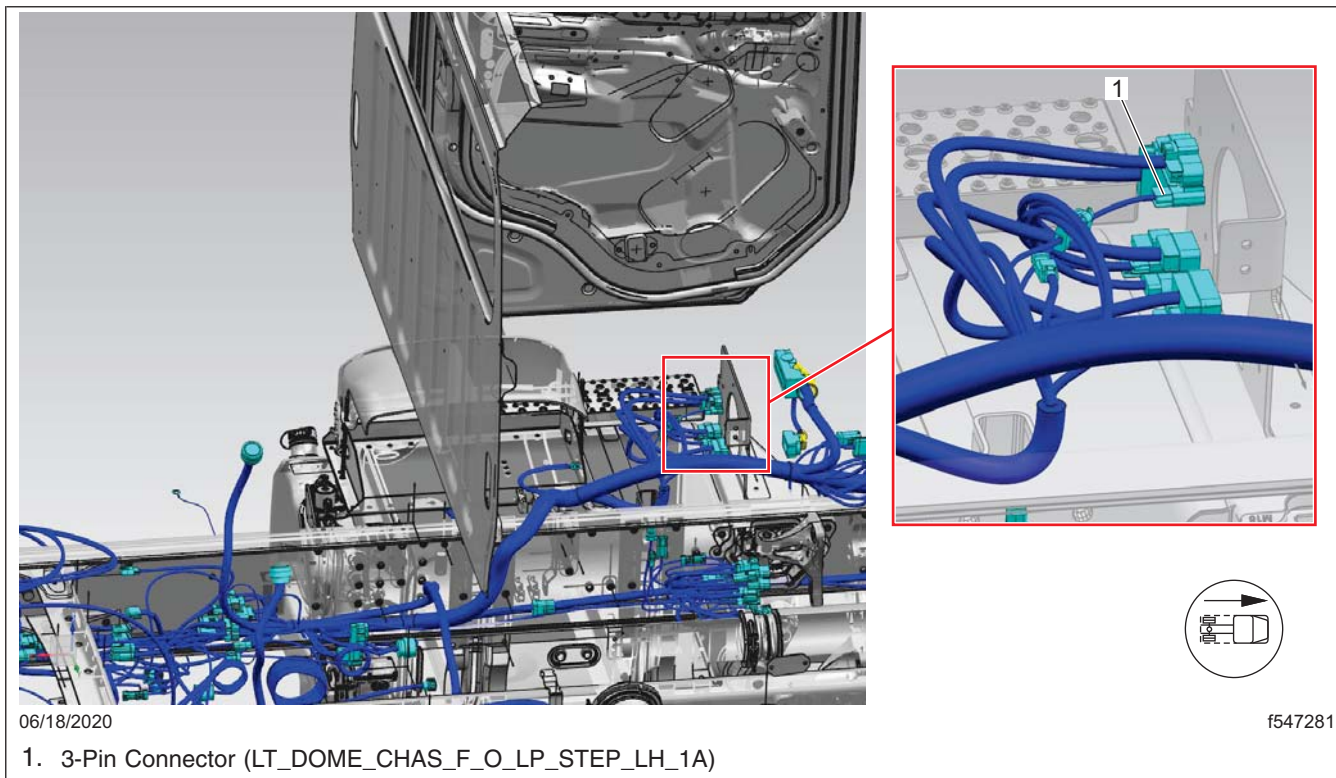
Fig. 10, LED Step Light Provision Wiring, LH

12. Test the operation of the LED step light provision wiring at the left front under-cab area (under the driver's side floor), and at the right inner frame rail near the aftertreatment system (ATS) for the output below.
See [Fig. 10](#) and [Fig. 11](#).

- Power should be present at each LED step connector when the driver or passenger door is open.
 - Power should not be present when the driver and passenger doors are both closed.
13. Wrap previously exposed harness wires, and the new section of the 16 gauge tan wire with appropriate side harness wrap.
 14. As needed, secure the harnesses and wires using tie straps and electrical tape.
 15. Clean a spot on the base label (Form WAR259) and attach a campaign completion sticker for SF605 (Form WAR261) indicating this work has been completed.
