HYUNDAI Technical Service Bulletin

20-BD-017H

Santa Fe (TMa)

FUEL FILLER DOOR HOUSING REPAIR

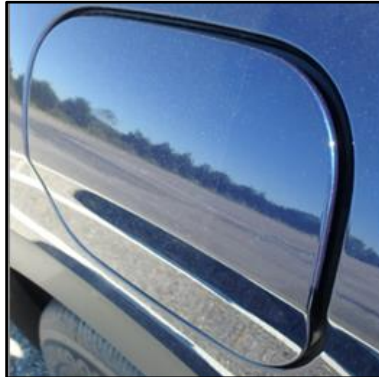
Part Name	Part Number	Image
Fuel Filler Door Housing	81595-S1010

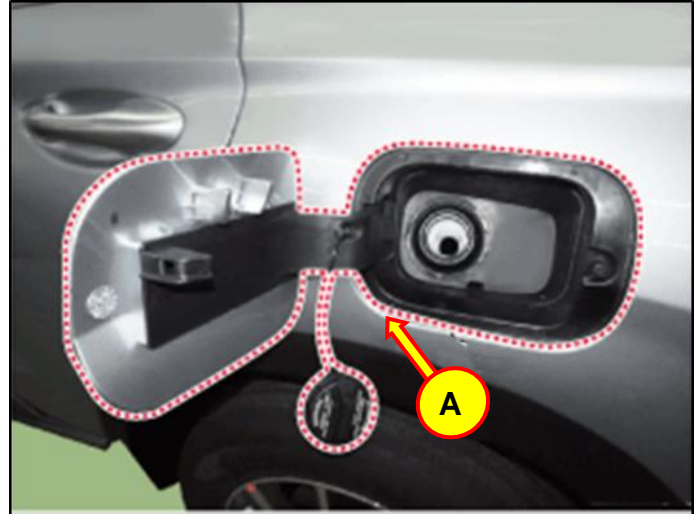
1. Refer to the shop manual to remove the fuel filler door assembly (A).

Do not damage the body panel when removing the fuel filler door assembly.

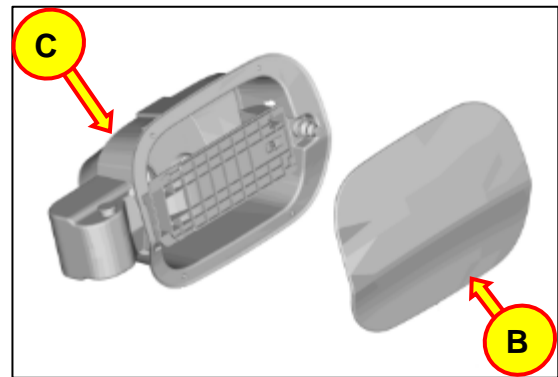
2. Remove the existing fuel filler door panel (B) from the fuel filler door housing (C).

Reuse the existing fuel filler door panel (B), and install on the replacement housing.
