Latest Vehicle Concern Fixes

Windshield Sealing

20MY Discovery

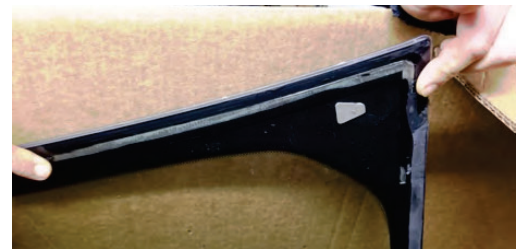
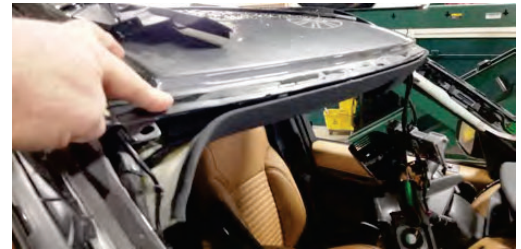
- There are a couple different potential sealing concerns relating to the windshield.
 - PU adhesive not sealing correctly to windshield glass
 - PU adhesive not sealing correctly to the vehicle body
 - Air gaps in the PU adhesive

- Engineering requests your support in identifying the root cause of the sealing concern.
- Please submit an EPQR with pictures showing what exact issue has caused the windshield to leak.
- Please include a picture of the windshield information in the lower left corner near the VIN cutout. It works best to place a piece of paper behind the windshield data to make it stand out better in pictures.
