# Keystone RV Company

## SERVICE ADVISORY # 20-380

### Fuzion and Impact Rear Leveling Legs

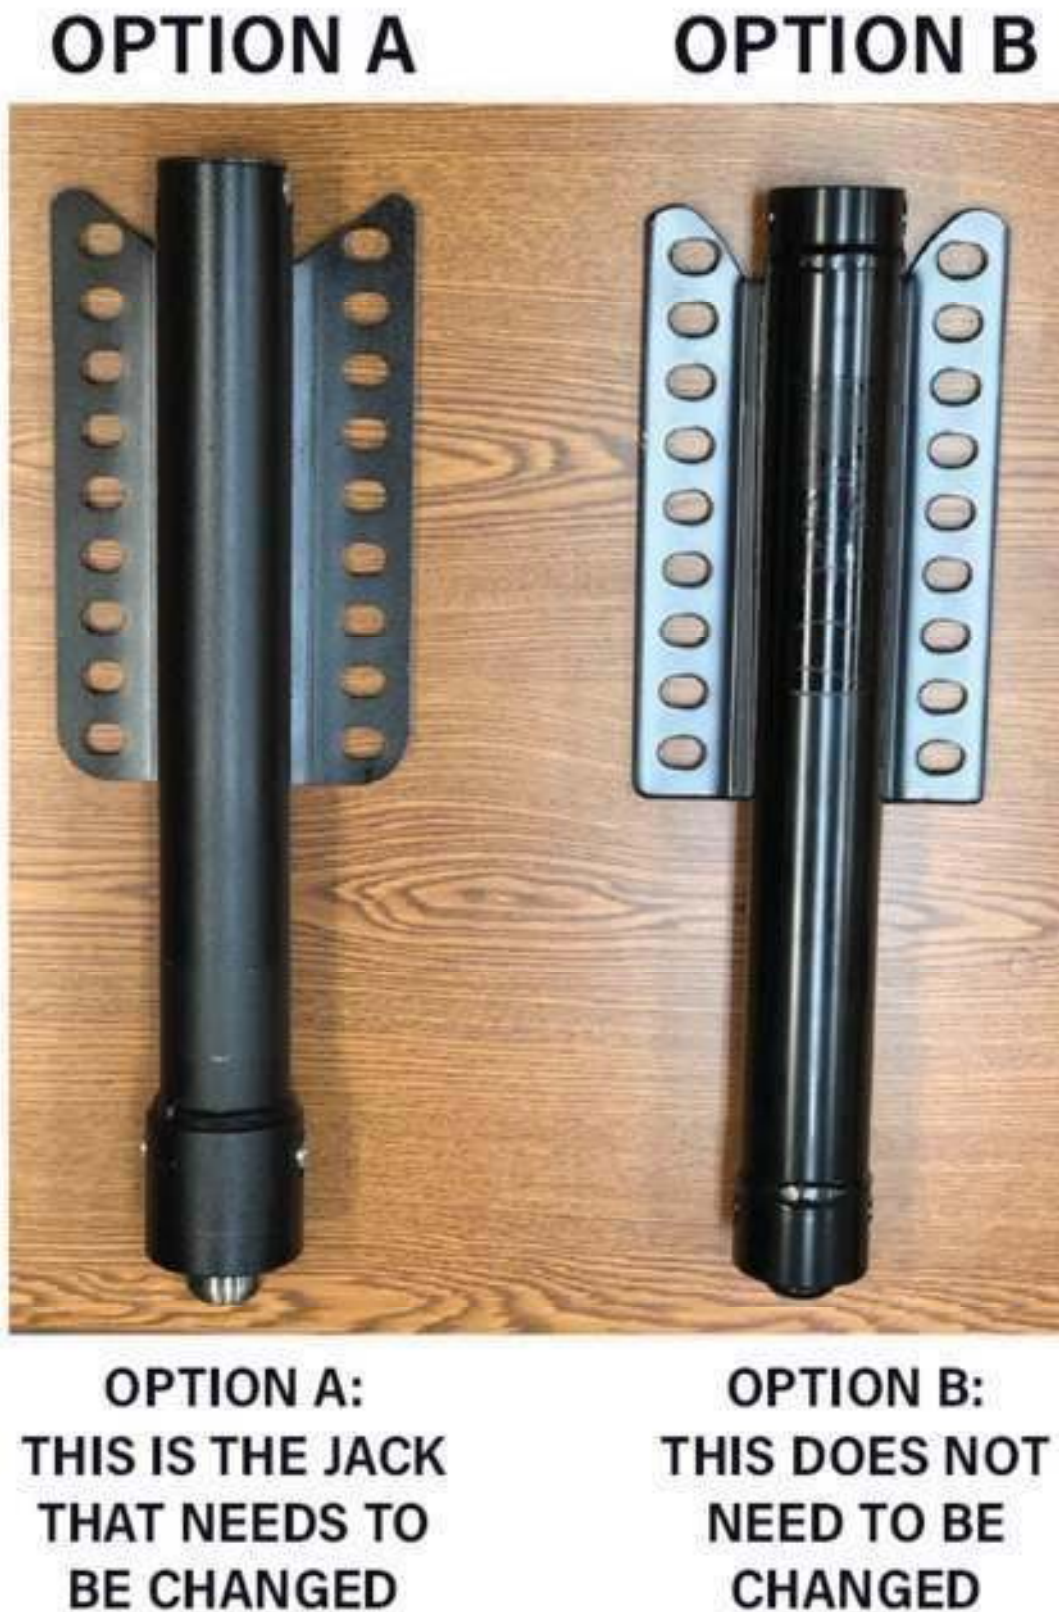
It has been determined that certain Fuzion and Impact units may have issues with Equalizer leveling legs. The Equalizer leveling legs may have a hydraulic tube size that is inconsistent and may cause the leg to bind or leak. The following procedure describes how to identify the part and replace it.

Perform a visual identification of the center and rear jacks as outline in Figure 1. If it is determined that jack “A” as described in Figure 1 is installed on the unit, use the following Equalizer Jack replacement instructions, replace the center and rear leveling jacks as needed using the following instructions from Equalizer using KRV # 662973 - Mechanism - Jack Leg Kit - For Service Campaign 20-380.

The remedy is to identify the part and replace the four rear leveling jacks as instructed.

In the Correction section note: Rear jack legs match Option B or are a different brand.
