**TECHNICAL INSTRUCTIONS
FOR
LIMITED SERVICE CAMPAIGN HLB
CARPET FLOOR MAT REPLACEMENT
CERTAIN 2017 MY GS 350 AWD**

The subject AWD (All Wheel Drive) vehicles received a set of carpet floor mats designed for a RWD (Rear Wheel Drive) model. If installed, the driver's floor mat is too wide and cannot be secured in the correct position using the retaining clips.

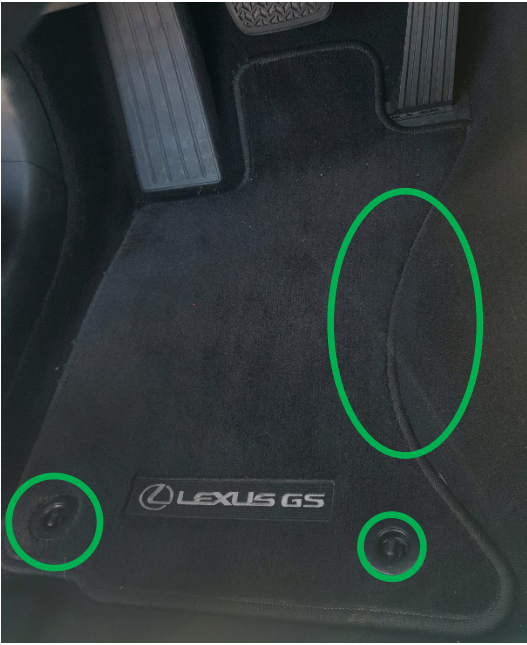
THIS IS THE CORRECT FLOOR MAT

a) Inspect the left front floor mat and compare to the photos.

The mat should fit around the transmission tunnel as shown.

Both rear hold down clips should line up and be secured.

CAMPAIGN COMPLETE

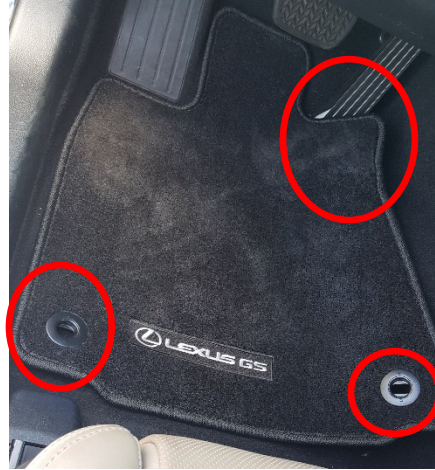
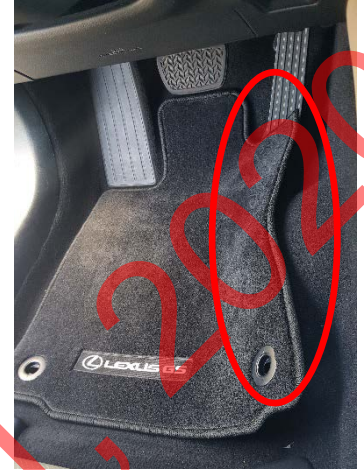
The edge of the mat does not fit in the vehicle correctly.

The gas pedal may be partially covered.

One or both rear hold down clips do not line up and are unsecured.

**THIS IS THE INCORRECT MAT
REPLACE ALL 4 FLOOR MATS**

NOTE: All-weather floor mats are not involved in this LSC. If all-weather floor mats are installed in the vehicle and the carpeted floor mat is NG, place the new mats in the trunk. DO NOT install the carpeted mats on top of or under the all-weather mats.
