Keystone RV Company

SERVICE ADVISORY # 20-383

Kodiak Self-Leveling Roof Sealant

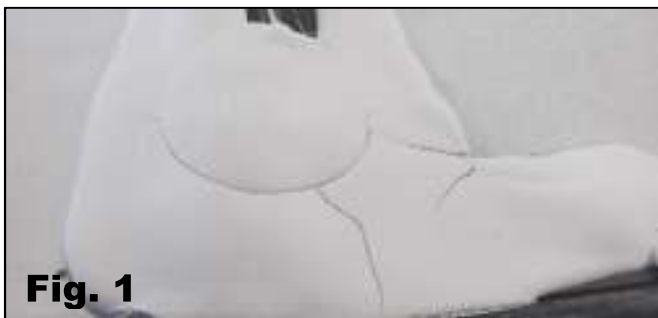
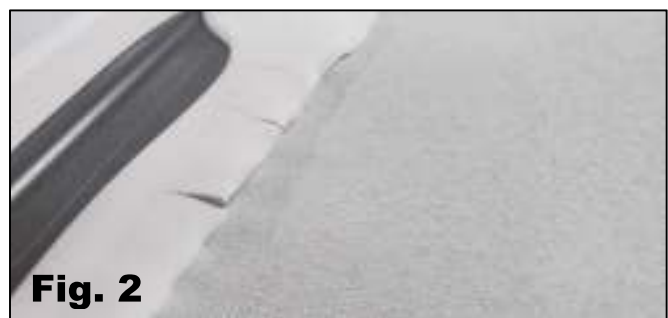
It has been determined certain Kodiak travel trailers may have defective self-leveling roof sealant that exhibits a hard, cracked appearance. The defective sealant exhibits poor adhesion and cracking within 96 hours of application and can be easily removed from the roof by pulling it up by hand. A visual inspection will reveal the defective sealant lifting from the roof due to poor adhesion properties. The following procedure describes how to correct the issue. Campaign closes November 30, 2020.

The remedy is to inspect the self-leveling roof sealant and replace if cracked and lifting. See Figure 1 and 2.

- Step 1.** Locate the trailer on a level, flat, hard surface. Chock the wheels.
- Step 2.** Visually inspect the roof sealant for cracking and/or lifting.
- Step 3.** If the sealant is cracking or lifting go to the Repair Instructions.
- Step 4.** If the sealant exhibits normal characteristics go to Warranty Reimbursement Inspection Only.

- Step 1.** Test the adhesion properties by pulling the sealant by hand.
- Step 2.** If it is not easily removable by hand then it is adhered properly and will be left in place. In these cases, touch up or reseal any void at the base edges of the existing bead seal and reseal any surface cracks as necessary.
- Step 3.** If the sealant can be easily removed by hand, remove it and apply new self leveling roof sealant per the instructions on the caulk tube. The roof must be clean and dry when applying sealant.
