GROUP BOD	MODEL 2020 Rio (SC)
	NUMBER 209	DATE July 2020

TECHNICAL SERVICE BULLETIN

**SUBJECT: SERVICE ACTION: LEFT REAR DOOR
CAVITY WAX APPLICATION (SA426)**

This bulletin provides the procedure to inspect and if necessary, add rust inhibitor (wax) to the left rear door panel of some 2020MY Rio (SC) vehicles produced from April 01, 2020 through April 04, 2020 which may exhibit surface rust inside the door panel. Before conducting the procedure, verify the vehicle is included in the list of affected VINs.

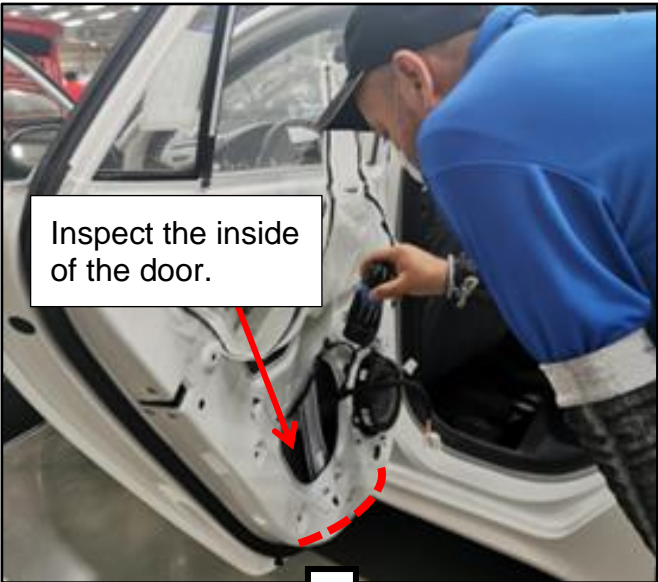
- 3. Inspect the left rear door inner bottom area where shown.

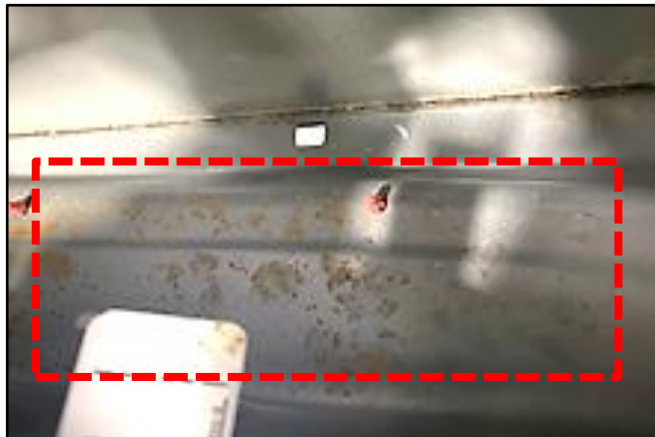
- 4b. If surface rust is detected, perform the repair procedure outlined below.

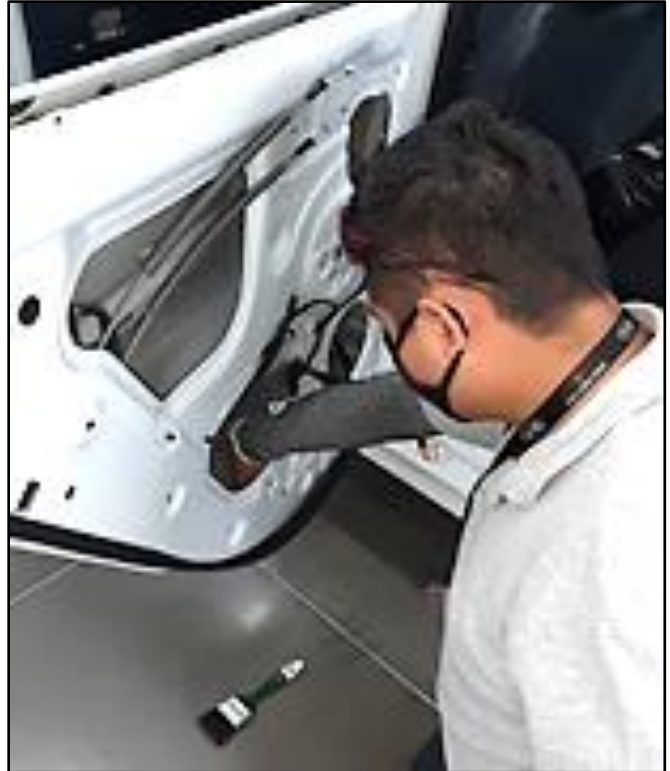
- Using a clean cloth and isopropyl alcohol, remove dust/debris to clean the inside of the door.

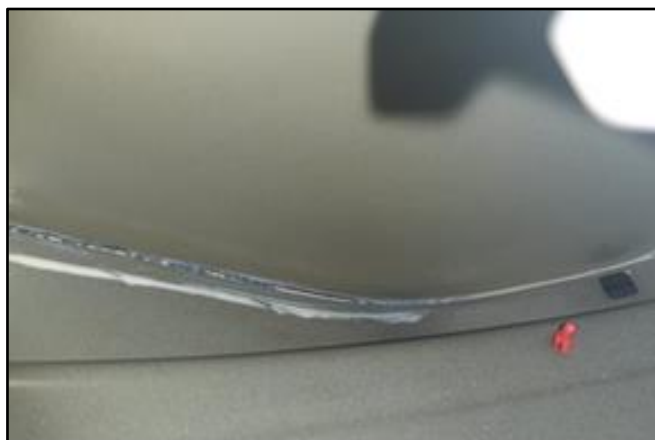
6. Confirm that no rust is present and then apply the cavity wax along the inside of door.
