GROUP ENG	MODEL 2017-19MY Niro (DE P/HEV)
	NUMBER 212 (Rev 1, 07/22/2020)	DATE June 2020

TECHNICAL SERVICE BULLETIN

SUBJECT: CYLINDER HEAD REPLACEMENT FOR LEAN MISFIRE

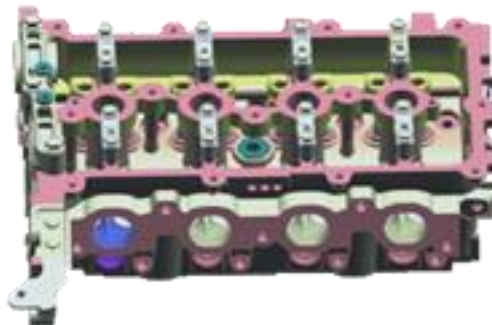
This bulletin provides the procedure to replace the engine cylinder head on some 2017-2019MY Niro (DE HEV/PHEV) vehicles produced from January 1, 2016 through November 13, 2018. These vehicles may exhibit a MIL with misfire DTC's and/or experience a slight engine hesitation at the speeds between 24 - 37 MPH due to Exhaust Gas Recirculation (EGR) operation. Follow the inspection instructions to check the production date range of the vehicle and the cylinder head before replacing the cylinder head as outlined in this bulletin.

**DTC Codes: P0300 (Random / Multiple Cylinder Misfire Detected),
P0301 (Cylinder 1 - Misfire Detected), P0302 (Cylinder 2 - Misfire Detected)
P0303 (Cylinder 3 - Misfire Detected), P0304 (Cylinder 4 - Misfire Detected)**

Note: The Cylinder Head part number provided comes assembled with Valves, Springs and Cylinder Head Bolts.

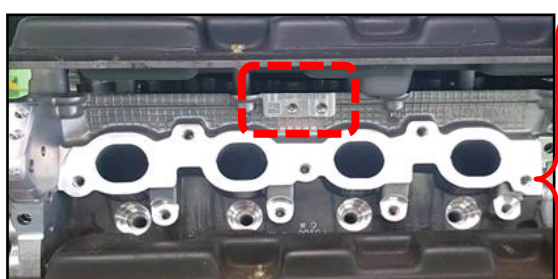
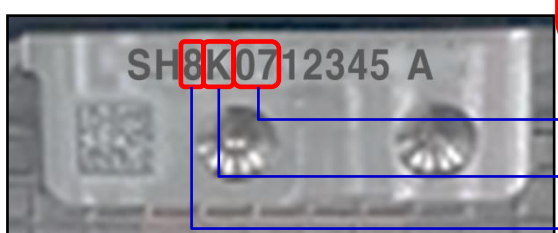
Locate the cylinder head **Lot Number** shown below and verify the cylinder head was produced within the production date listed in the table above.

(Ex. Lot No.)
SH8K07XXXXX
 ↓
(November 07, 2018)

This repair **ONLY** applies if the existing cylinder head was produced on or before November 7, 2018.

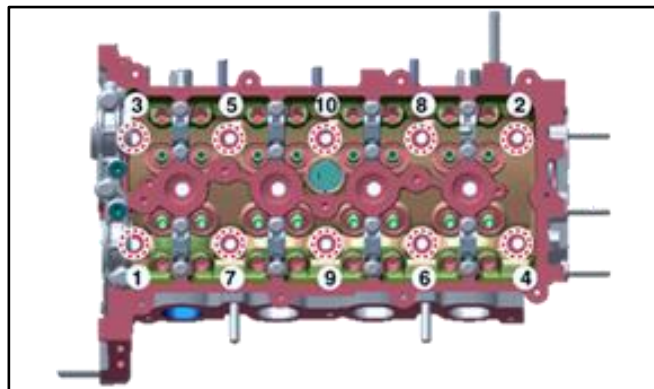
Damage to cylinder head may occur if head bolts are not removed in the recommended order.

Read and carefully follow the cylinder head disassembly instructions provided on KGIS.

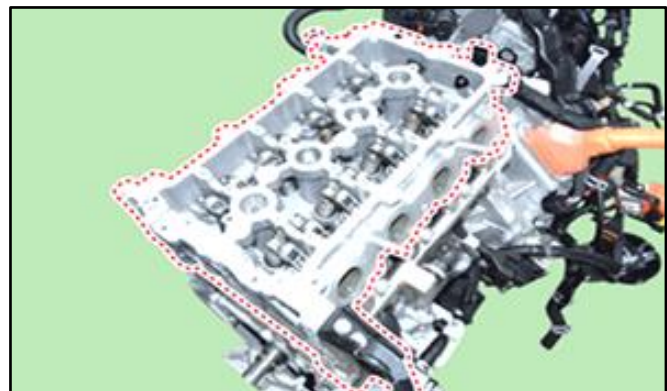
Damage to cylinder head may occur if head bolts are not torqued in the recommended order shown.

Torque Specifications for cylinder head bolts:

9.4 - 12.3 lb.ft (12.7 - 16.7 N.m,
1.3 - 17 kgf.m) + [120 - 125°] + [120 - 125°]

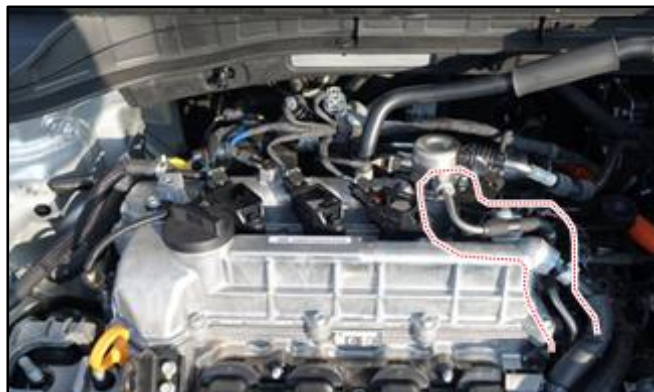
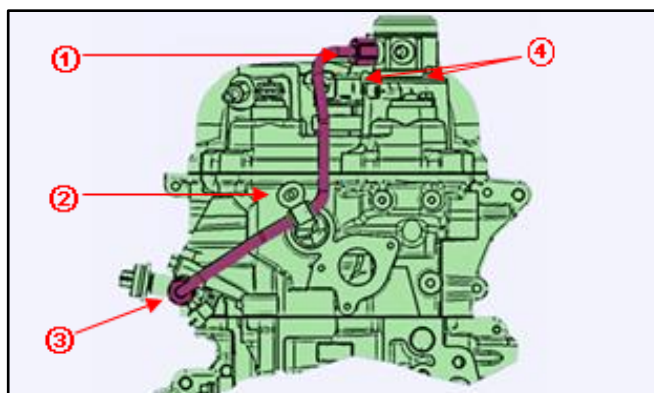
- When installing the new high pressure fuel pipe assembly, tentatively tighten the flange nuts ① and ③ by hand and ensure that the fuel pipe does not bend or twist. DO NOT tighten.
- Tighten the fuel pipe securing bracket ② as well as the vacuum pump bracket to the torque specifications.
- Tighten the high-pressure fuel pipe flange nuts ① and ③ to the torque specifications.
- Tighten the bolt flange ④ to the torque specifications.

Item No.	Torque Specifications
1	19.5 - 23.9 lb-ft (26.5 - 32.4 Nm, 2.7 - 3.3 kgf.m)
2	5.8 - 8.7 lb-ft (7.8 - 11.8 N.m, 0.8 - 1.2 kgf.m)
3	19.5 - 23.9 lb-ft (26.5 - 32.4 Nm, 2.7 - 3.3 kgf.m)
4	9.4 - 10.8 lb-ft (12.7 - 14.7 N.m, 1.3 - 15 kgf.m)

Use the **SST 09314-3Q100** when tightening the flange nuts to the torque specifications. **DO NOT** use a general purpose tool.

Confirm that no fuel is leaking from the high pressure fuel pipe assembly connections after the engine is running.

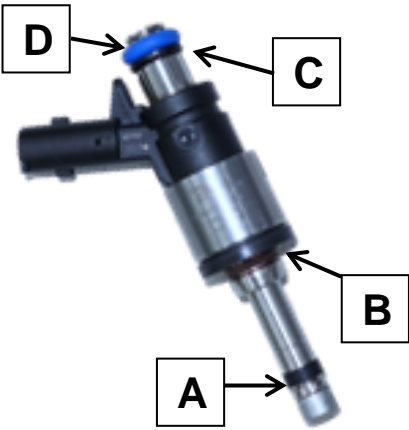
4
Washer-Injector Bracket Kit (B)			
Support Disc Kit (C)			
O-ring Kit (D)			
High Pressure Fuel Pump Bolts	N/A		2
Fuel Rail Bolts			4

Note: The Fuel Injector is NOT included in the kit. Image is for reference use only.
