Rear Door Inoperative Inside Door Handle

Service Category Vehicle Exterior

Section Door/Hatch

YEAR(S)	MODEL(S)	ADDITIONAL INFORMATION
2016 - 2019	RX350, RX450H

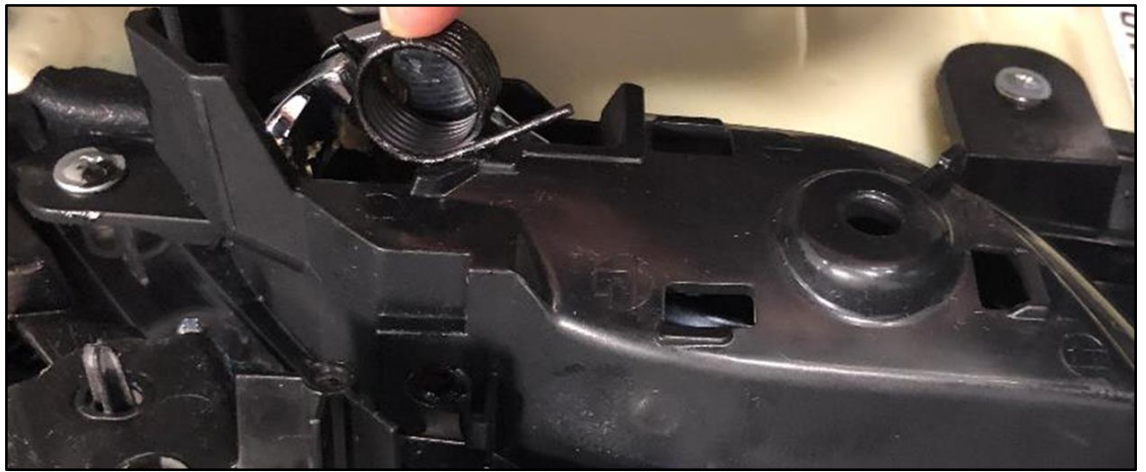
Figure 8.

- C. Install the inside door handle.
 - (1) Install the NEW inside door handle.
 - (2) Place the spring as shown.

- (3) While supporting the inside door handle from the bottom, push straight in the spring from the top.
- (4) Insert the pin.
- (5) Apply the grease (Plasguard SG) to the positions shown.
- (6) Move the lever several times to make sure it functions normally.

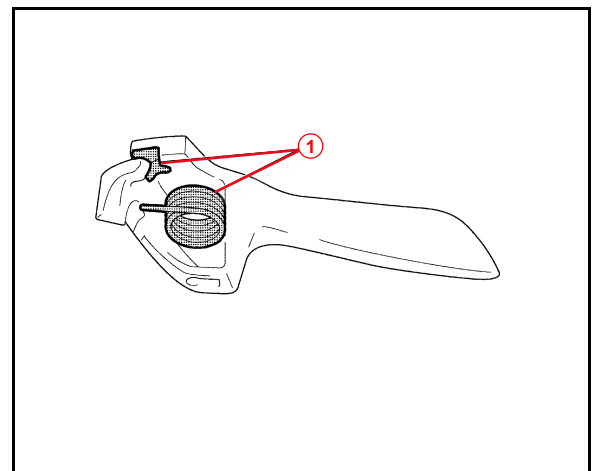
Figure 9.

1	Application Area
----------	-------------------------

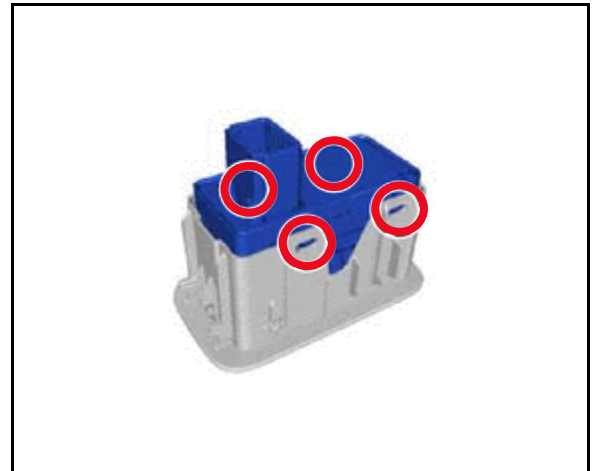
Figure 10.

6. Replace the rear door upper armrest base panel.
 - A. Disengage the four claws to remove the rear power window regulator switch assembly.
 - B. Remove rear door upper armrest base panel and store it in a separate container.
 - C. Engage the four claws to install the NEW rear door upper armrest base panel.
