Technical Service Bulletin

57 Exterior door handles do not return to the zero position

57 20 70 2060196/1 July 16, 2020.

Model(s)	Year	VIN Range	Vehicle-Specific Equipment
Audi e-tron quattro	2019	All	Not Applicable

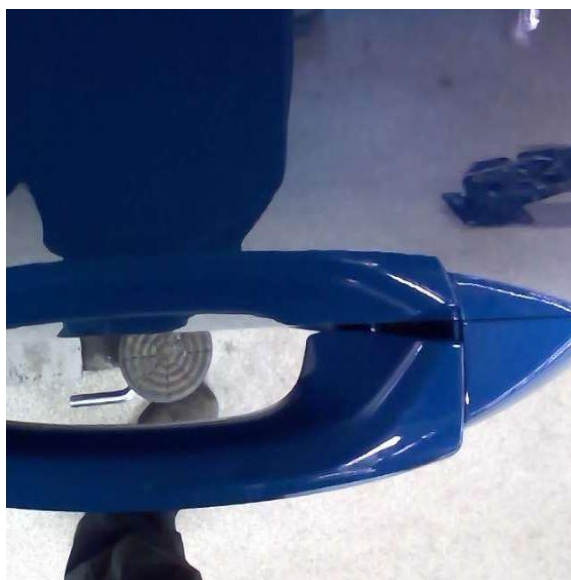
- Exterior door handles are binding and are not returning to the zero position.

Due to material tolerances, the door handle guide is binding within the door handle mounting bracket.

1. Check the function of all door handles. Door handles should return to the zero position without binding and/or jamming (Figure 1).

Figure 1. Door handle binding and not returning to zero position.

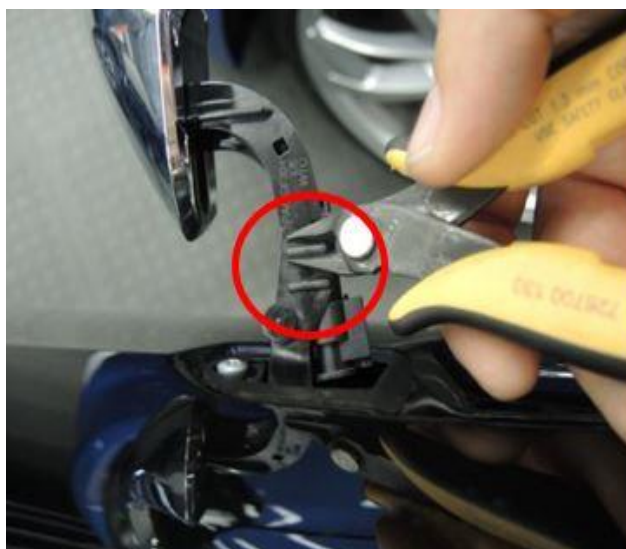
Figure 2. #1 and #2 door handle ribs prior to removal.

2. Remove any affected door handles following the repair manuals in ElsaPro.
3. Using precision diagonal cutting pliers, remove door handle rib #1 and #2 on the pivot side of the mounting bracket, towards the front of the vehicle (Figure 2).

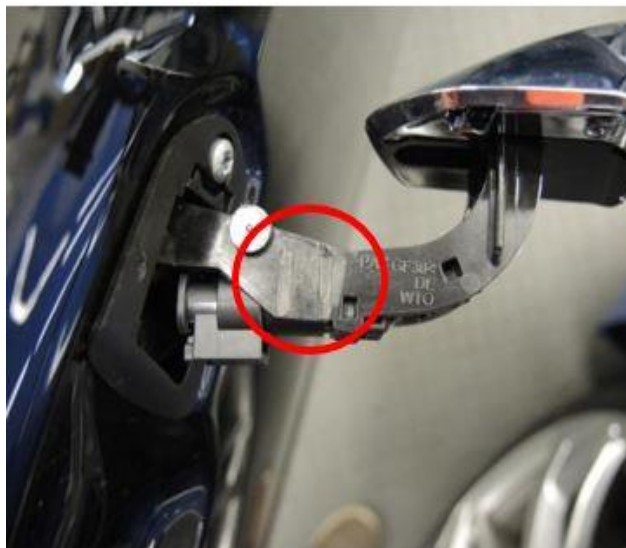
Figure 3. Door handle shown with #1 and #2 ribs removed, leaving an even surface.

4. After removing both ribs, ensure that the resulting surface is smooth and without any protrusions (Figure 3).

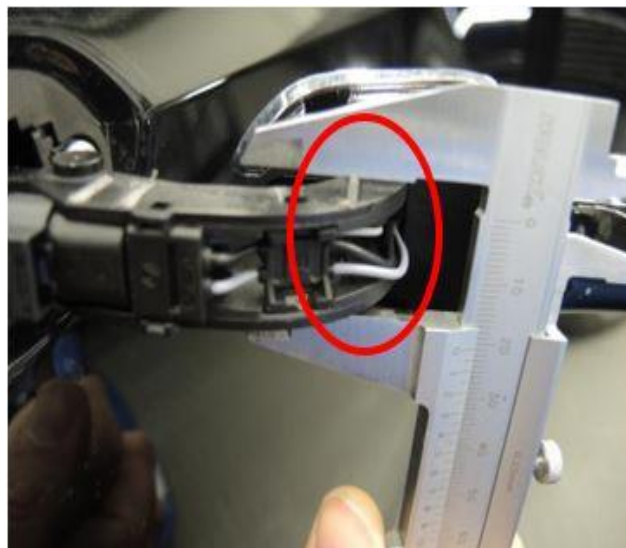
Figure 4. Measuring dimension of door handle at rib #3.

5. Using a vernier caliper, measure the dimension from the bottom edge of the door handle to the top of rib #3 (Figure 4).

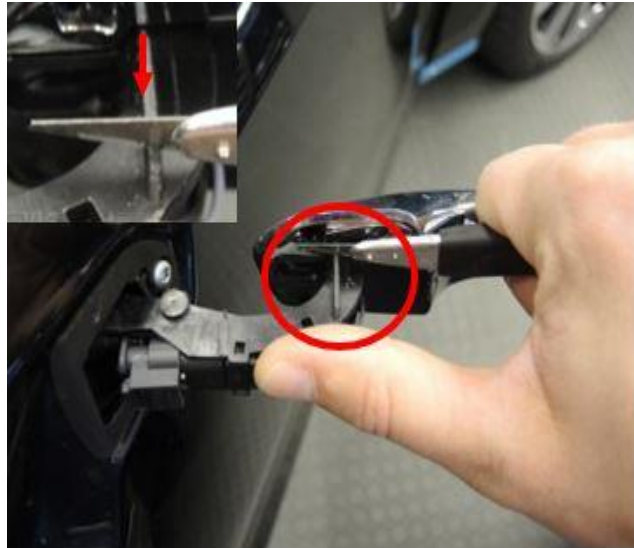
Figure 5. Rib #3 shown with direction of scraping motion.

6. If the dimension is larger than 20.9 mm (~ 0.82 inches), scrape the top of rib #3 with a precision/utility knife in direction of the arrow (Figure 5).

7. Repeat steps #5 and #6 until the dimension of the door handle at rib #3 is less than 20.9mm.
8. Replace the door handle guide piece on the lock cylinder side, towards the back of the vehicle (Figure 6) with a new guide piece (check parts table for part number).

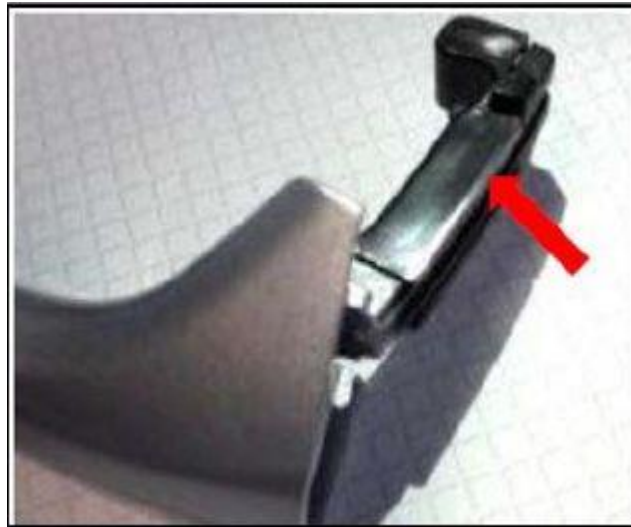
Figure 6. Door handle guide piece to be replaced.

Always check with your Parts Department and/or ETKA for the latest information and parts bulletins.		
Part Number	Part Description	Quantity
See ETKA	Fasteners, Bolts, Nuts, and Screws as needed per the Repair Manual	See ETKA/ELSA
4N0837259	Guide Piece	01-04 (As needed)
