REFERENCE:	Nova Bus Manuals
SECTION:	16: Electrical system
RS N°:	MQR 7621-1331
EFFECTIVE IN PROD.:	LB45 (2018AL)

SUBJECT:	Throttle pedal sensors (TPS) cable replacement for 60-ft buses ISL13 engine			
JUSTIFICATION:	Cummins code 1242 for throttle pedal sensor circuit			
LEVEL	DESCRIPTION	DIRECT CHARGES		TIME
		LABOUR	MATERIAL	
1	Install the throttle pedal sensor bypass cable.	Client	Client	2.75 h
2	Install the throttle pedal sensor front to back cable.	Client	Client	16 h

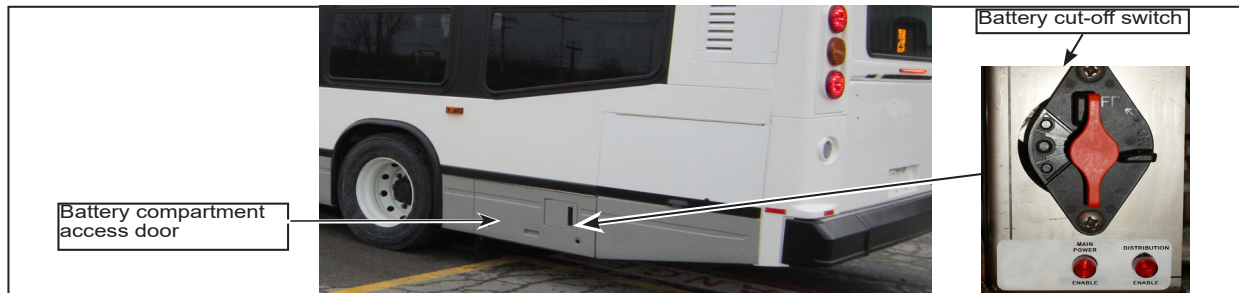
Figure 2 - Deactivate the Vehicle's Power Supply

1.2. Open the battery compartment access door, and ensure that the vehicle's power supply has been deactivated by turning off the battery cut-off switch (see Figure 2).

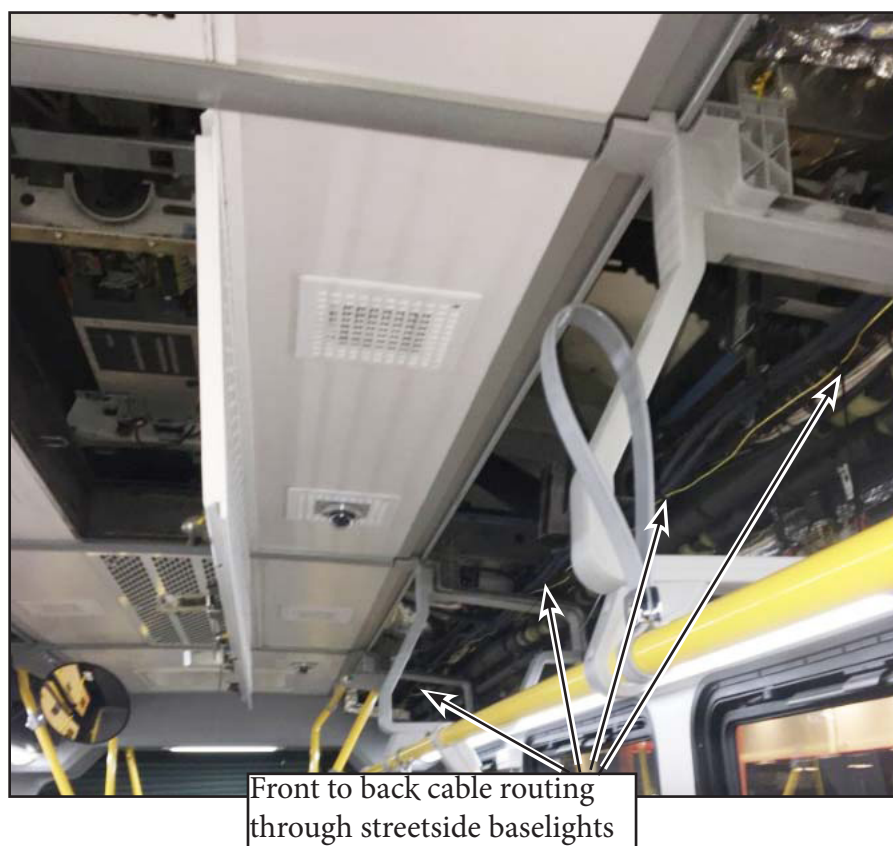
Figure 22 - Front to Back Cable Routing in the Streetside Baselights

- 2.9. Continue routing and tie wrapping the front to back cable through the streetside baselights (see Figure 22).

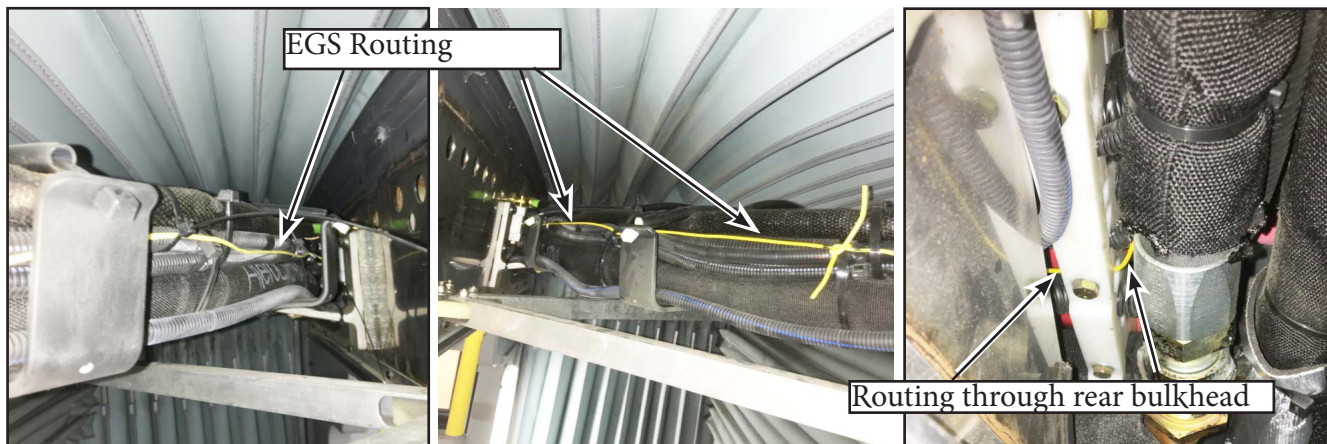
Figure 24 - Front-to-Back Cable Routing in the EGS

- 2.11. Continue routing the front to back cable through the EGS, secure it to the existing cables with cable ties and continue routing through the rear bulkhead (see Figure 24).
