Preliminary Information

PIP5741 2015 2018 8L45 8L90 No Movement After Valve Body Replacement.

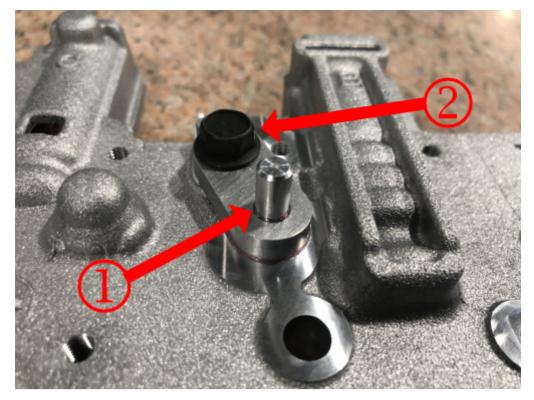
| Dronde | Model: | | Model Years: | VIN: | | Freeiner | - | |
|--|---|---|---|---|---|---|---|--|
| | | Plug and retaining bolt may be missing on valve body part numbers 24296270, 24296272, 24296273, 24297634 and 24297637. | | | | | | |

Inspect for the plug and retaining bolt for being present in the picture shown below.

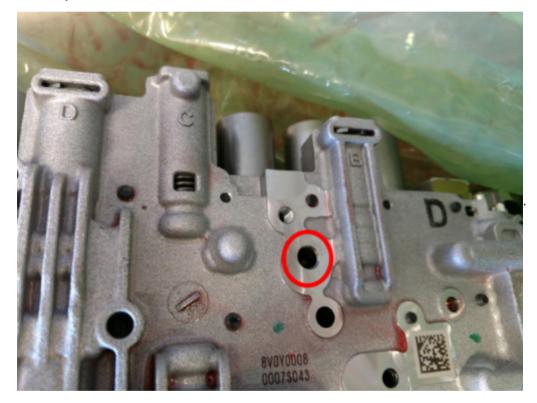
If the plug and retaining bolt are missing as shown in the picture below please fill out the WPC part request form and send it to the WPC following the instructions below.

The plug and retaining bolt are packaged as a kit.

The kit part number is WPC 853

The plug and bolt kit WPC part number WPC 853 can be obtained from the Warranty Parts Center (WPC) using the TSP Dealer Request Form
