| <b>Tesla, Inc.</b><br>Service Bulletin | | <b><i>Inspect Front Fascia Injection Date</i></b> | |
| <b>SB-20-10-003</b><br>July 9, 2020 | | | |

On some Model Y vehicles, front fascias with an injection date in a certain date range might have potential delamination/peeling issues.

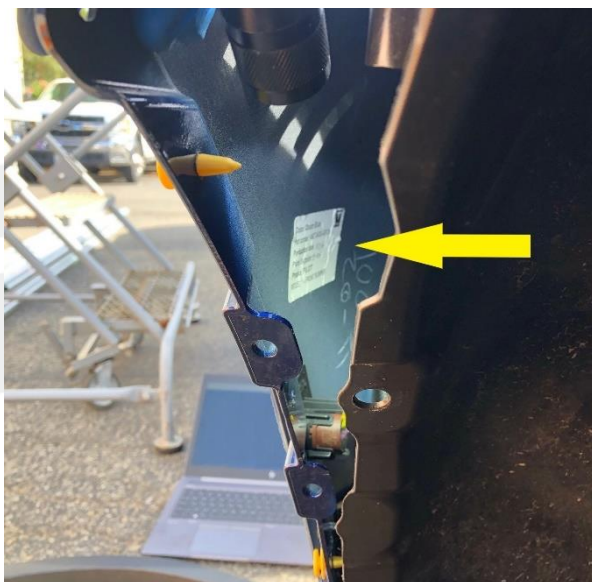
Figure 4

7. Inspect the injection date on the traceability label on the front fascia (Figure 4 and Figure 5).

**NOTE:** The “Date & Time” printed on the label is formatted as DD/MM/YYYY.

- If the “Date & Time” printed on the label is 22/02/2020 through 03/03/2020, replace the front fascia (refer to Service Manual procedure [10011002](#)).
- If the “Date & Time” printed on the label is before 22/02/2020 or after 03/03/2020, no repairs are needed. Install all parts that were removed for access, and then discontinue this procedure.
