Technical Service Bulletin

66 Exterior black optic trim is discolored

66 20 66 2060333/1 August 4, 2020.

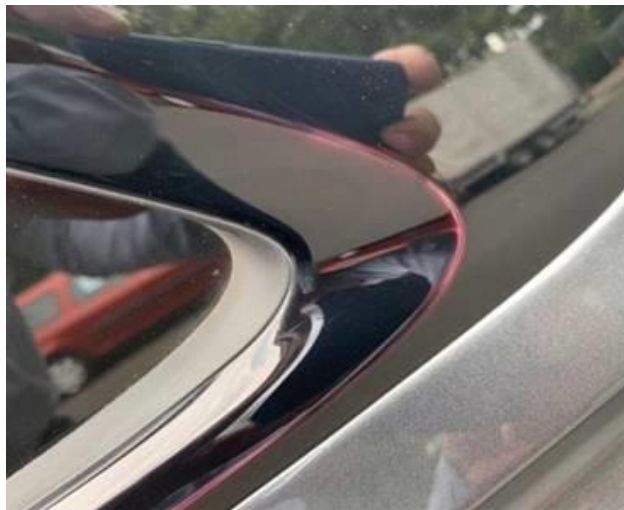
The ultraviolet radiation resistance in the trim coating was found to be insufficient.

Figure 1. The black optic trim takes on a red or purple hue.

2. Should the symptom described in this TSB present as described, then replace the affected trim. Any other symptom on a black optic trim piece or an issue with a non-black optic trim piece may require AASM authorization as specified in the Warranty Policies and Procedures.

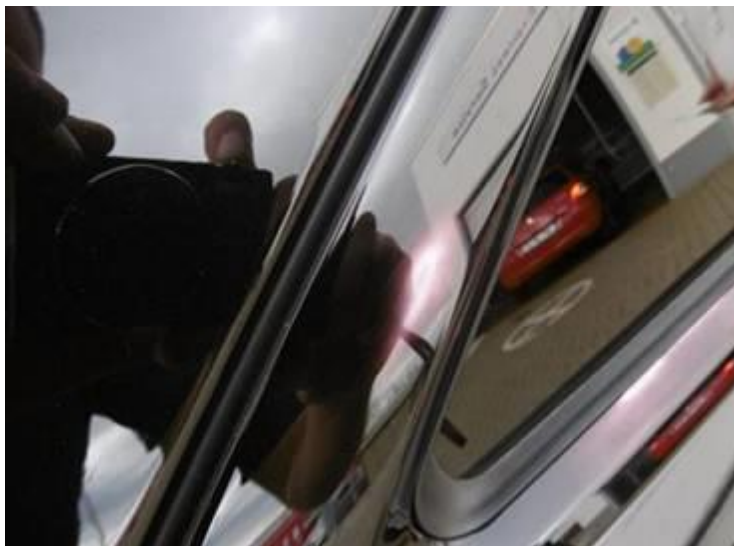
Figure 2. An additional example of the trim discoloration.

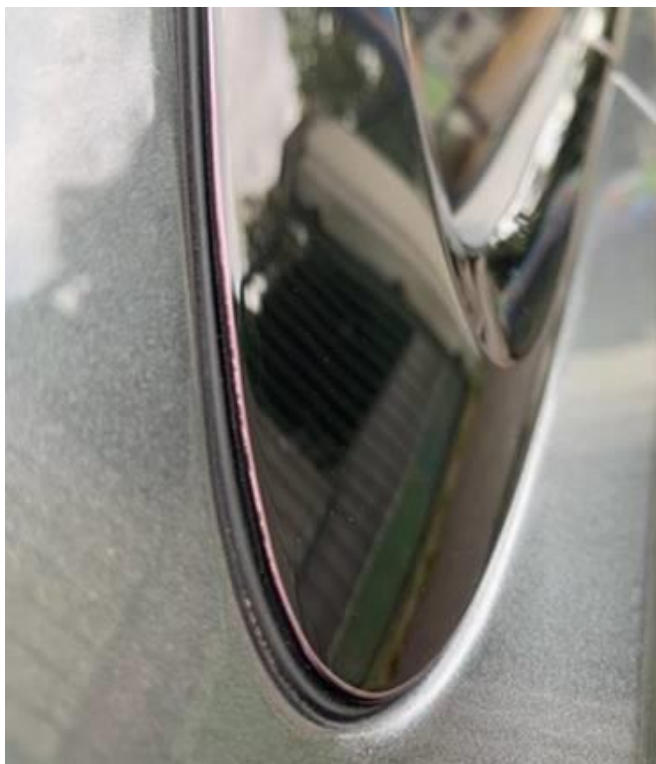
Figure 3. Discolored black optic trim around rear side window.
