August 4, 2020

Popping or Crackling from the Speakers; No Sound from the Audio System; Network Loss Message and/or Display Issues

AFFECTED VEHICLES

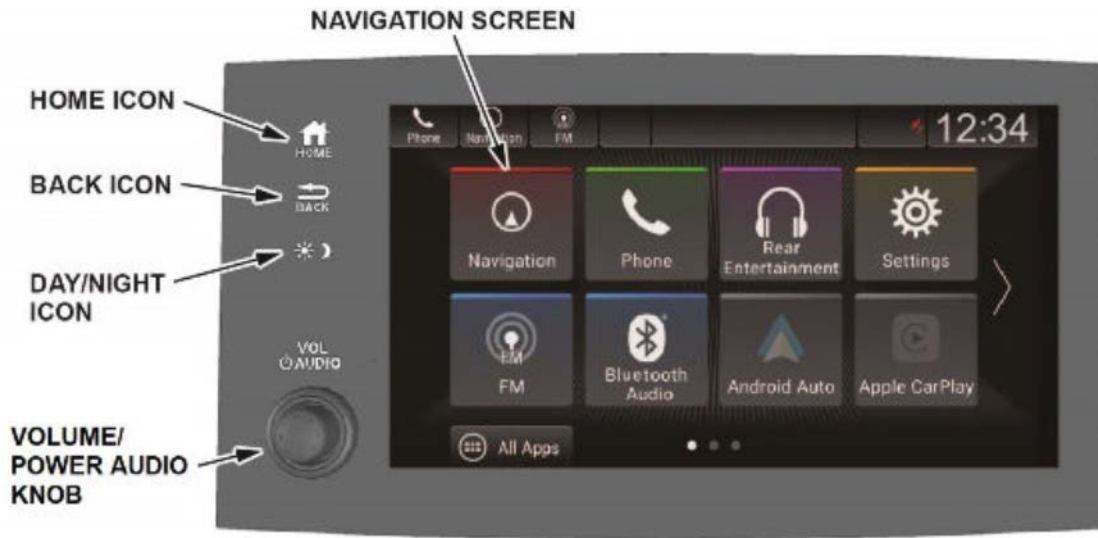
2. Press and hold the VOL/Power AUDIO knob, **DAY/NIGHT** icon, and **HOME** icon at the same time. Hold until the **Dealer Diagnostics** menu screen appears.

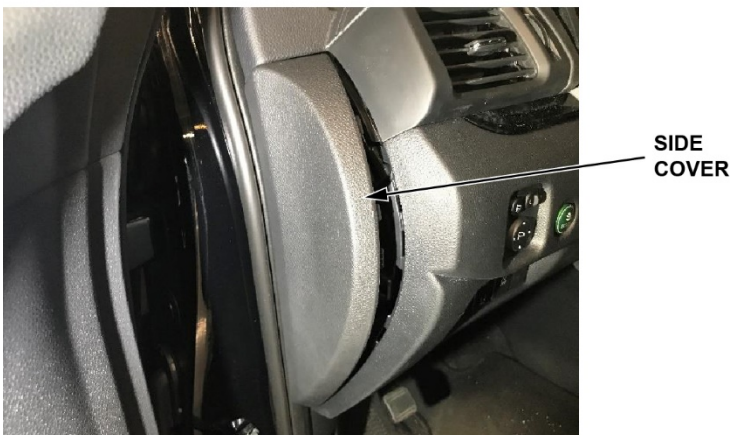
1. Remove the side cover.

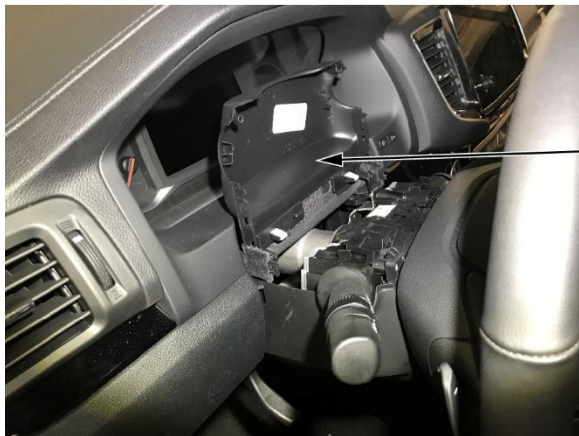
UPPER
COLUMN
COVER

2. Loosen the upper column cover.

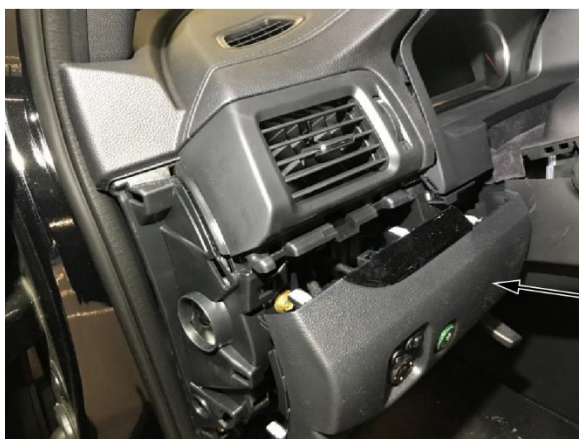
LOWER
DASH PANEL

3. Remove the lower dash panel.

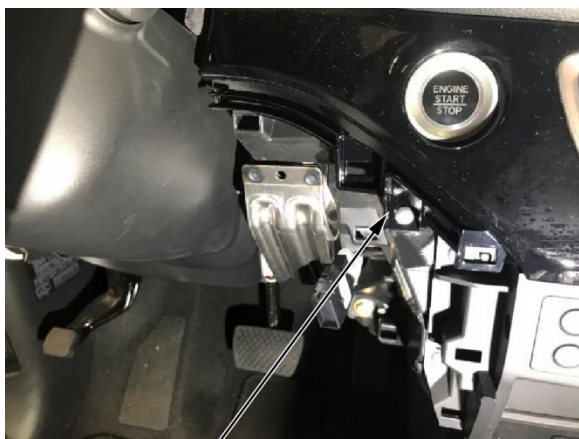
SCREW

4. Remove the screw to loosen the dash panel.

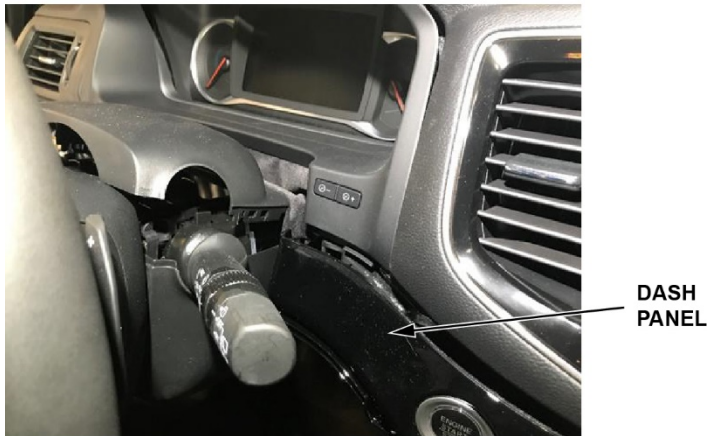
5. Pull back the dash panel to allow meter bezel removal.

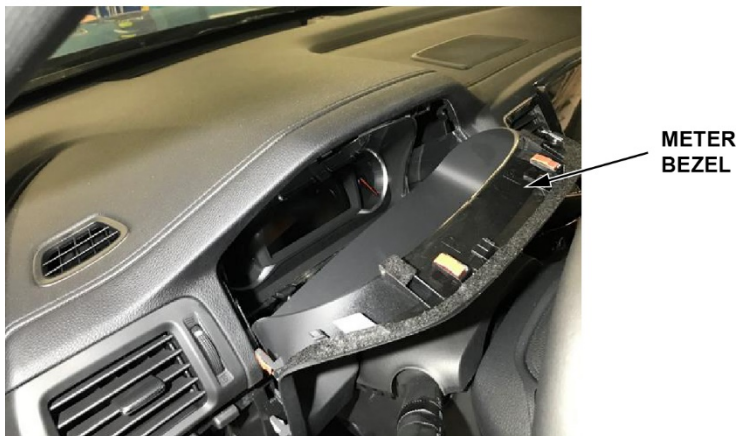
6. Disengage the clips around the meter bezel, then remove the bezel and upper column cover as one piece.

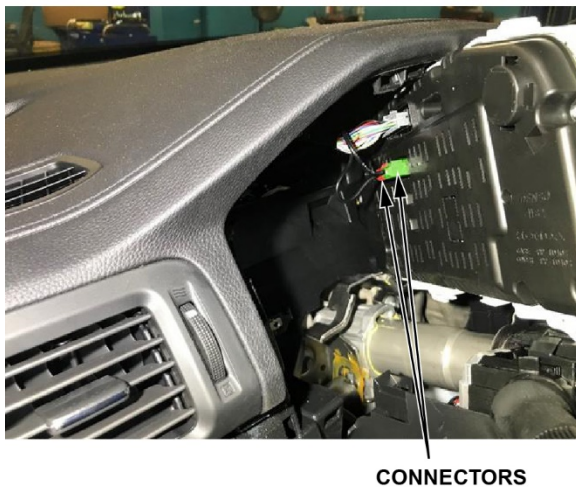
7. Turn the gauge control module to access the rear connectors. Then, using the straight FAKRA tool, disconnect the red and green FAKRA connectors, and remove them from the gauge control module.

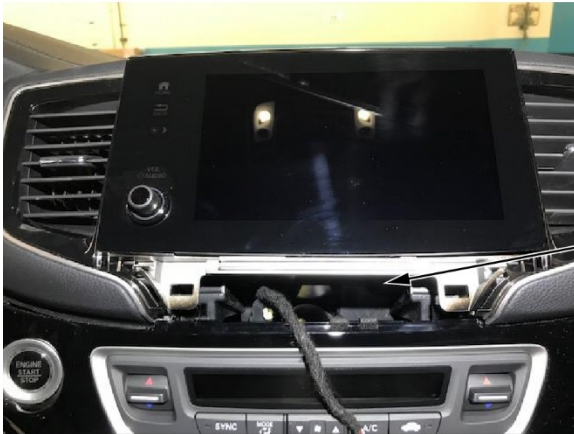
HAZARD
SWITCH
PANEL

8. Remove the hazard switch panel.

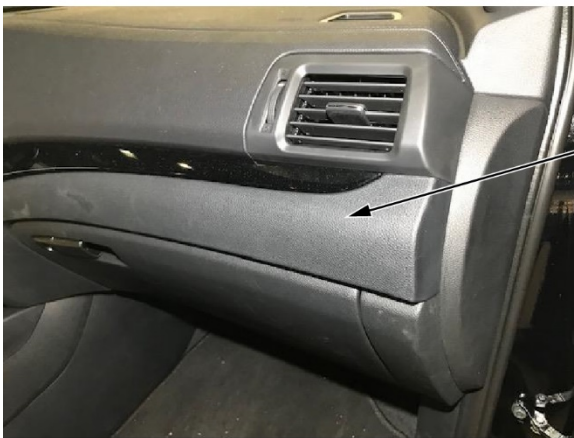
PASSENGER
MID DASH
PANEL

9. Remove the passenger mid dash panel.

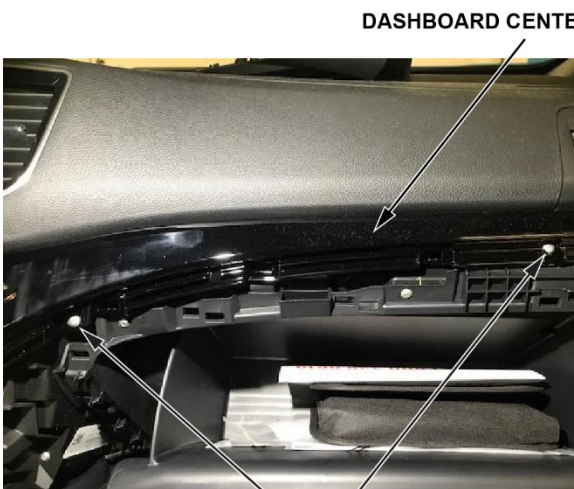
DASHBOARD CENTER MIDDLE TRIM

10. Remove the two screws, then remove the dashboard center middle trim.

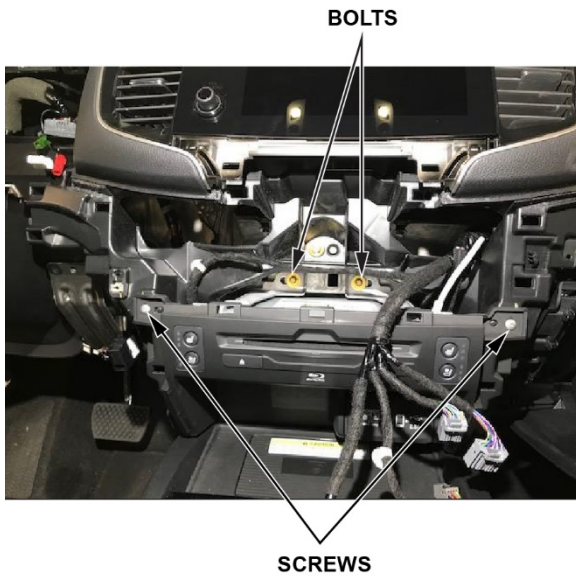
11. Remove the two screws and bolts, then remove the dashboard center lower panel or accessory CD player.

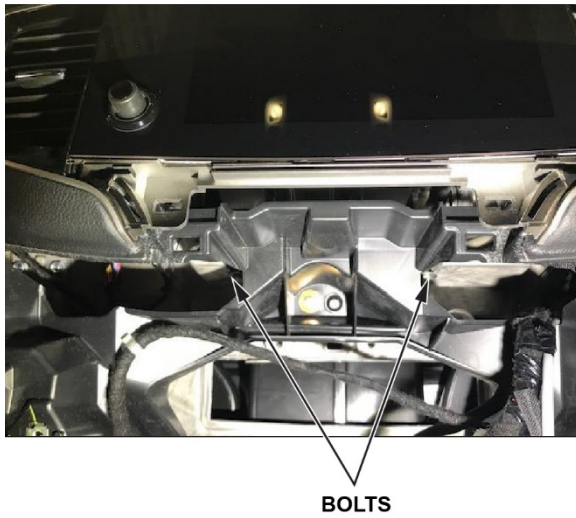
12. Loosen the two bolts holding the infotainment unit, then remove the unit.

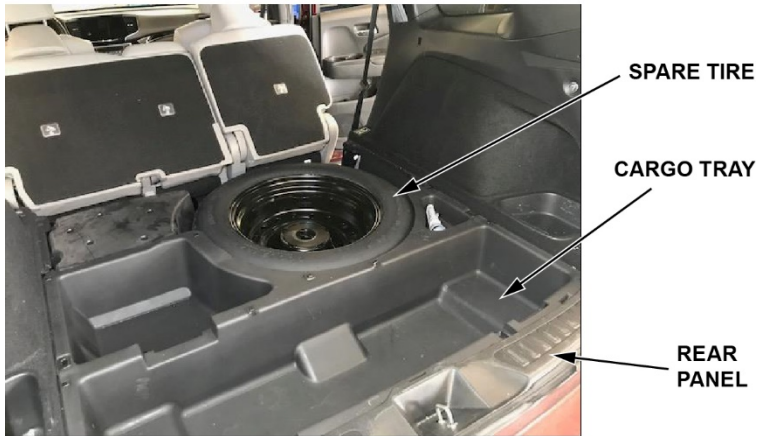
13. Remove the rear cargo cover, cargo tray, rear panel, and spare tire.

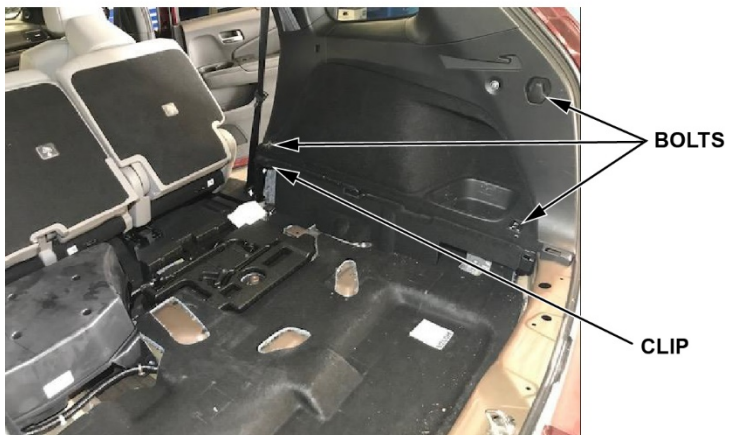
15. Remove the three screws and one clip from the quarter panel, then remove the panel.

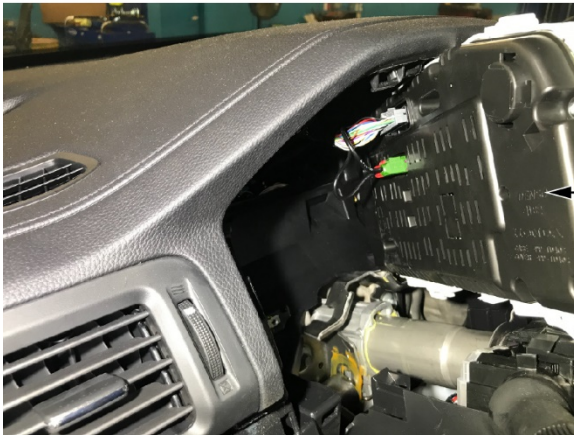
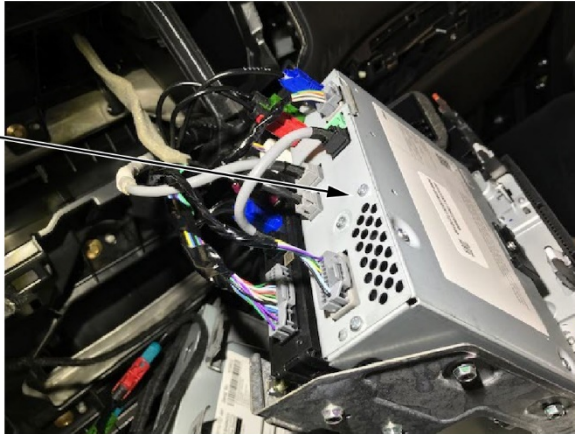
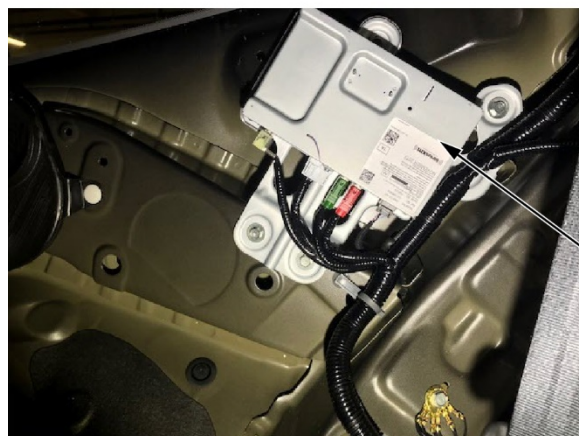
16. Disconnect the red and green FAKRA connectors at the gauge control module, infotainment unit, and tuner unit (Touring, Elite), using the straight FAKRA puller.

Disassemble the connectors one at a time to avoid swapping the green and red wires.

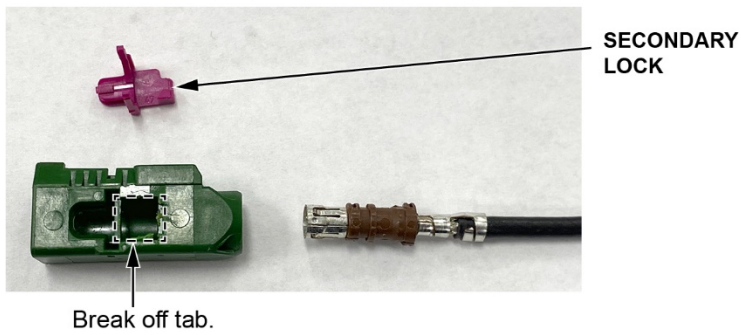
17. Using a small screwdriver, remove the secondary lock, then break off the tab as shown. Then, discard the housing and lock.

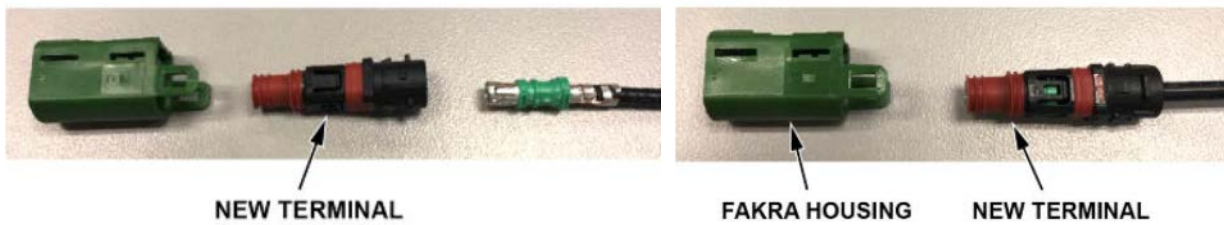
19. Select the correct color FAKRA housing, then slide the new terminal over the wire until it clicks into place.

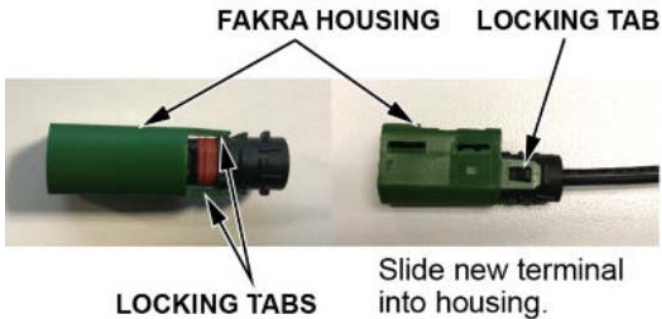
20. Line up locking tabs of the FAKRA housing to the new terminal, then push in the terminal until it clicks into place.

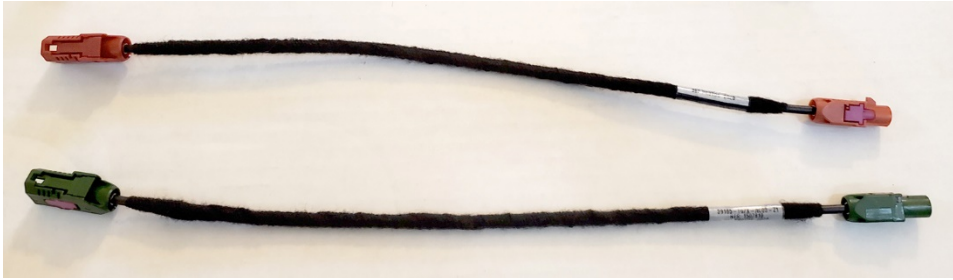
22. Install the MOST service cord between the dash harness and gauge control module (straight connector at both ends). Then, install the FAKRA connectors to the gauge control module.

Important:
Keep smooth curve
with radius of the bend
greater than 25 mm.

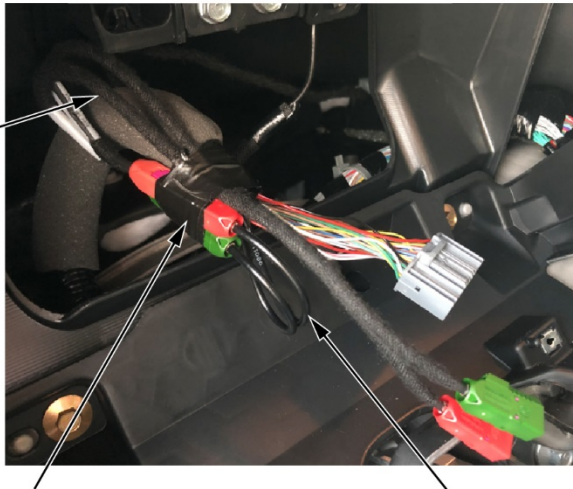
Attach couplers to the main span with tape to prevent any rattles (roughly in line with existing PVC tape on the tube). Attach the MOST cord at the same location.

Important:
Keep smooth curve with target
bend radius greater than 25 mm.

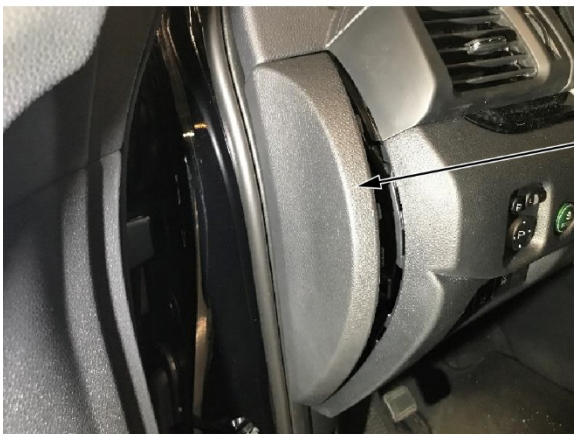
SIDE
COVER

1. Remove the side cover.

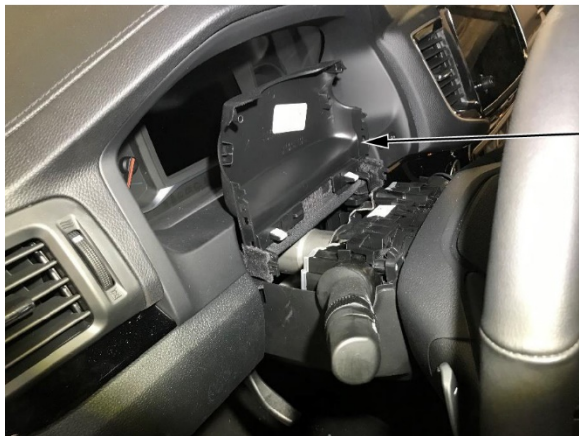
UPPER
COLUMN
COVER

2. Loosen the upper column cover.

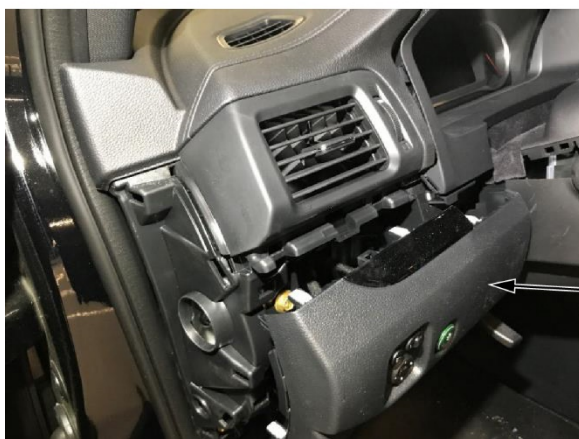
LOWER
DASH PANEL

3. Remove the lower dash panel.

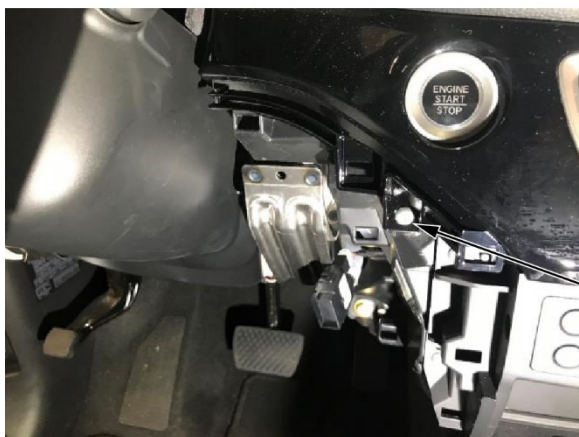
SCREW

4. Remove the screw to loosen the dash panel.

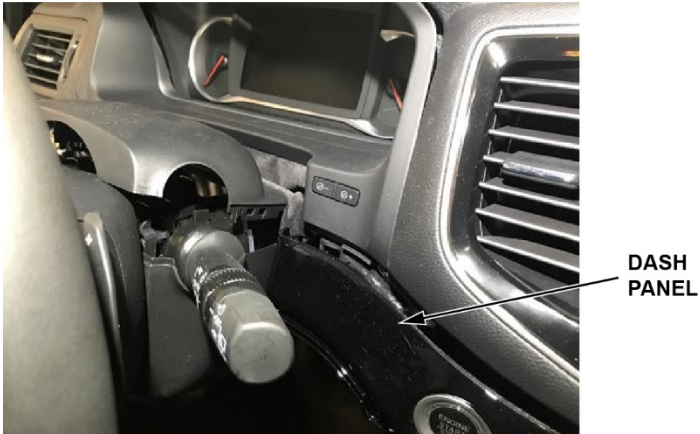
5. Pull back the dash panel to allow the meter bezel removal.

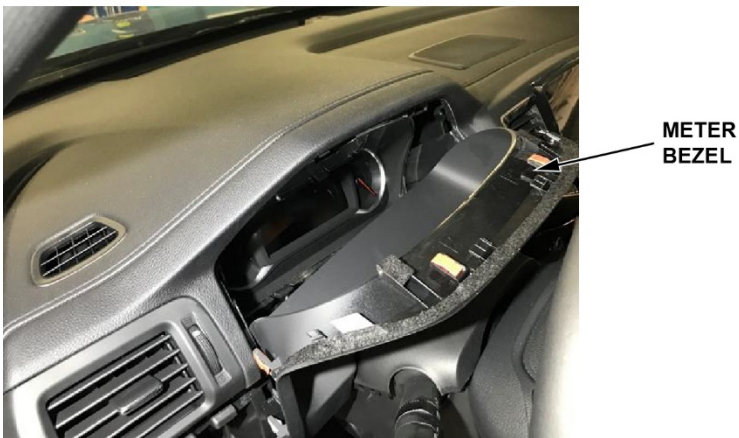
6. Disengage the clips around the meter bezel, then remove the bezel and upper column cover as one piece.

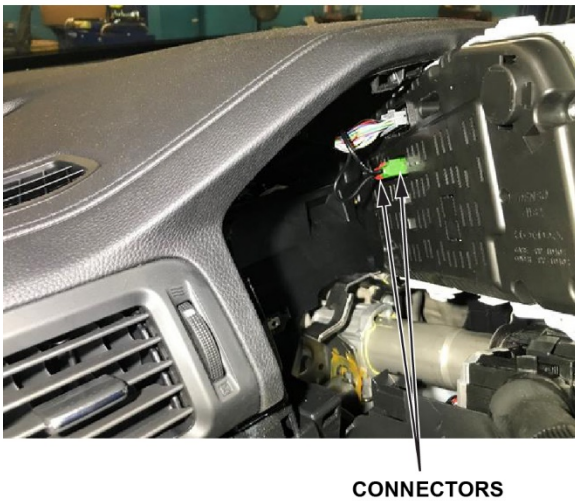
7. Turn the gauge control module to access the rear connectors. Then, using the straight FAKRA tool, disconnect the red and green FAKRA connectors, and remove them from the gauge control module.

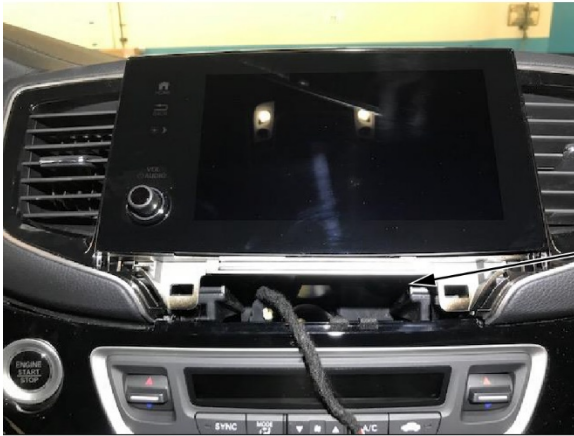
HAZARD
SWITCH
PANEL

8. Remove the hazard switch panel.

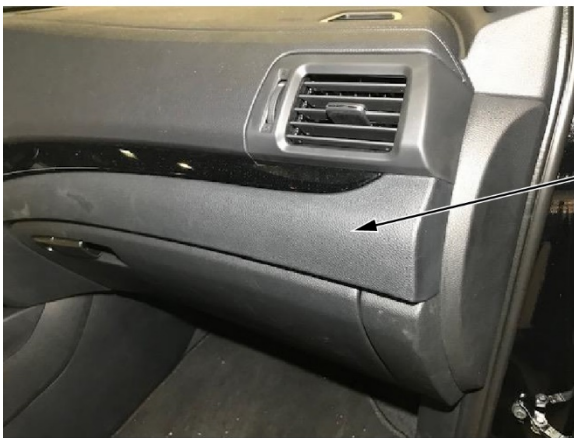
PASSENGER
MID DASH
PANEL

9. Remove the passenger mid dash panel.

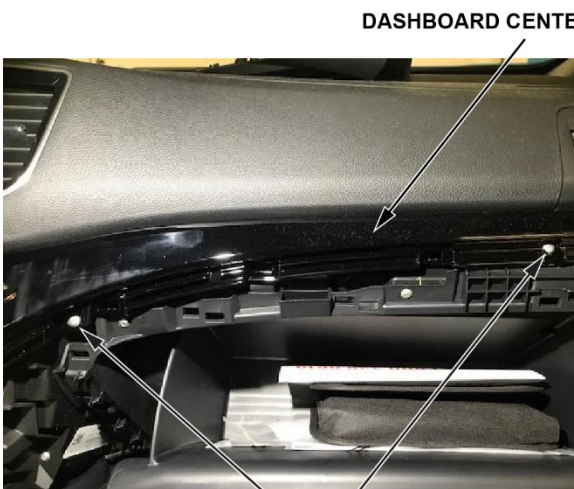
DASHBOARD CENTER MIDDLE TRIM

10. Remove the two screws, then remove the dashboard center middle trim.

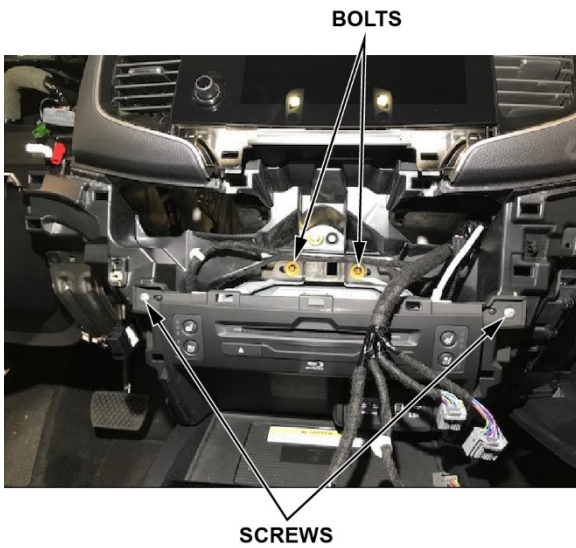
11. Remove the two screws and bolts to remove the DVD player.

Some trim levels will have a CD player or dashboard center lower panel.

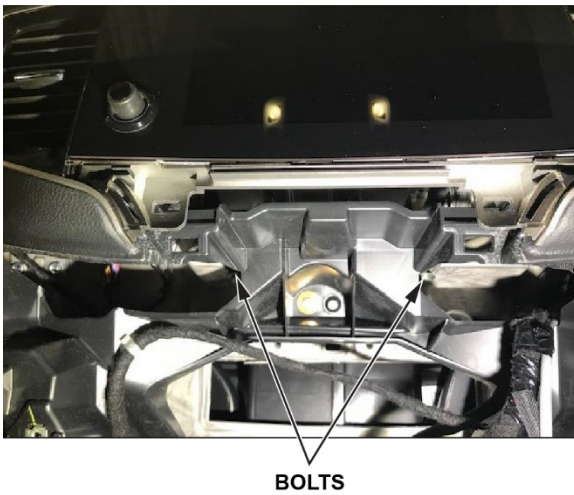
12. Loosen the two bolts holding the infotainment unit, then remove the unit.

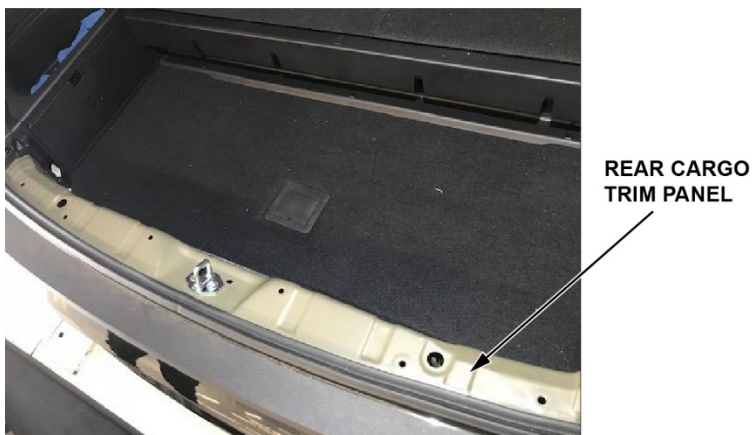
13. Remove the rear cargo trim panel.

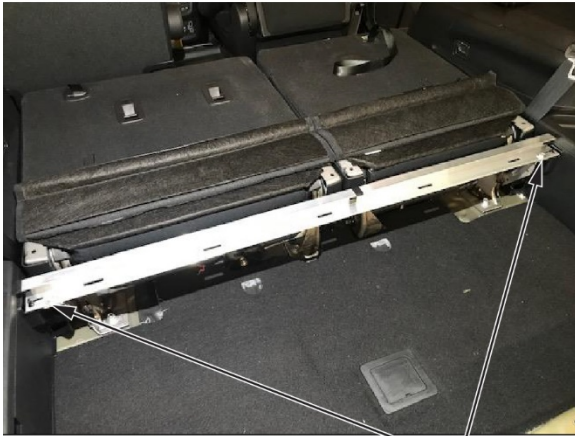
BOLTS

14. Remove the aluminum support brace by removing the two bolts.

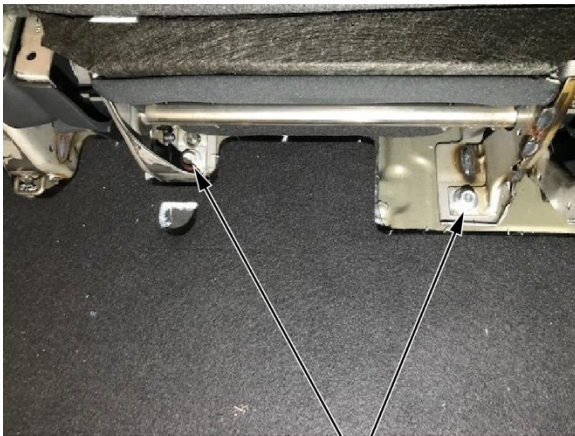
BOLTS

15. Remove the two rear bolts for the right third row seat.

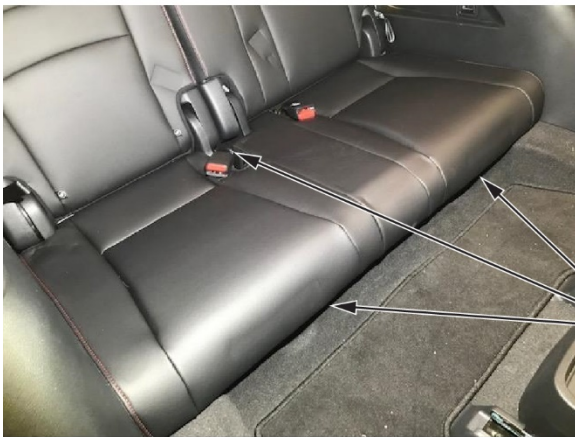
BOLTS

16. Remove the third row lower seat cushion by removing the three bolts.

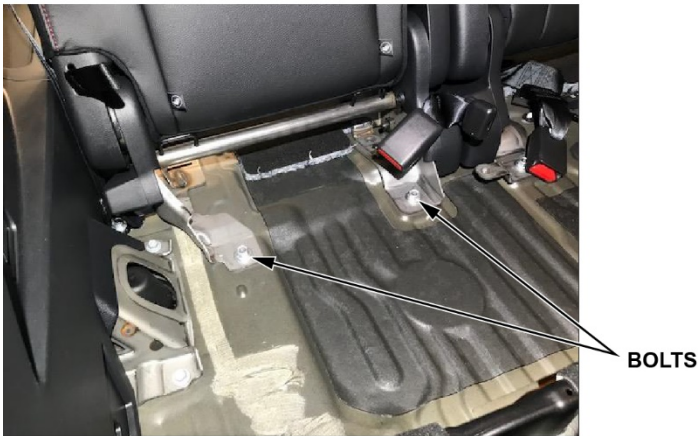
17. Remove the two front bolts for the passenger third row seat-back.

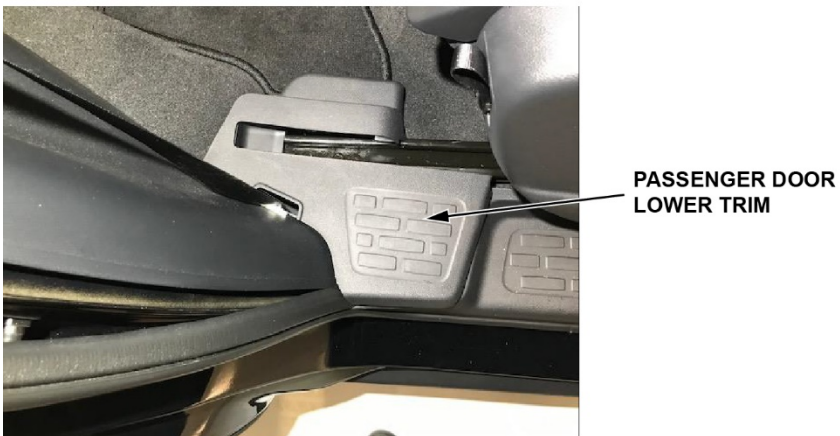
18. Remove the passenger door lower trim.

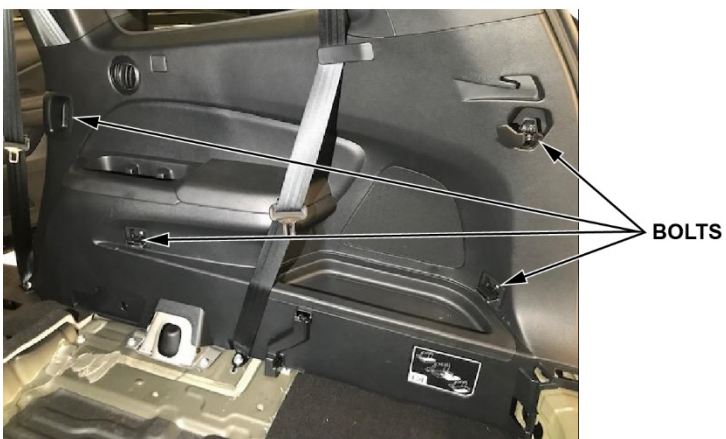
19. Remove the four bolts securing the right quarter panel.

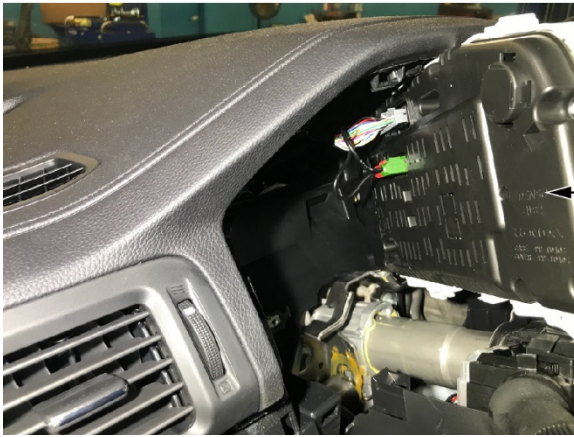
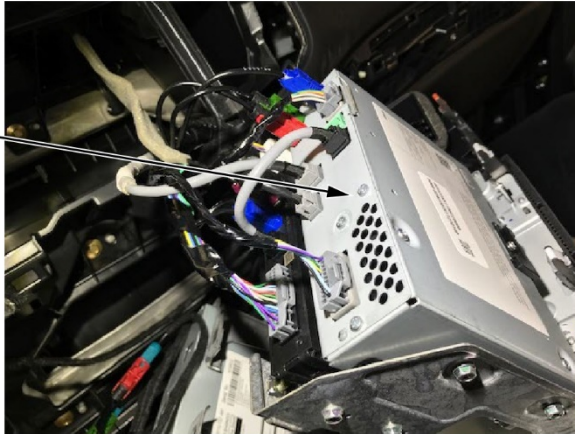
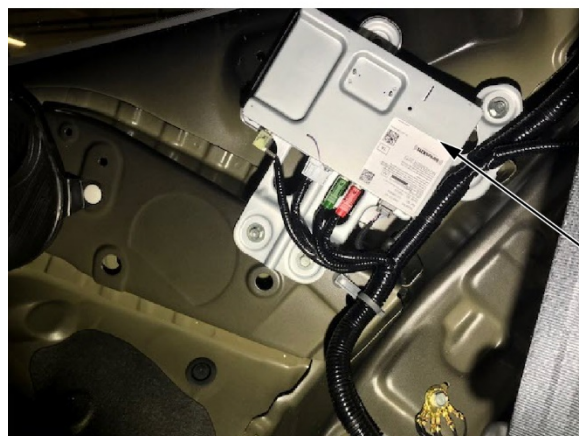
20. Disconnect the red and green FAKRA connectors at the gauge control module, infotainment unit, DVD player (if equipped), and tuner unit(Touring, Elite) using the straight FAKRA puller.

Disassemble the connectors one at a time to avoid swapping the green and red wires.

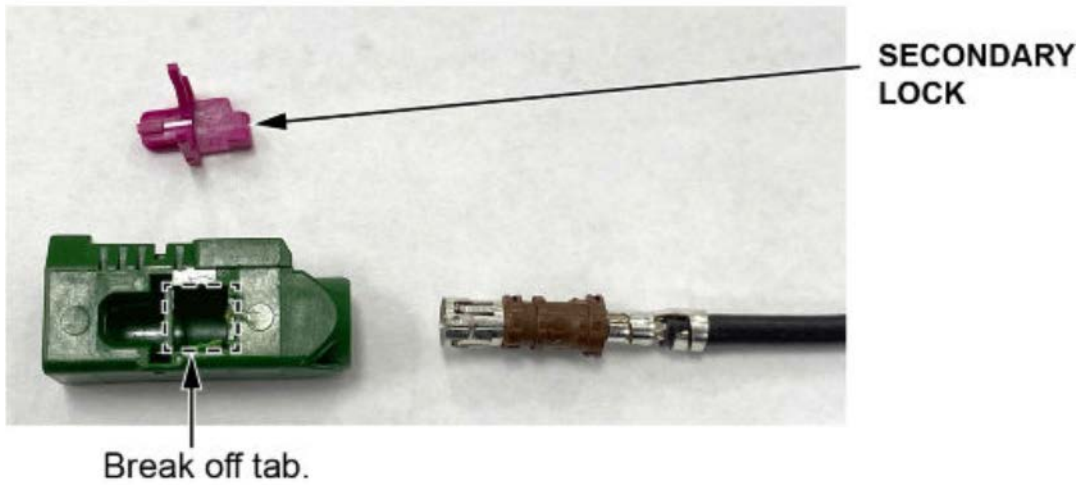
21. Using a small screwdriver, remove the secondary lock, then break off the tab as shown. Then, discard the housing and lock.

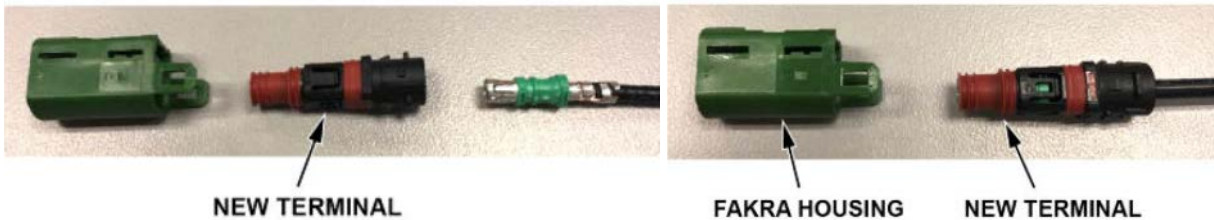
22. Pull and twist counterclockwise to remove the housing from the wire.
23. Select the correct color FAKRA housing, then slide the new terminal over the wire until it clicks into place.

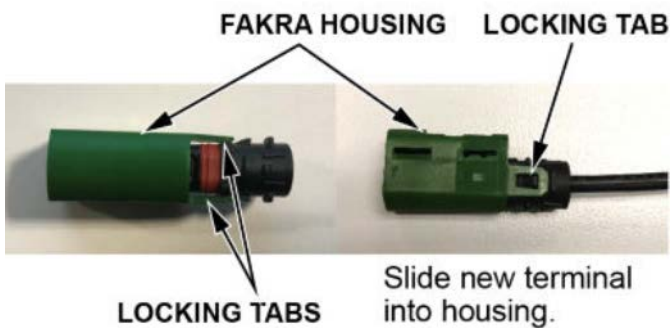
24. Line up the locking tabs of the FAKRA housing to the new terminal, then push in the terminal until it clicks into place.

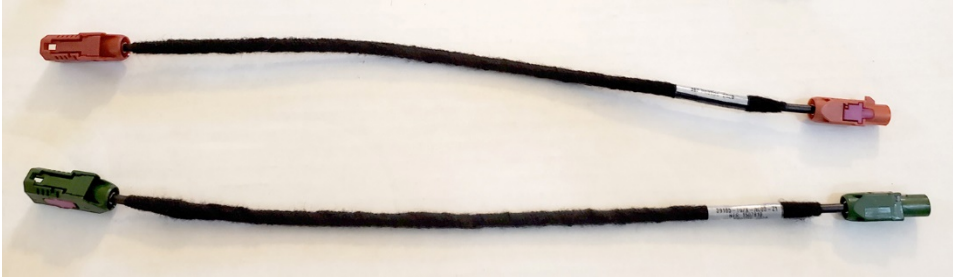
26. Install the MOST service cord between the dash harness and the gauge control module (straight connectors at both ends). Then, install the FAKRA connectors to the gauge control module.

Important:
Keep smooth curve
with radius of the bend
greater than 25 mm.

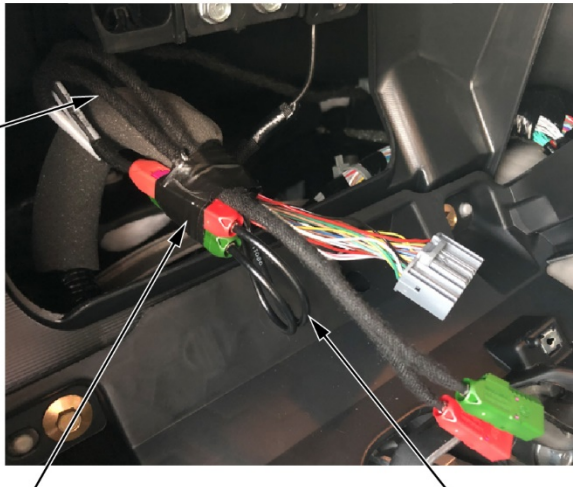
Attach couplers to the main span with tape to prevent any rattles (roughly in line with existing PVC tape on the tube). Attach the MOST cord at the same location.

Important:
Keep smooth curve with target
bend radius greater than 25 mm.

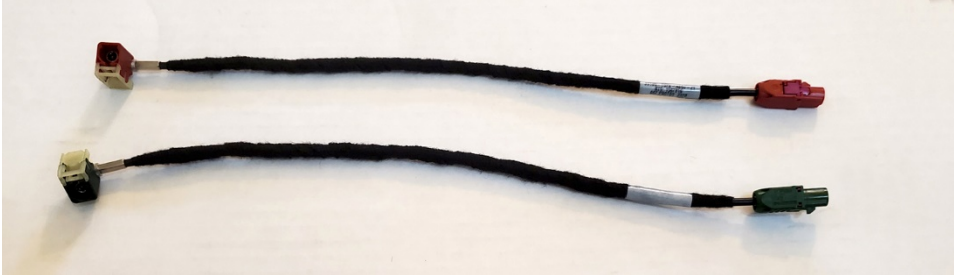
27. *Trim levels with CD or DVD player.* Install the MOST service cord between the dash harness and the CD or DVD player (straight connector to the dash harness and the 90 degree connector to the CD or DVD player). Then, install the FAKRA connectors to the CD or DVD player.

Important:
Keep smooth curve
with radius of the bend
greater than 25 mm.

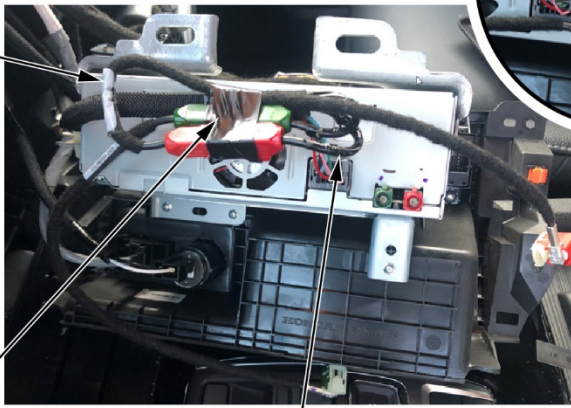
Important:
During re-install
ensure u-turn is
not pinched between
IP and Bluray Player
target bend radius
greater than 25 mm.

Attach couplers to the main span with
tape to prevent any rattles (roughly in
line with existing PVC tape on the tube).
Attach the MOST cord at the same location.

Important:
Keep smooth curve
with target bend radius
greater than 25 mm.
