SERVICE POLICY LETTER

Reference number:	SPL-30-1396	Issued: 14 July, 2020
Subject:	Managing Customer Expectations – Brake Squeal	
Applicable to:	All Dealers	
Distribute to:	Head of Business After Sales Manager Service Manager Sales Manager	Warranty Staff Technician(s) Parts Staff

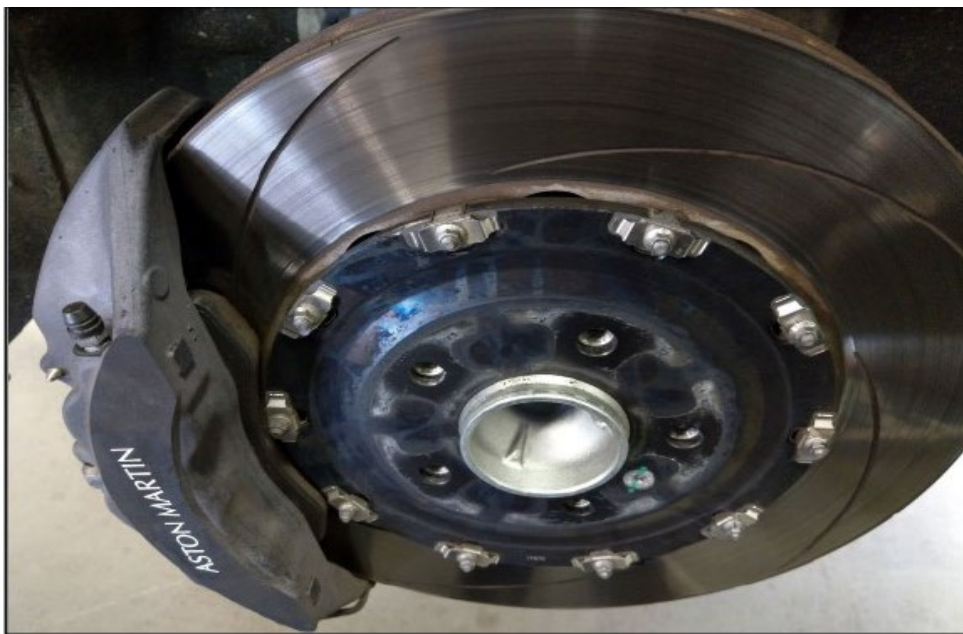
Figure 1

If the customer still has complaints related to brake noise, do a visual inspection of the brake discs, pads and wheel mounting face for signs of external contamination. If there are signs of external contamination because the incorrect wheel cleaner was used, this damage will not be covered by the vehicle warranty. The brake pads must be replaced.

The image that follows gives an example of contamination on the wheel mounting face and caliper refer to Figure 1.
